APPENDICES

APPENDIX G

Agar Grove noise policy for Demolition works.

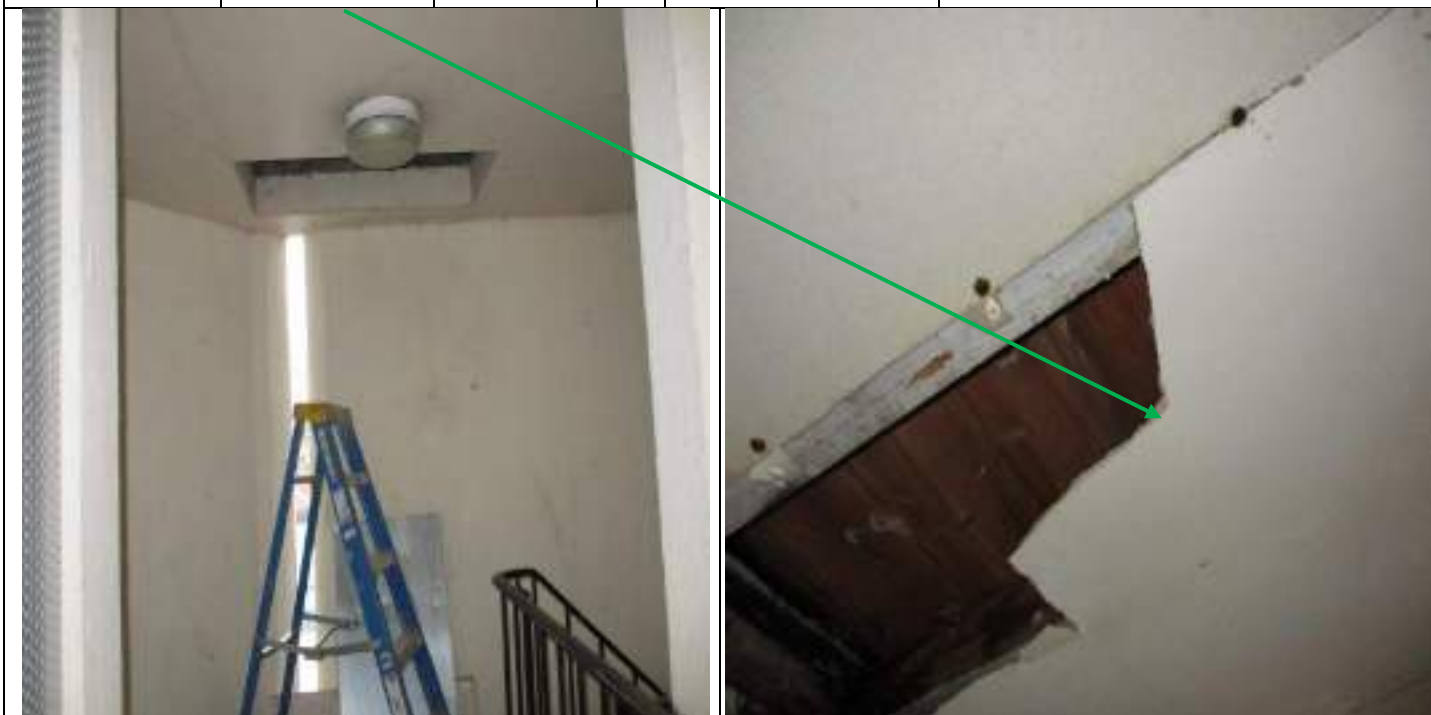
<i>Environmental Inspection Record</i>				FRAMPTON, AGAR GROVE, LONDON, NW1 9TB	
<i>Location</i>		<i>Component</i>		<i>Inspection Ref</i>	
EXTERNAL STAIRWELL		NON-ASBESTOS INSULATION BOARD TO TIMBER JOIST CEILING BRICK WALLS CONCRETE FLOOR & STAIRCASE		<i>Surveyor:</i>	PB & MC
				PICTURE 1 & 2 SAMPLE 8	
				<i>Date:</i>	20/01/21
				<i>Survey Type:</i>	REFURBISHMENT/ DEMOLITION SURVEY
<i>Condition:</i>	N/A	<i>Access:</i>	N/A	<i>Asbestos?</i>	NO
				<i>Re Inspection Date:</i>	N/A
<i>Friability:</i>	N/A	<i>Amount:</i>	N/A	<i>Type:</i>	NON ASBESTOS
<i>Damage:</i>	N/A	<i>Exposure:</i>	N/A	<i>Analysis:</i>	NADIS
<i>Position:</i>	INSULATION BOARD	<i>Risk Factor</i>	0	<i>Priority Assessment:</i>	NO RISK
		<i>Risk Band</i>	E

<i>Recommended Action</i>	NO ASBESTOS MATERIALS IDENTIFIED.
---------------------------	--

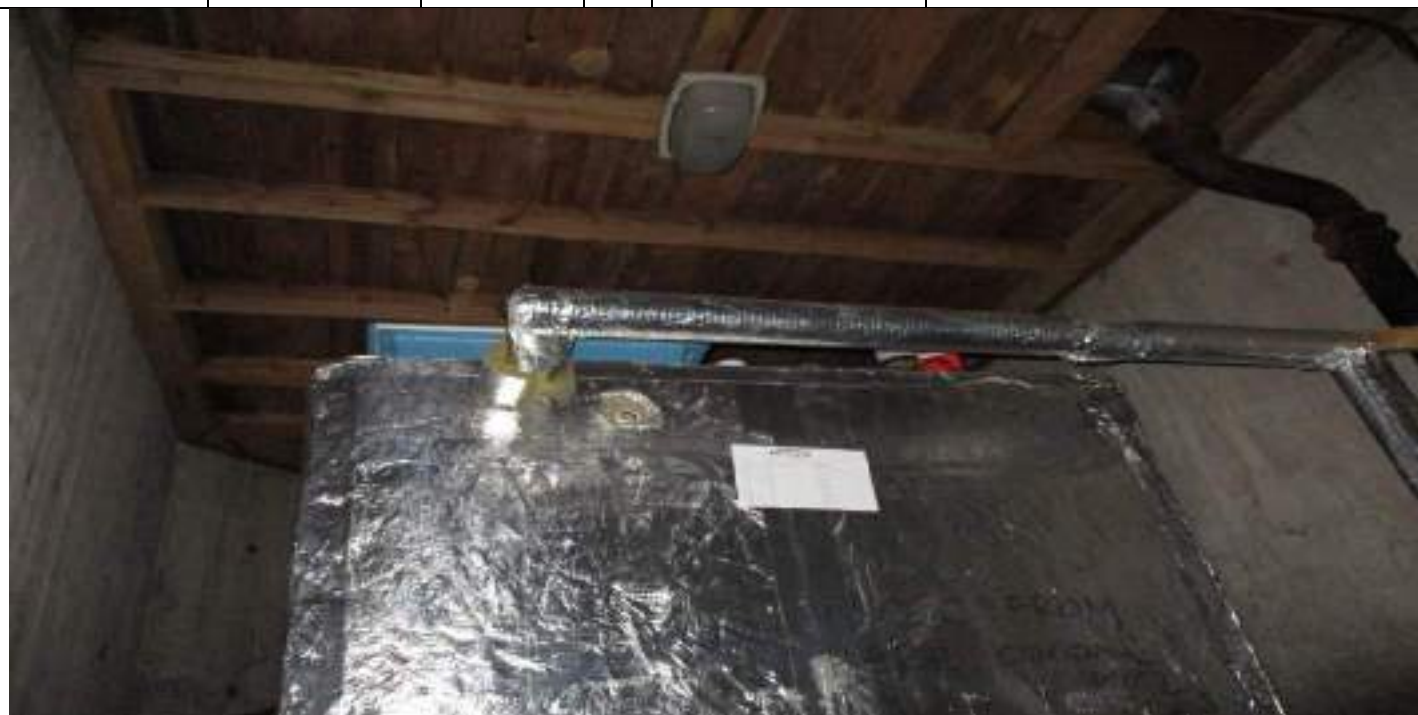
<i>Environmental Inspection Record</i>				FRAMPTON, AGAR GROVE, LONDON, NW1 9TB	
<i>Location</i>		<i>Component</i>		<i>Inspection Ref</i>	
LOFT TANK ROOM		TIMBER ROOF CONCRETE WALLS CONCRETE FLOOR FOIL FACES GLASS FIBRE INSULATION TO RIGID FIBRE GLASS WATER TANKS		<i>Surveyor:</i>	PB & MC
				PICTURE 5	
				<i>Date:</i>	20/01/21
				<i>Survey Type:</i>	REFURBISHMENT/ DEMOLITION SURVEY
<i>Condition:</i>	N/A	<i>Access:</i>	N/A	<i>Asbestos?</i>	NO
				<i>Re Inspection Date:</i>	N/A
<i>Friability:</i>	N/A	<i>Amount:</i>	N/A	<i>Type:</i>	NON ASBESTOS
<i>Damage:</i>	N/A	<i>Exposure:</i>	N/A	<i>Analysis:</i>	
<i>Position:</i>	WATER TANK	<i>Risk Factor</i>	0	<i>Priority Assessment:</i>	NO RISK
		<i>Risk Band</i>	E

<i>Recommended Action</i>	NO ASBESTOS MATERIALS IDENTIFIED.
---------------------------	--

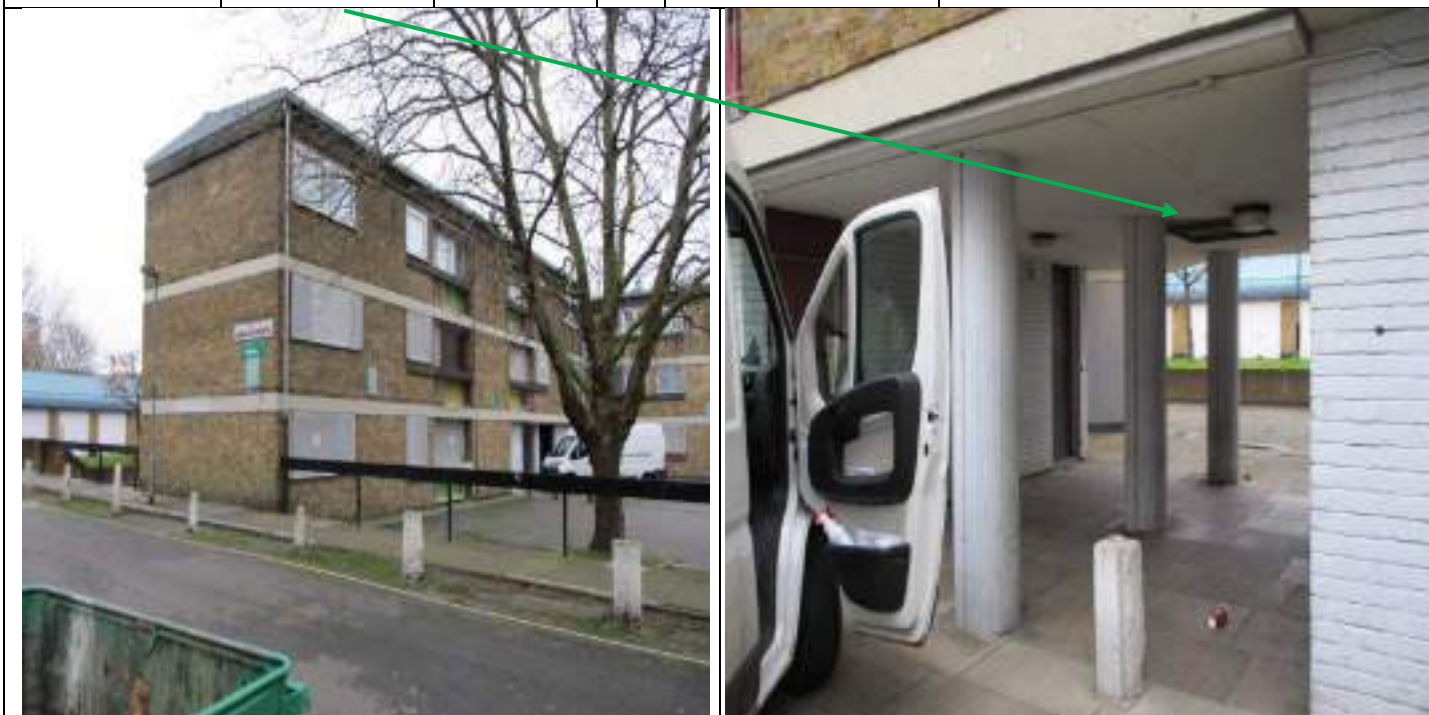
<i>Environmental Inspection Record</i>				ABBOTSBURY, AGAR GROVE, LONDON, NW1 9TB	
<i>Location</i>		<i>Component</i>		<i>Inspection Ref</i>	
EXTERNAL		NON-ASBESTOS INSULATION BOARD TO TIMBER JOIST CEILING BRICK WALLS CONCRETE FLOOR		<i>Surveyor:</i>	PB & MC
				PICTURE 6 & 7 AS SAMPLE 8	
				<i>Date:</i>	20/01/21
				<i>Survey Type:</i>	REFURBISHMENT/ DEMOLITION SURVEY
<i>Condition:</i>	N/A	<i>Access:</i>	N/A	<i>Asbestos?</i>	NO
				<i>Re Inspection Date:</i>	N/A
<i>Friability:</i>	N/A	<i>Amount:</i>	N/A	<i>Type:</i>	NON ASBESTOS
<i>Damage:</i>	N/A	<i>Exposure:</i>	N/A	<i>Analysis:</i>	N/A
<i>Position:</i>	INSULATION BOARD	<i>Risk Factor</i>	0	<i>Priority Assessment:</i>	NO RISK
		<i>Risk Band</i>	E

<i>Recommended Action</i>	NO ASBESTOS MATERIALS IDENTIFIED.
---------------------------	--

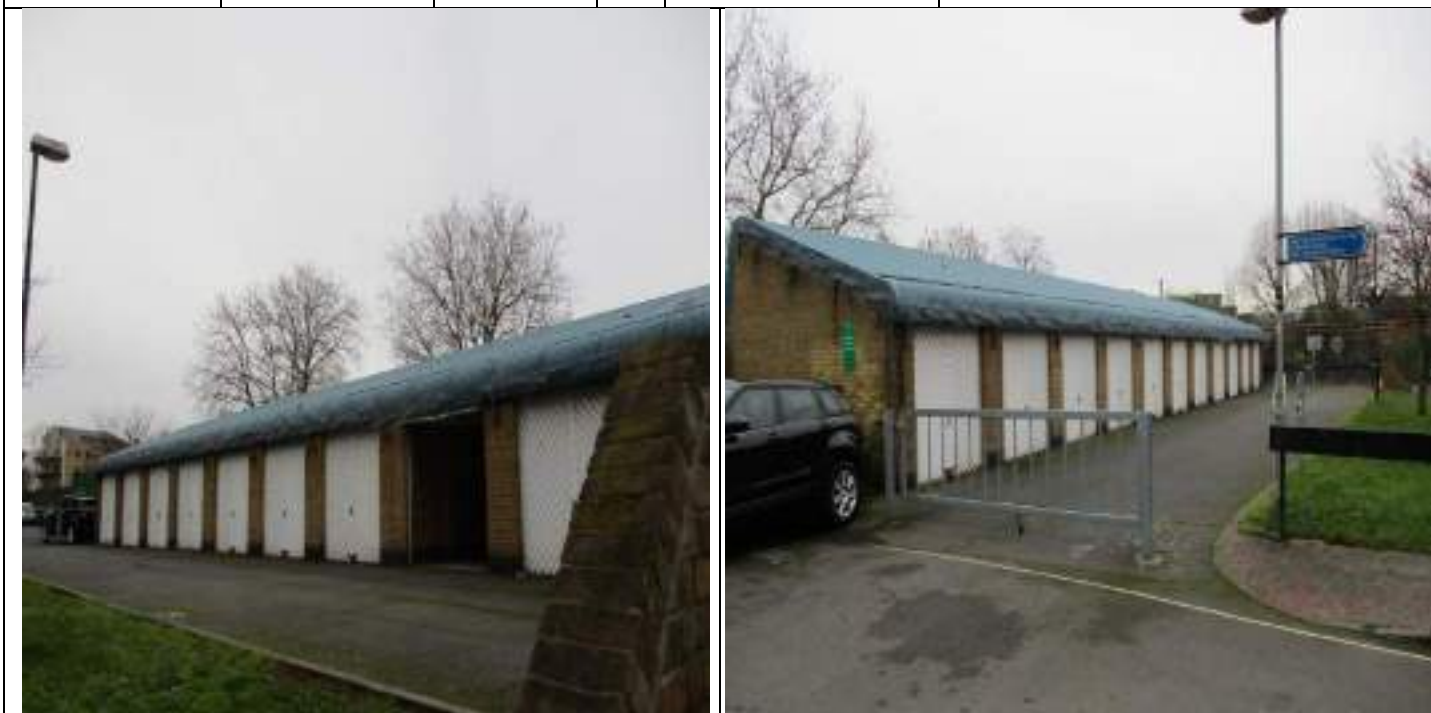
<i>Environmental Inspection Record</i>				ABBOTSBURY, AGAR GROVE, LONDON, NW1 9TB	
<i>Location</i>		<i>Component</i>		<i>Inspection Ref</i>	
EXTERNAL GARAGES		PROFILED METAL SHEET ROOF BRICK WALLS CONCRETE FLOOR		<i>Surveyor:</i>	PB & MC
				PICTURE 10 & 11	
				<i>Date:</i>	20/01/21
				<i>Survey Type:</i>	REFURBISHMENT/ DEMOLITION SURVEY
<i>Condition:</i>	N/A	<i>Access:</i>	N/A	<i>Asbestos?</i>	NO
				<i>Re Inspection Date:</i>	N/A
<i>Friability:</i>	N/A	<i>Amount:</i>	N/A	<i>Type:</i>	NON ASBESTOS
<i>Damage:</i>	N/A	<i>Exposure:</i>	N/A	<i>Analysis:</i>	N/A
<i>Position:</i>	GARAGES	<i>Risk Factor</i>	0	<i>Priority Assessment:</i>	NO RISK
		<i>Risk Band</i>	E

<i>Recommended Action</i>	NO ASBESTOS MATERIALS IDENTIFIED.
---------------------------	--

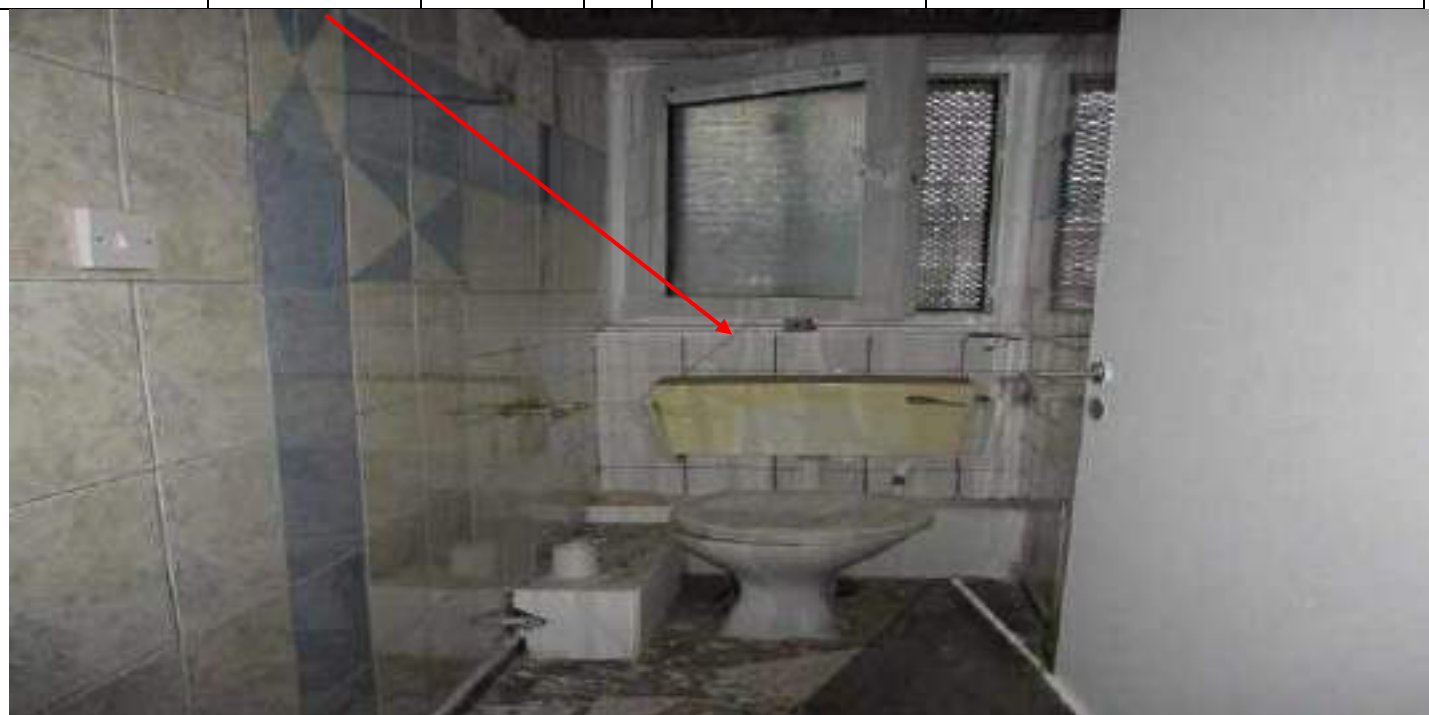
<i>Environmental Inspection Record</i>			FRAMPTON, AGAR GROVE, LONDON, NW1 2SN		
<i>Location</i>		<i>Component</i>		<i>Inspection Ref</i>	
GROUND FLOOR FLAT 2 WC		ASBESTOS CEMENT SHELF		<i>Surveyor:</i>	PB & MC
				PICTURE 19 AS SAMPLE 4	
				<i>Date:</i>	19/01/21
				<i>Survey Type:</i>	REFURBISHMENT/ DEMOLITION SURVEY
<i>Condition:</i>	FAIR	<i>Access:</i>	EASY	<i>Asbestos?</i>	YES
				<i>Re Inspection Date:</i>	N/A
<i>Friability:</i>	LOW	<i>Amount:</i>	APPROX: 0.5M ²	<i>Type:</i>	CHRYSOTILE
<i>Damage:</i>	LOW	<i>Exposure:</i>	OCCUPANTS	<i>Analysis:</i>	< 25%
<i>Position:</i>	CEMENT SHELF	<i>Risk Factor</i>	5	<i>Priority Assessment:</i>	MINOR RISK
		<i>Risk Band</i>	D

<i>Recommended Action</i>	REMOVE IDENTIFIED ASBESTOS CEMENT SHELF BEFORE DEMOLITION WORKS COMMENCE, USING A COMPETENT CONTRACTOR
----------------------------------	---
