APPENDICES

APPENDIX G

Agar Grove noise policy for Demolition works.

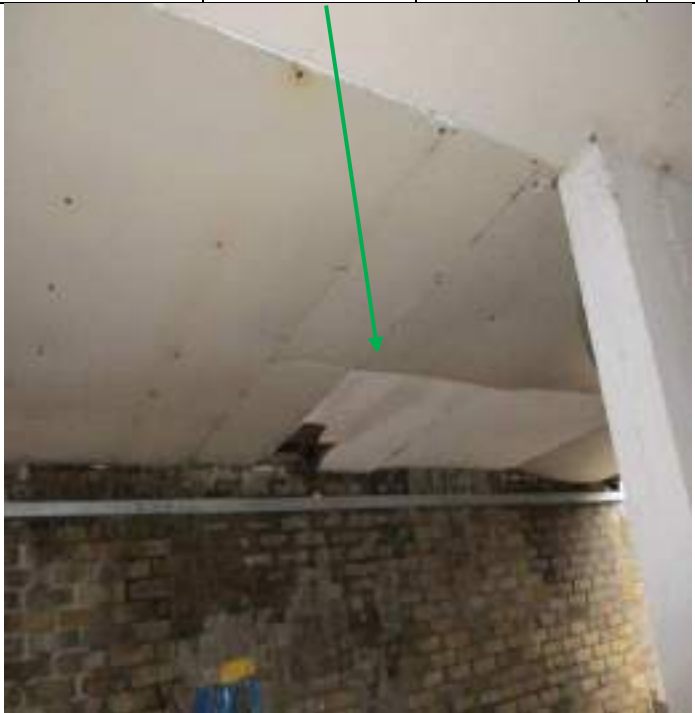
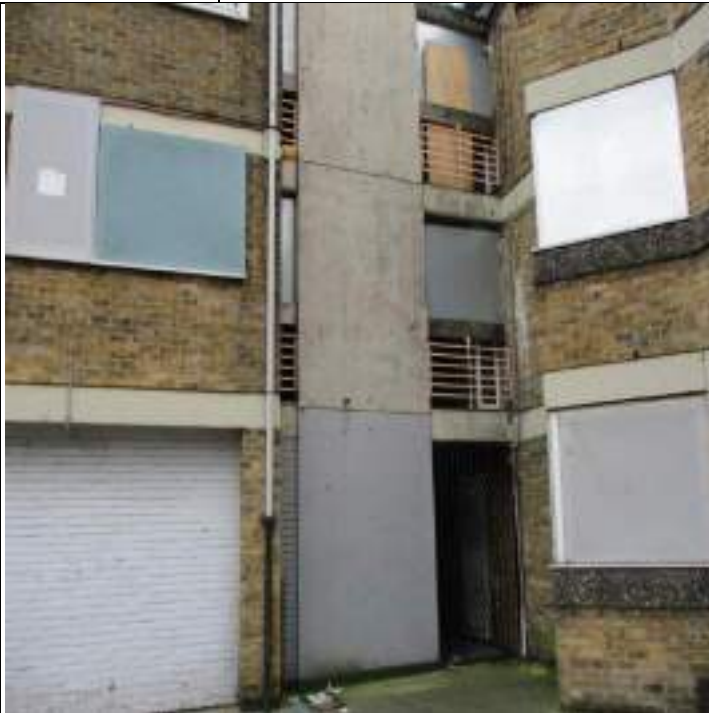
<i>Environmental Inspection Record</i>				FRAMPTON, AGAR GROVE, LONDON, NW1 9TB	
<i>Location</i>		<i>Component</i>		<i>Inspection Ref</i>	
EXTERNAL		NON-ASBESTOS INSULATION BOARD TO TIMBER JOIST CEILING BRICK WALLS CONCRETE FLOOR		<i>Surveyor:</i>	PB & MC
				PICTURE 3 & 4 AS SAMPLE 8	
				<i>Date:</i>	20/01/21
				<i>Survey Type:</i>	REFURBISHMENT/ DEMOLITION SURVEY
<i>Condition:</i>	N/A	<i>Access:</i>	N/A	<i>Asbestos?</i>	NO
				<i>Re Inspection Date:</i>	N/A
<i>Friability:</i>	N/A	<i>Amount:</i>	N/A	<i>Type:</i>	NON ASBESTOS
<i>Damage:</i>	N/A	<i>Exposure:</i>	N/A	<i>Analysis:</i>	N/A
<i>Position:</i>	INSULATION BOARD	<i>Risk Factor</i>	0	<i>Priority Assessment:</i>	NO RISK
		<i>Risk Band</i>	E

<i>Recommended Action</i>		NO ASBESTOS MATERIALS IDENTIFIED.

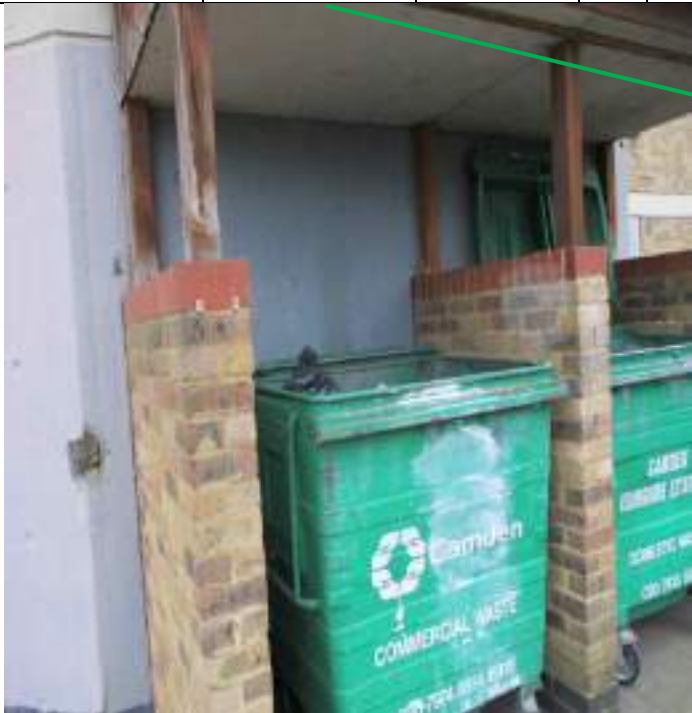
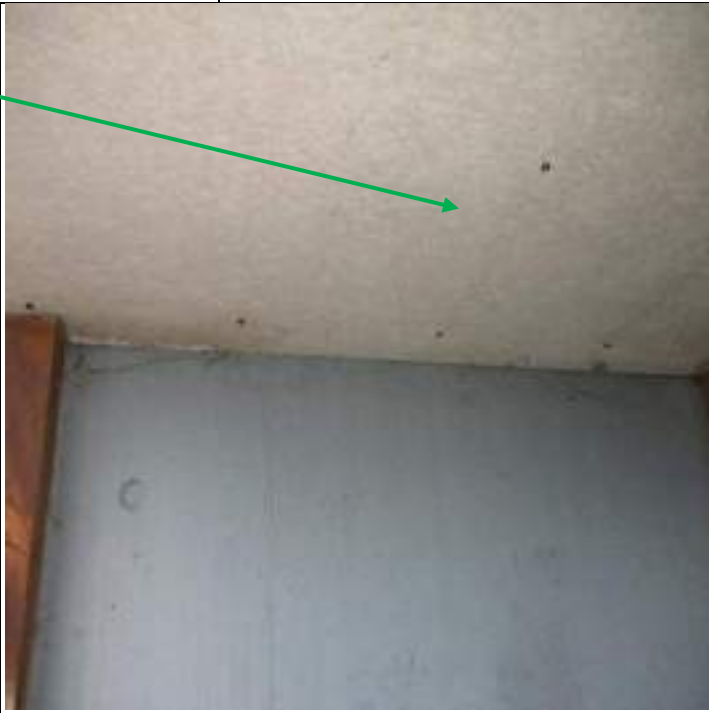
<i>Environmental Inspection Record</i>				ABBOTSBURY, AGAR GROVE, LONDON, NW1 9TB	
<i>Location</i>		<i>Component</i>		<i>Inspection Ref</i>	
EXTERNAL BIN STORE		NON-ASBESTOS INSULATION BOARD TO TIMBER JOIST CEILING BRICK WALLS CONCRETE FLOOR		<i>Surveyor:</i>	PB & MC
				PICTURE 8 & 9 AS SAMPLE 8	
				<i>Date:</i>	20/01/21
				<i>Survey Type:</i>	REFURBISHMENT/ DEMOLITION SURVEY
<i>Condition:</i>	N/A	<i>Access:</i>	N/A	<i>Asbestos?</i>	NO
				<i>Re Inspection Date:</i>	N/A
<i>Friability:</i>	N/A	<i>Amount:</i>	N/A	<i>Type:</i>	NON ASBESTOS
<i>Damage:</i>	N/A	<i>Exposure:</i>	N/A	<i>Analysis:</i>	N/A
<i>Position:</i>	INSULATION BOARD	<i>Risk Factor</i>	0	<i>Priority Assessment:</i>	NO RISK
		<i>Risk Band</i>	E

<i>Recommended Action</i>		NO ASBESTOS MATERIALS IDENTIFIED.

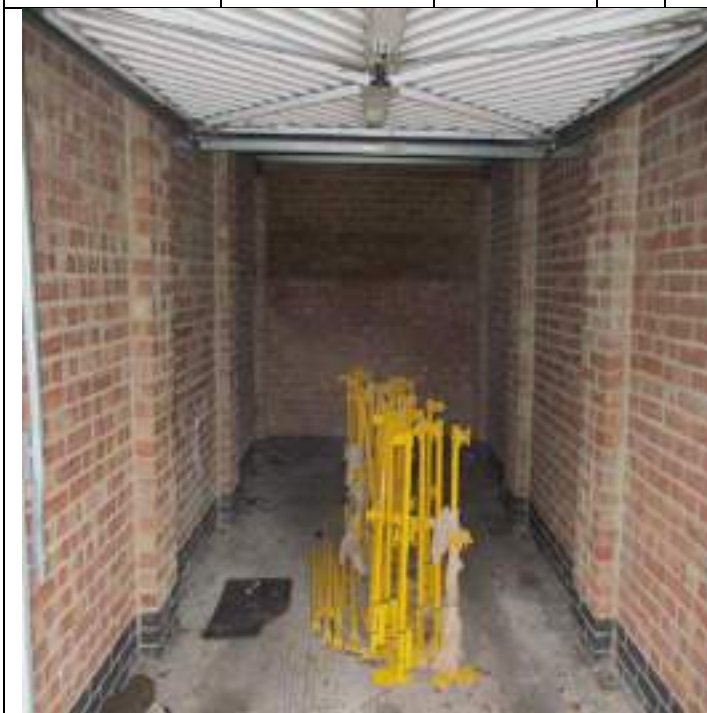
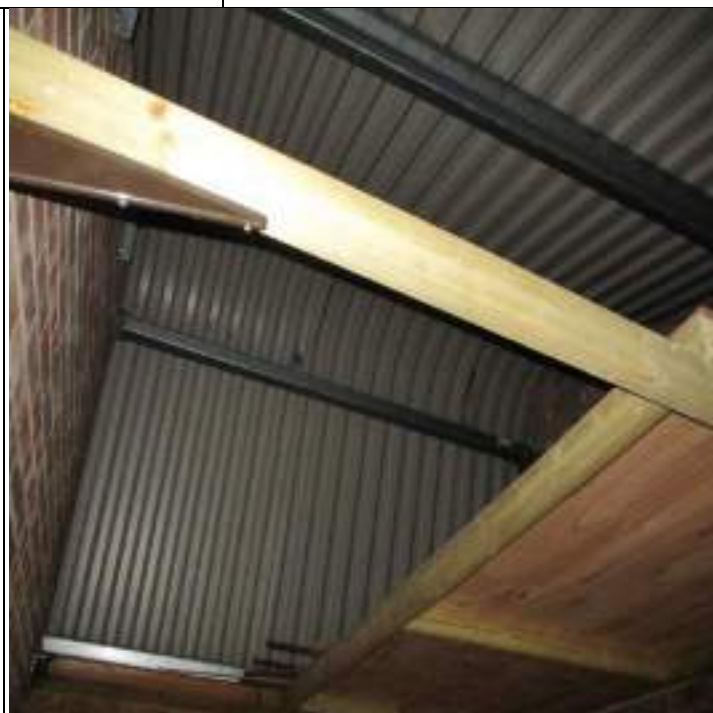
<i>Environmental Inspection Record</i>				ABBOTSBURY, AGAR GROVE, LONDON, NW1 9TB	
<i>Location</i>		<i>Component</i>		<i>Inspection Ref</i>	
EXTERNAL GARAGES		PROFILED METAL SHEET ROOF BRICK WALLS CONCRETE FLOOR		<i>Surveyor:</i>	PB & MC
				PICTURE 12 & 13	
				<i>Date:</i>	20/01/21
				<i>Survey Type:</i>	REFURBISHMENT/ DEMOLITION SURVEY
<i>Condition:</i>	N/A	<i>Access:</i>	N/A	<i>Asbestos?</i>	NO
				<i>Re Inspection Date:</i>	N/A
<i>Friability:</i>	N/A	<i>Amount:</i>	N/A	<i>Type:</i>	NON ASBESTOS
<i>Damage:</i>	N/A	<i>Exposure:</i>	N/A	<i>Analysis:</i>	N/A
<i>Position:</i>	GARAGES	<i>Risk Factor</i>	0	<i>Priority Assessment:</i>	NO RISK
		<i>Risk Band</i>	E

<i>Recommended Action</i>	NO ASBESTOS MATERIALS IDENTIFIED.
----------------------------------	--

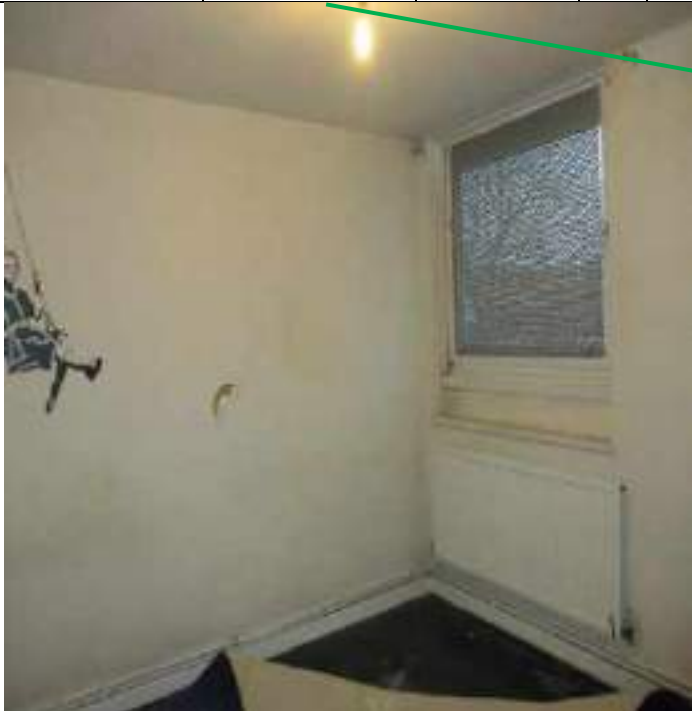
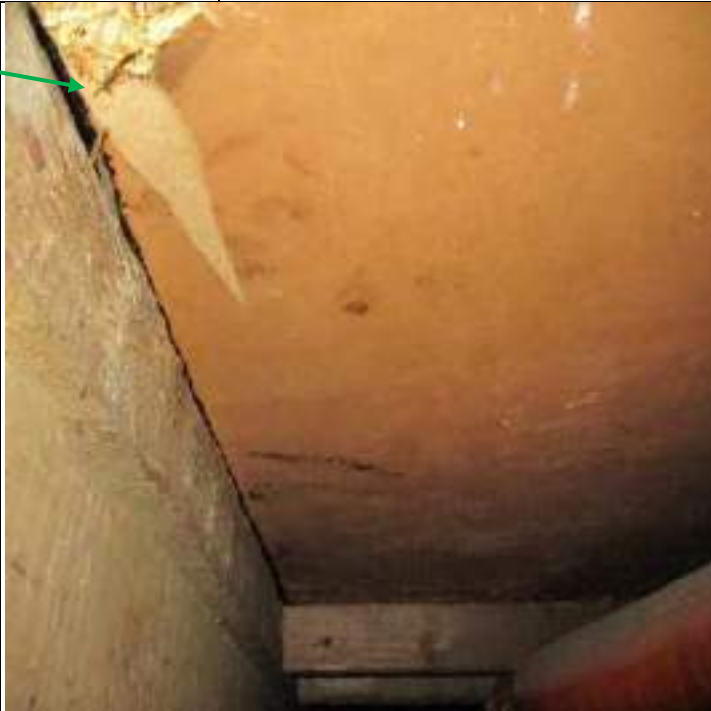
<i>Environmental Inspection Record</i>				ABBOTSBURY, AGAR GROVE, LONDON, NW1 9TB	
<i>Location</i>		<i>Component</i>		<i>Inspection Ref</i>	
SECOND FLOOR FLAT 5 BEDROOM 3		NON-ASBESTOS BITUMEN ABOVE PLASTERBOARD CEILING WITH TIMBER JOISTS PLASTERED BRICK/BREEZE BLOCK WALLS CARPET OVER ASBESTOS VINYL FLOOR TILES & BITUMEN TO CONCRETE		<i>Surveyor:</i>	PB & MC
				PICTURE 1 & 2 SAMPLE 1	
				<i>Date:</i>	20/01/21
				<i>Survey Type:</i>	REFURBISHMENT/ DEMOLITION SURVEY
<i>Condition:</i>	N/A	<i>Access:</i>	N/A	<i>Asbestos?</i>	NO
				<i>Re Inspection Date:</i>	N/A
<i>Friability:</i>	N/A	<i>Amount:</i>	N/A	<i>Type:</i>	NON ASBESTOS
<i>Damage:</i>	N/A	<i>Exposure:</i>	N/A	<i>Analysis:</i>	NADIS
<i>Position:</i>	BITUMEN	<i>Risk Factor</i>	0	<i>Priority Assessment:</i>	NO RISK
		<i>Risk Band</i>	E

<i>Recommended Action</i>		NO ASBESTOS MATERIALS IDENTIFIED.

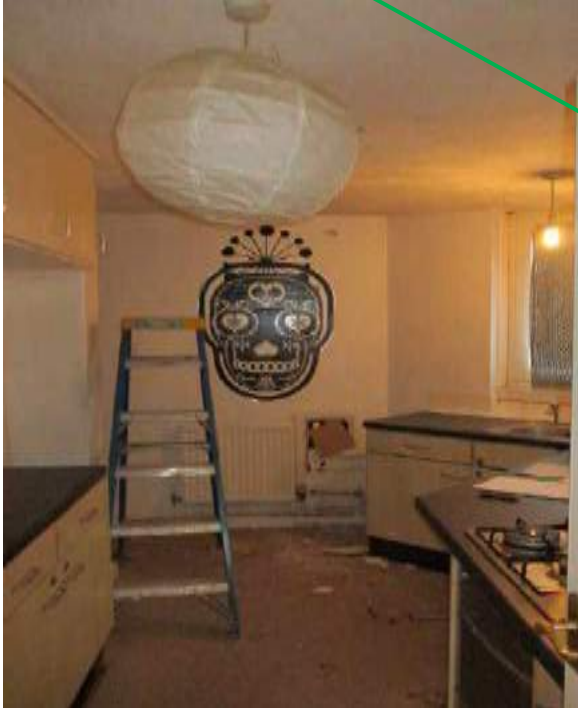
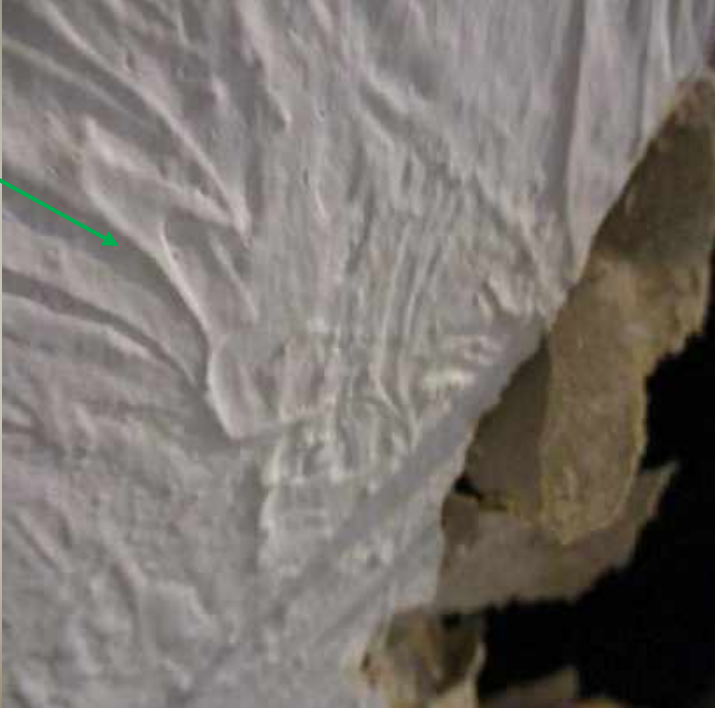
<i>Environmental Inspection Record</i>				ABBOTSBURY, AGAR GROVE, LONDON, NW1 9TB	
<i>Location</i>		<i>Component</i>		<i>Inspection Ref</i>	
SECOND FLOOR FLAT 5 KITCHEN		NON-ASBESTOS TEXTURED COATING TO PLASTERBOARD CEILING		<i>Surveyor:</i>	PB & MC
				PICTURE 10 & 11 SAMPLE 4	
				<i>Date:</i>	20/01/21
				<i>Survey Type:</i>	REFURBISHMENT/ DEMOLITION SURVEY
<i>Condition:</i>	N/A	<i>Access:</i>	N/A	<i>Asbestos?</i>	NO
				<i>Re Inspection Date:</i>	N/A
<i>Friability:</i>	N/A	<i>Amount:</i>	N/A	<i>Type:</i>	NON ASBESTOS
<i>Damage:</i>	N/A	<i>Exposure:</i>	N/A	<i>Analysis:</i>	NADIS
<i>Position:</i>	TEXTURED COATING	<i>Risk Factor</i>	0	<i>Priority Assessment:</i>	NO RISK
		<i>Risk Band</i>	E

<i>Recommended Action</i>		NO ASBESTOS MATERIALS IDENTIFIED.

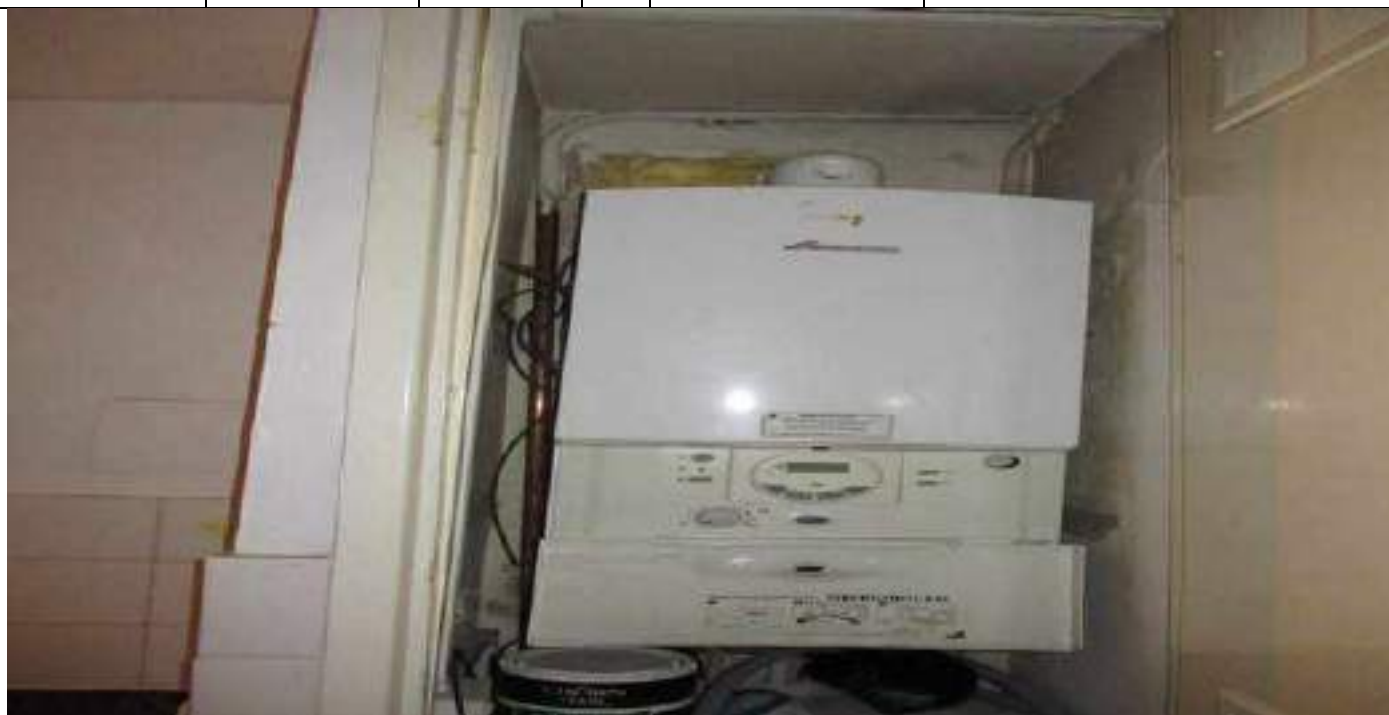
<i>Environmental Inspection Record</i>				ABBOTSBURY, AGAR GROVE, LONDON, NW1 9TB	
<i>Location</i>		<i>Component</i>		<i>Inspection Ref</i>	
SECOND FLOOR FLAT 5		MODERN BOILER WITH METAL FLUE		<i>Surveyor:</i>	PB & MC
				PICTURE 14	
				<i>Date:</i>	20/01/21
				<i>Survey Type:</i>	REFURBISHMENT/ DEMOLITION SURVEY
<i>Condition:</i>	N/A	<i>Access:</i>	N/A	<i>Asbestos?</i>	NO
				<i>Re Inspection Date:</i>	N/A
<i>Friability:</i>	N/A	<i>Amount:</i>	N/A	<i>Type:</i>	NON ASBESTOS
<i>Damage:</i>	N/A	<i>Exposure:</i>	N/A	<i>Analysis:</i>	N/A
<i>Position:</i>	CUPBOARDS	<i>Risk Factor</i>	0	<i>Priority Assessment:</i>	NO RISK
		<i>Risk Band</i>	E

NO ASBESTOS MATERIALS IDENTIFIED.

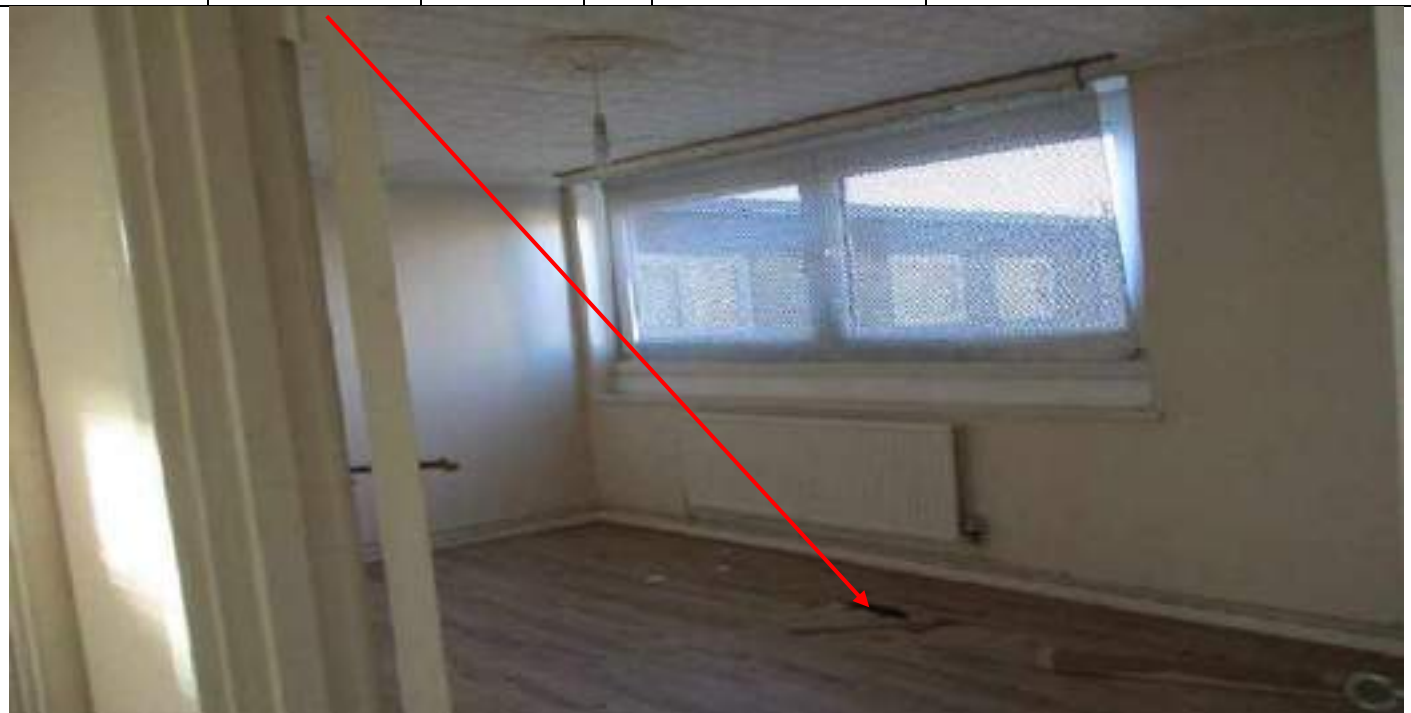
<i>Environmental Inspection Record</i>				ABBOTSBURY, AGAR GROVE, LONDON, NW1 9TB				
<i>Location</i>		<i>Component</i>			<i>Inspection Ref</i>			
SECOND FLOOR FLAT 4 BEDROOM 1		NON-ASBESTOS BITUMEN ABOVE PLASTERBOARD CEILING WITH TIMBER JOISTS PLASTERED BRICK/BREEZE BLOCK WALLS TIMBER FLOORING OVER ASBESTOS VINYL FLOOR TILES & BITUMEN TO CONCRETE			<i>Surveyor:</i>		PB & MC	
					PICTURE 15 AS SAMPLE 2			
					<i>Date:</i>		20/01/21	
					<i>Survey Type:</i>		REFURBISHMENT/ DEMOLITION SURVEY	
<i>Condition:</i>	FAIR	<i>Access:</i>	EASY		<i>Asbestos?</i>		YES	
						<i>Re Inspection Date:</i>		N/A
<i>Friability:</i>	LOW	<i>Amount:</i>	APPROX: 18M ²		<i>Type:</i>	CHRYSO TILE TO BOTH		
<i>Damage:</i>	LOW	<i>Exposure:</i>	OCCUPANTS		<i>Analysis:</i>	TILES	<7%	
						BITUMEN	<8%	
<i>Position:</i>	VINYL FLOOR TILE & BITUMEN	<i>Risk Factor</i>	4	<i>Priority Assessment:</i>	MINOR RISK			
		<i>Risk Band</i>	D

<i>Recommended Action</i>	REMOVE IDENTIFIED ASBESTOS VINYL TILES & ADHESIVE BEFORE DEMOLITION WORKS COMMENCE, USING A COMPETENT CONTRACTOR
----------------------------------	--

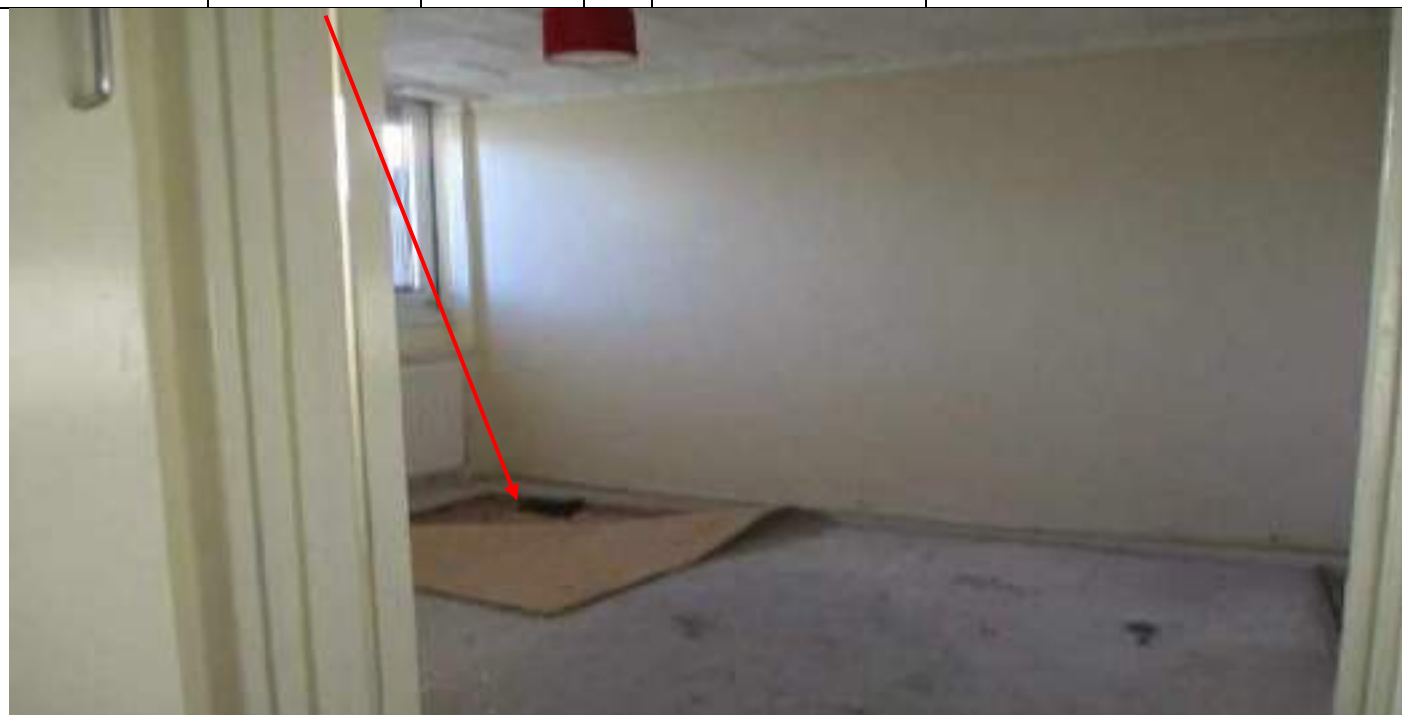
<i>Environmental Inspection Record</i>				ABBOTSBURY, AGAR GROVE, LONDON, NW1 9TB					
<i>Location</i>		<i>Component</i>			<i>Inspection Ref</i>				
SECOND FLOOR FLAT 4 BEDROOM 2		NON-ASBESTOS BITUMEN ABOVE PLASTERBOARD CEILING WITH TIMBER JOISTS PLASTERED BRICK/BREEZE BLOCK WALLS CARPET OVER ASBESTOS VINYL FLOOR TILES & BITUMEN TO CONCRETE			<i>Surveyor:</i>		PB & MC		
					PICTURE 16 AS SAMPLE 2				
					<i>Date:</i>		20/01/21		
					<i>Survey Type:</i>		REFURBISHMENT/ DEMOLITION SURVEY		
<i>Condition:</i>	FAIR	<i>Access:</i>	EASY		<i>Asbestos?</i>		YES		
					<i>Re Inspection Date:</i>			N/A	
<i>Friability:</i>	LOW	<i>Amount:</i>	APPROX: 10M ²		<i>Type:</i>	CHRYSO TILE TO BOTH			
<i>Damage:</i>	LOW	<i>Exposure:</i>	OCCUPANTS		<i>Analysis:</i>	TILES	<7%		
					BITUMEN		<8%		
<i>Position:</i>	VINYL FLOOR TILE & BITUMEN	<i>Risk Factor</i>	4	<i>Priority Assessment:</i>	MINOR RISK				
		<i>Risk Band</i>	D

<i>Recommended Action</i>	REMOVE IDENTIFIED ASBESTOS VINYL TILES & ADHESIVE BEFORE DEMOLITION WORKS COMMENCE, USING A COMPETENT CONTRACTOR
----------------------------------	---

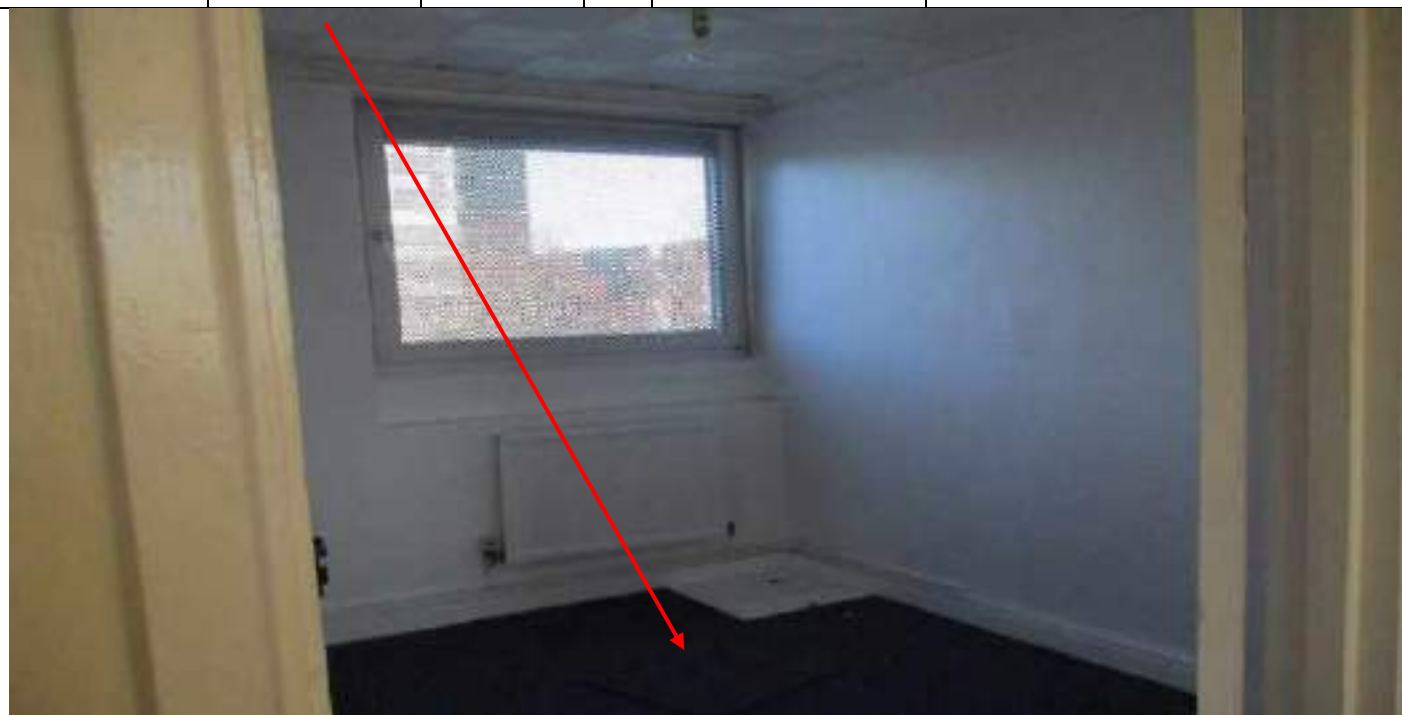
<i>Environmental Inspection Record</i>			ABBOTSBURY, AGAR GROVE, LONDON, NW1 9TB		
<i>Location</i>		<i>Component</i>		<i>Inspection Ref</i>	
SECOND FLOOR FLAT 4 BEDROOM 2		NON-ASBESTOS BITUMEN ABOVE PLASTERBOARD CEILING WITH TIMBER JOISTS PLASTERED BRICK/BREEZE BLOCK WALLS CARPET OVER ASBESTOS VINYL FLOOR TILES & BITUMEN TO CONCRETE		<i>Surveyor:</i>	PB & MC
				PICTURE 17 AS SAMPLE 2	
				<i>Date:</i>	20/01/21
				<i>Survey Type:</i>	REFURBISHMENT/ DEMOLITION SURVEY
<i>Condition:</i>	FAIR	<i>Access:</i>	EASY	<i>Asbestos?</i>	YES
				<i>Re Inspection Date:</i>	N/A
<i>Friability:</i>	LOW	<i>Amount:</i>	APPROX: 6M ²	<i>Type:</i>	CHRYSOTILE TO BOTH
<i>Damage:</i>	LOW	<i>Exposure:</i>	OCCUPANTS	<i>Analysis:</i>	TILES <7% BITUMEN <8%
<i>Position:</i>	VINYL FLOOR TILE & BITUMEN	<i>Risk Factor</i>	4	<i>Priority Assessment:</i>	MINOR RISK
		<i>Risk Band</i>	D

<i>Recommended Action</i>	REMOVE IDENTIFIED ASBESTOS VINYL TILES & ADHESIVE BEFORE DEMOLITION WORKS COMMENCE, USING A COMPETENT CONTRACTOR
----------------------------------	---

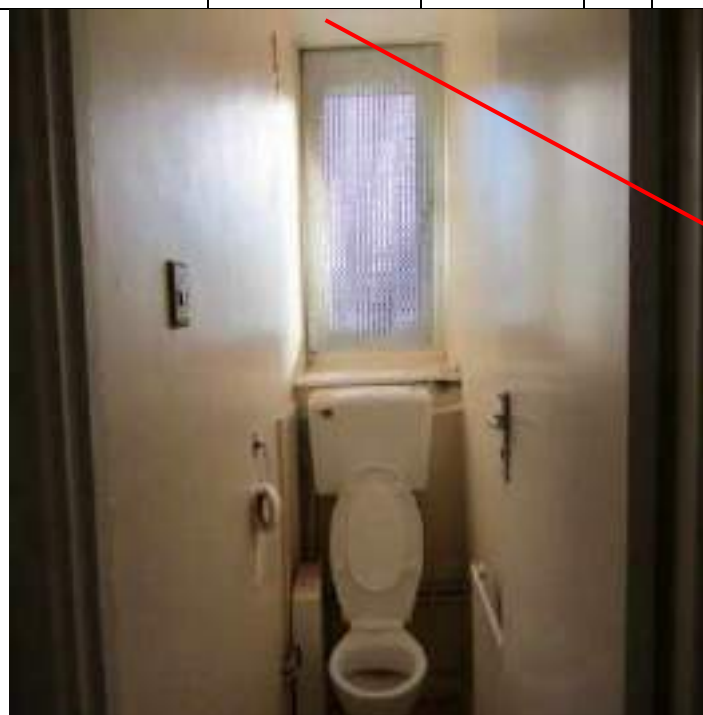
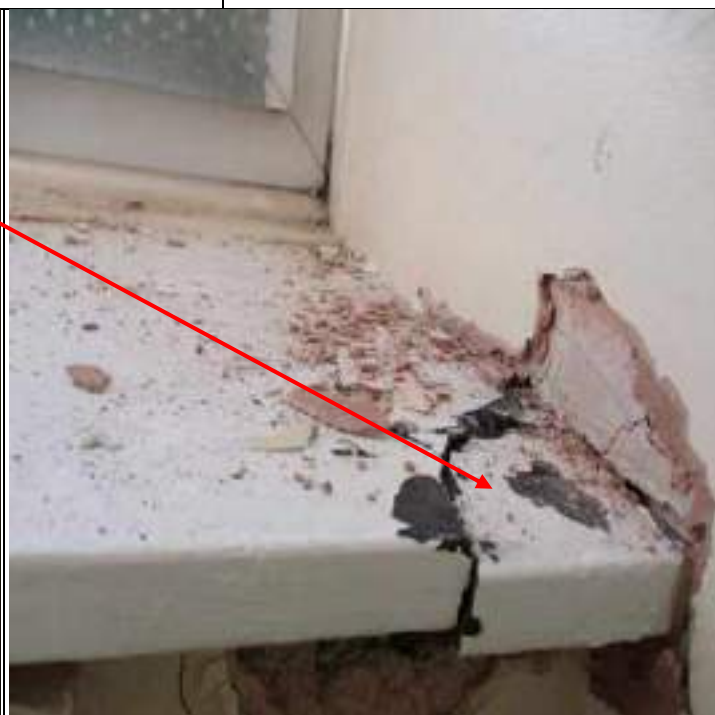
<i>Environmental Inspection Record</i>				ABBOTSBURY, AGAR GROVE, LONDON, NW1 9TB	
<i>Location</i>		<i>Component</i>		<i>Inspection Ref</i>	
SECOND FLOOR FLAT 4 WC		NON-ASBESTOS BITUMEN ABOVE PLASTERBOARD CEILING WITH TIMBER JOISTS PLASTERED BRICK/BREEZE BLOCK WALLS MODERN VINYL FLOOR COVER OVER ASBESTOS BITUMEN TO CONCRETE ASBESTOS CEMENT COMPOSITE SHELF		<i>Surveyor:</i>	PB & MC
				PICTURE 18 SAMPLE 5	
				<i>Date:</i>	20/01/21
				<i>Survey Type:</i>	REFURBISHMENT/ DEMOLITION SURVEY
<i>Condition:</i>	FAIR	<i>Access:</i>	EASY	<i>Asbestos?</i>	YES
				<i>Re Inspection Date:</i>	N/A
<i>Friability:</i>	LOW	<i>Amount:</i>	APPROX: 0.5M ²	<i>Type:</i>	CHRYSOTILE
<i>Damage:</i>	LOW	<i>Exposure:</i>	OCCUPANTS	<i>Analysis:</i>	< 25%
<i>Position:</i>	CEMENT COMPOSITE SHELF	<i>Risk Factor</i>	5	<i>Priority Assessment:</i>	MINOR RISK
		<i>Risk Band</i>	D

<i>Recommended Action</i>	REMOVE IDENTIFIED ASBESTOS CEMENT COMPOSITE SHELF BEFORE DEMOLITION WORKS COMMENCE, USING A COMPETENT CONTRACTOR
----------------------------------	---

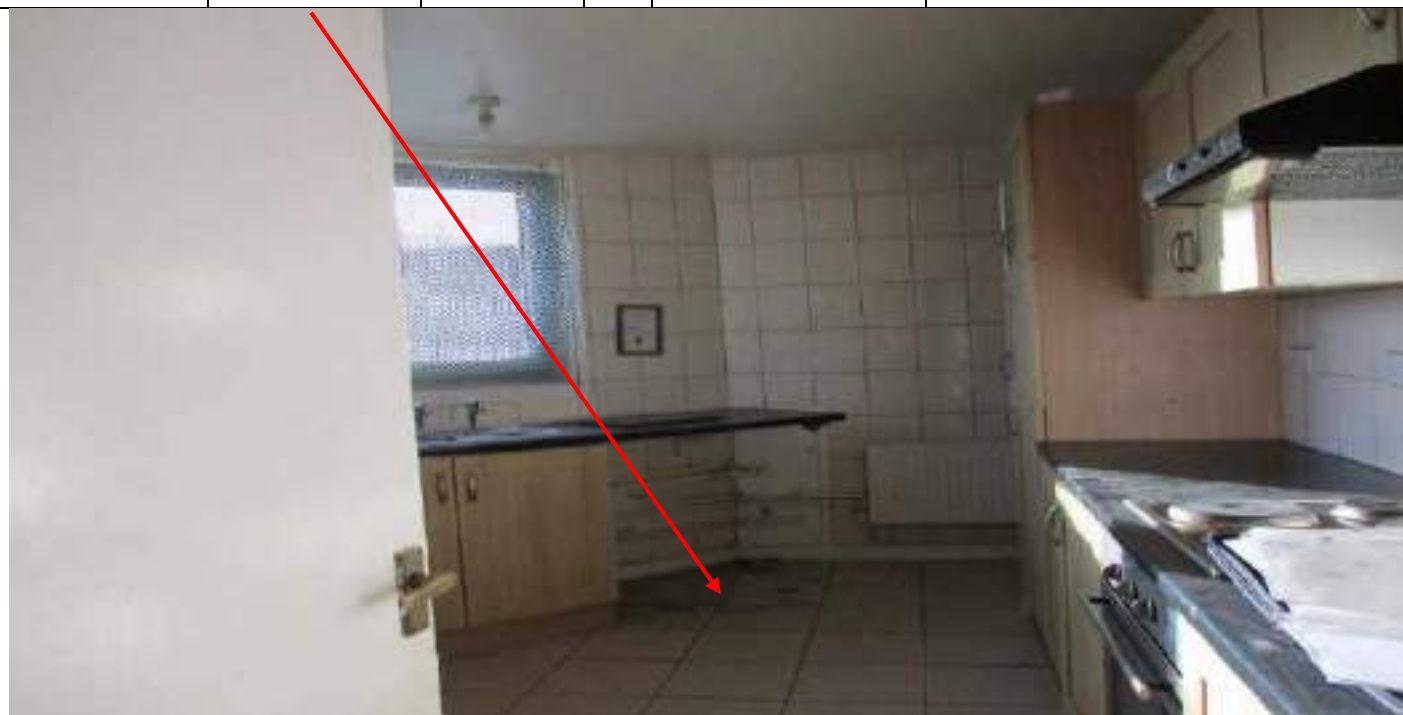
<i>Environmental Inspection Record</i>				ABBOTSBURY, AGAR GROVE, LONDON, NW1 9TB						
<i>Location</i>		<i>Component</i>			<i>Inspection Ref</i>					
SECOND FLOOR FLAT 4 KITCHEN		NON-ASBESTOS BITUMEN ABOVE PLASTERBOARD CEILING WITH TIMBER JOISTS CERAMIC TILES TO PLASTERED BRICK/BREEZE BLOCK WALLS CERAMIC TILES OVER ASBESTOS VINYL FLOOR TILES & BITUMEN TO CONCRETE			<i>Surveyor:</i>		PB & MC			
					PICTURE 21 AS SAMPLE 2					
					<i>Date:</i>		20/01/21			
					<i>Survey Type:</i>		REFURBISHMENT/ DEMOLITION SURVEY			
<i>Condition:</i>	FAIR	<i>Access:</i>	DIFFICULT		<i>Asbestos?</i>		YES			
						<i>Re Inspection Date:</i>		N/A		
<i>Friability:</i>	LOW	<i>Amount:</i>	APPROX: 12M ²		<i>Type:</i>	CHRYSOTILE TO BOTH				
<i>Damage:</i>	LOW	<i>Exposure:</i>	OCCUPANTS		<i>Analysis:</i>	TILES	<7%			
						BITUMEN		<8%		
<i>Position:</i>	VINYL FLOOR TILE & BITUMEN	<i>Risk Factor</i>	3	<i>Priority Assessment:</i>	MINOR RISK

<i>Risk Band</i>	D

<i>Recommended Action</i>	REMOVE IDENTIFIED ASBESTOS VINYL TILES & ADHESIVE BEFORE DEMOLITION WORKS COMMENCE, USING A COMPETENT CONTRACTOR
----------------------------------	---

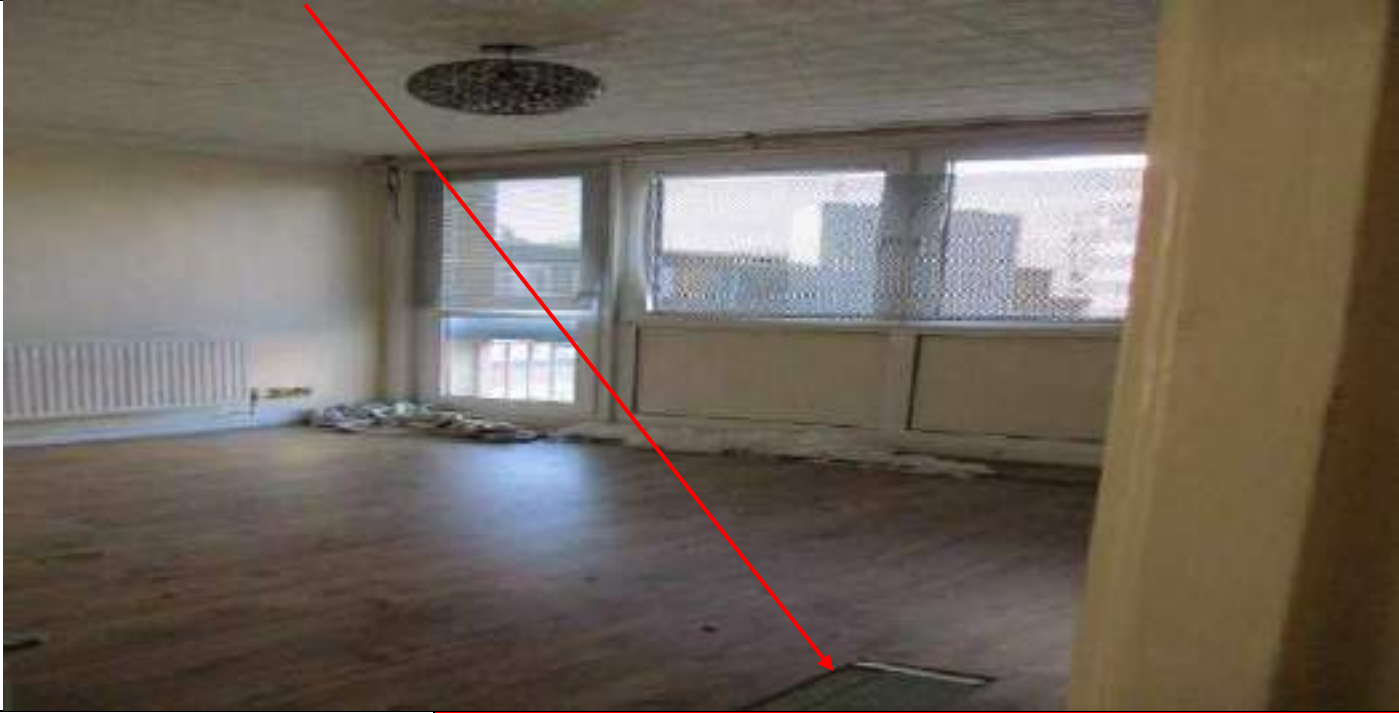
<i>Environmental Inspection Record</i>				ABBOTSBURY, AGAR GROVE, LONDON, NW1 9TB						
<i>Location</i>		<i>Component</i>			<i>Inspection Ref</i>					
SECOND FLOOR FLAT 4 LOUNGE		NON-ASBESTOS BITUMEN ABOVE PLASTERBOARD CEILING WITH TIMBER JOISTS PLASTERED BRICK/BREEZE BLOCK WALLS TIMBER FLOORING OVER ASBESTOS VINYL FLOOR TILES & BITUMEN TO CONCRETE			<i>Surveyor:</i>		PB & MC			
					PICTURE 22 AS SAMPLE 2					
					<i>Date:</i>		20/01/21			
					<i>Survey Type:</i>		REFURBISHMENT/ DEMOLITION SURVEY			
<i>Condition:</i>	FAIR	<i>Access:</i>	EASY		<i>Asbestos?</i>		YES			
						<i>Re Inspection Date:</i>	N/A			
<i>Friability:</i>	LOW	<i>Amount:</i>	APPROX: 25M ²		<i>Type:</i>	CHRYSOTILE TO BOTH				
<i>Damage:</i>	LOW	<i>Exposure:</i>	OCCUPANTS		<i>Analysis:</i>	TILES	<7%			
						BITUMEN	<8%			
<i>Position:</i>	VINYL FLOOR TILE & BITUMEN	<i>Risk Factor</i>	4	<i>Priority Assessment:</i>	MINOR RISK

<i>Risk Band</i>	D

<i>Recommended Action</i>				REMOVE IDENTIFIED ASBESTOS VINYL TILES & ADHESIVE BEFORE DEMOLITION WORKS COMMENCE, USING A COMPETENT CONTRACTOR

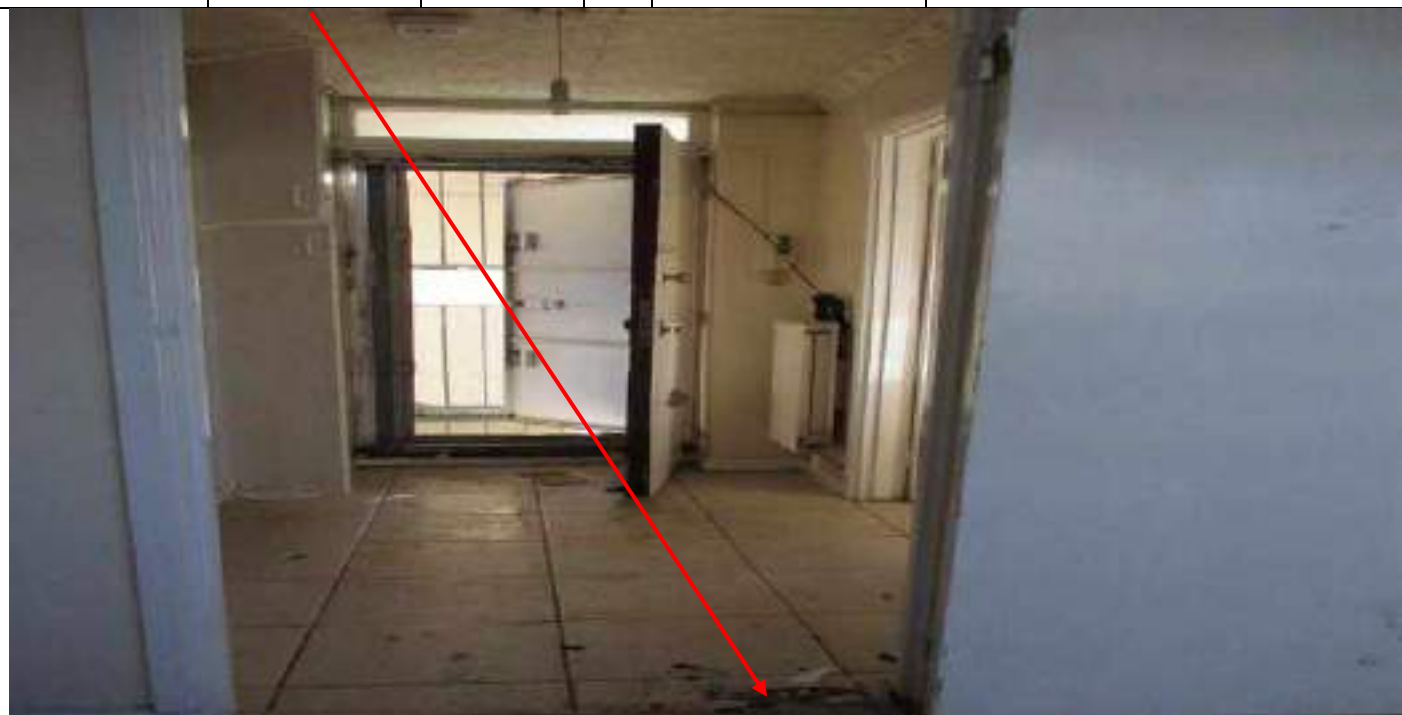
<i>Environmental Inspection Record</i>				ABBOTSBURY, AGAR GROVE, LONDON, NW1 9TB						
<i>Location</i>		<i>Component</i>			<i>Inspection Ref</i>					
SECOND FLOOR FLAT 4 HALLWAY		NON-ASBESTOS BITUMEN ABOVE PLASTERBOARD CEILING WITH TIMBER JOISTS CERAMIC TILES TO PLASTERED BRICK/BREEZE BLOCK WALLS CERAMIC TILES OVER ASBESTOS VINYL FLOOR TILES & BITUMEN TO CONCRETE			Surveyor:		PB & MC			
					PICTURE 23 AS SAMPLE 2					
					Date:		20/01/21			
					Survey Type:		REFURBISHMENT/ DEMOLITION SURVEY			
Condition:	FAIR	Access:	EASY		Asbestos?		YES			
						Re Inspection Date:		N/A		
Friability:	LOW	Amount:	APPROX: 5M ²		Type:	CHRYSO TILE TO BOTH				
Damage:	LOW	Exposure:	OCCUPANTS		Analysis:	TILES	<7%			
						BITUMEN	<8%			
Position:	VINYL FLOOR TILE & BITUMEN	Risk Factor	4	Priority Assessment:	MINOR RISK					
		Risk Band	D

Recommended Action	REMOVE IDENTIFIED ASBESTOS VINYL TILES & ADHESIVE BEFORE DEMOLITION WORKS COMMENCE, USING A COMPETENT CONTRACTOR
---------------------------	---

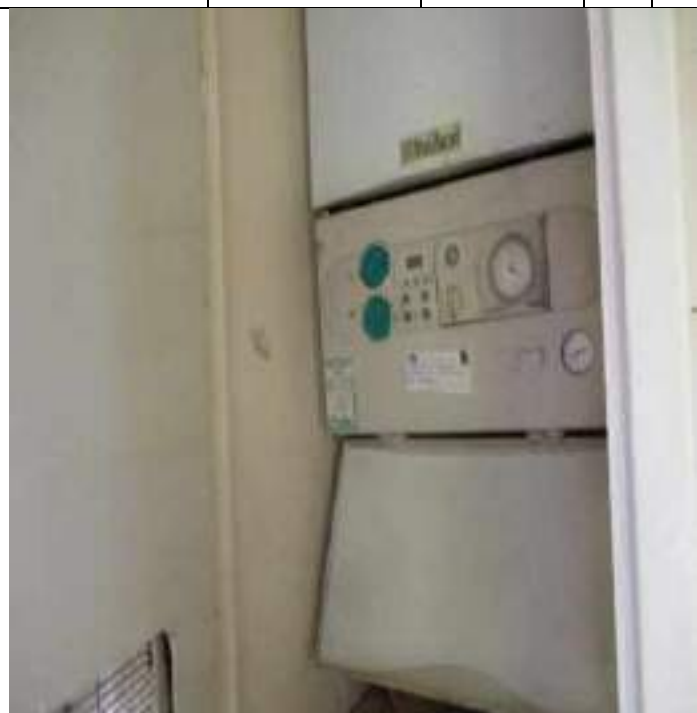
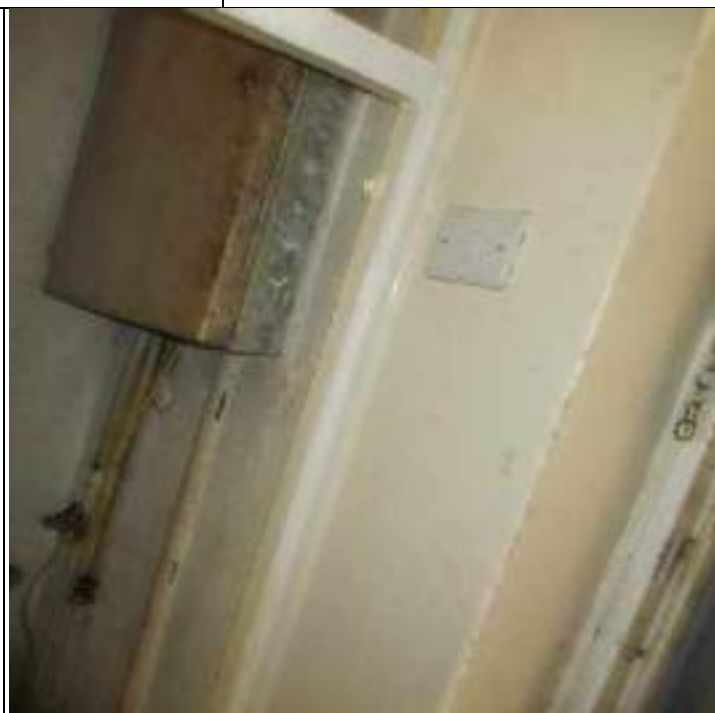
<i>Environmental Inspection Record</i>				ABBOTSBURY, AGAR GROVE, LONDON, NW1 9TB	
<i>Location</i>		<i>Component</i>		<i>Inspection Ref</i>	
SECOND FLOOR FLAT 4 HALLWAY		MODERN BOILER WITH METAL FLUE ELECTRICAL FUSE BOARD		<i>Surveyor:</i>	PB & MC
				PICTURE 24 & 25	
				<i>Date:</i>	20/01/21
				<i>Survey Type:</i>	REFURBISHMENT/ DEMOLITION SURVEY
<i>Condition:</i>	N/A	<i>Access:</i>	N/A	<i>Asbestos?</i>	NO
				<i>Re Inspection Date:</i>	N/A
<i>Friability:</i>	N/A	<i>Amount:</i>	N/A	<i>Type:</i>	NON ASBESTOS
<i>Damage:</i>	N/A	<i>Exposure:</i>	N/A	<i>Analysis:</i>	N/A
<i>Position:</i>	CUPBOARDS	<i>Risk Factor</i>	0	<i>Priority Assessment:</i>	NO RISK
		<i>Risk Band</i>	E

<i>Recommended Action</i>	NO ASBESTOS MATERIALS IDENTIFIED.
----------------------------------	--

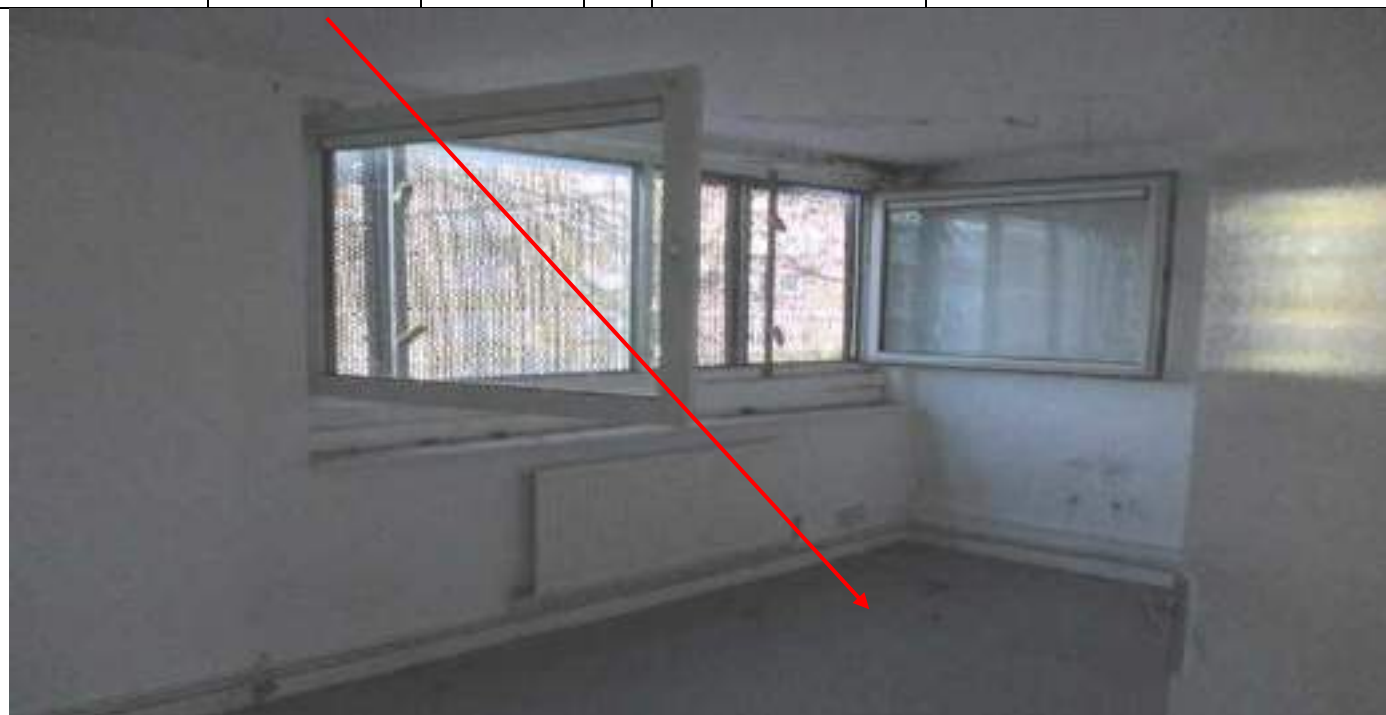
<i>Environmental Inspection Record</i>			ABBOTSBURY, AGAR GROVE, LONDON, NW1 9TB		
<i>Location</i>		<i>Component</i>		<i>Inspection Ref</i>	
FIRST FLOOR FLAT 3 BEDROOM 1		CONCRETE CEILING PLASTERED BRICK/BREEZE BLOCK WALLS CARPET OVER ASBESTOS VINYL FLOOR TILES & BITUMEN TO CONCRETE		<i>Surveyor:</i>	PB & MC
				PICTURE 26 AS SAMPLE 2	
				<i>Date:</i>	20/01/21
				<i>Survey Type:</i>	REFURBISHMENT/ DEMOLITION SURVEY
<i>Condition:</i>	FAIR	<i>Access:</i>	EASY	<i>Asbestos?</i>	YES
				<i>Re Inspection Date:</i>	N/A
<i>Friability:</i>	LOW	<i>Amount:</i>	APPROX: 18M ²	<i>Type:</i>	CHRYSO TILE TO BOTH
<i>Damage:</i>	LOW	<i>Exposure:</i>	OCCUPANTS	<i>Analysis:</i>	TILES <7% BITUMEN <8%
<i>Position:</i>	VINYL FLOOR TILE & BITUMEN	<i>Risk Factor</i>	4	<i>Priority Assessment:</i>	MINOR RISK
		<i>Risk Band</i>	D

<i>Recommended Action</i>	REMOVE IDENTIFIED ASBESTOS VINYL TILES & ADHESIVE BEFORE DEMOLITION WORKS COMMENCE, USING A COMPETENT CONTRACTOR
---------------------------	---

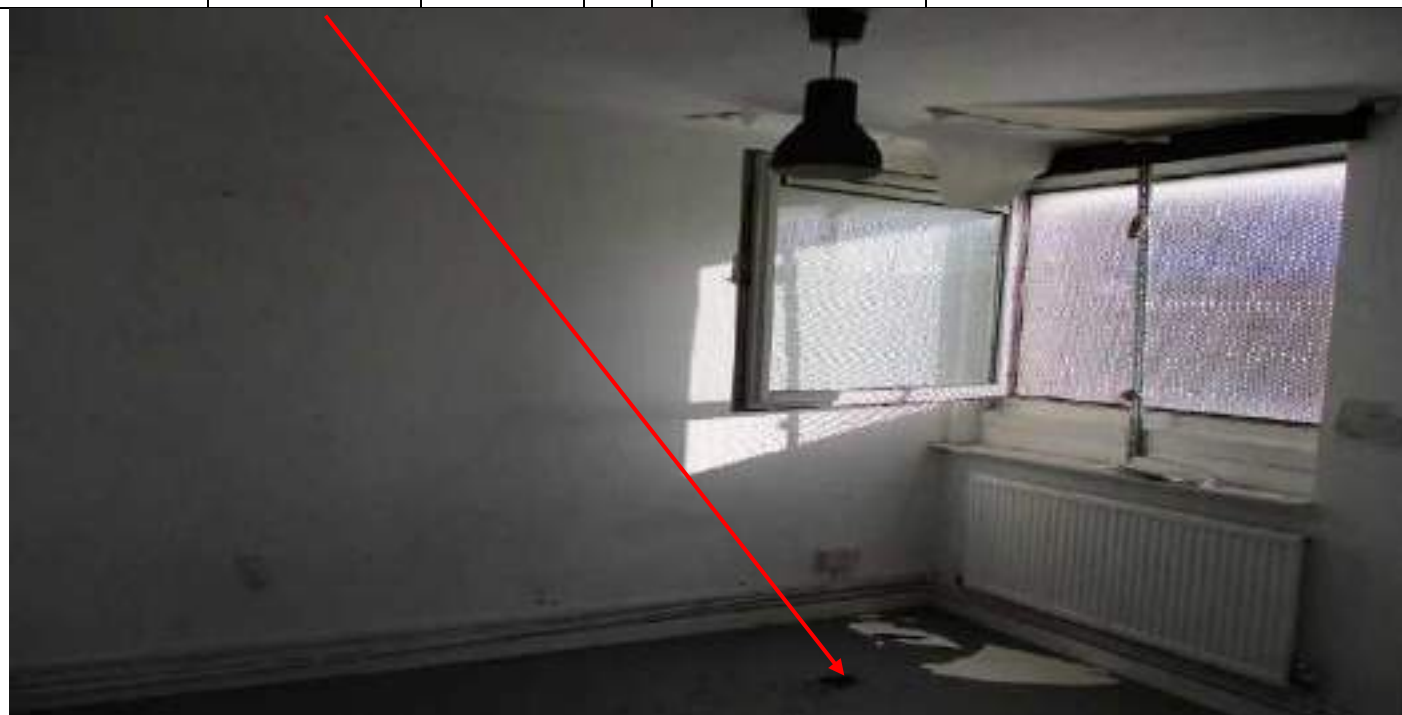
<i>Environmental Inspection Record</i>			ABBOTSBURY, AGAR GROVE, LONDON, NW1 9TB		
<i>Location</i>		<i>Component</i>		<i>Inspection Ref</i>	
FIRST FLOOR FLAT 3 BEDROOM 2		CONCRETE CEILING PLASTERED BRICK/BREEZE BLOCK WALLS CARPET OVER ASBESTOS VINYL FLOOR TILES & BITUMEN TO CONCRETE		<i>Surveyor:</i>	PB & MC
				PICTURE 27 AS SAMPLE 2	
				<i>Date:</i>	20/01/21
				<i>Survey Type:</i>	REFURBISHMENT/ DEMOLITION SURVEY
<i>Condition:</i>	FAIR	<i>Access:</i>	EASY	<i>Asbestos?</i>	YES
				<i>Re Inspection Date:</i>	N/A
<i>Friability:</i>	LOW	<i>Amount:</i>	APPROX: 10M ²	<i>Type:</i>	CHRYSOTILE TO BOTH
<i>Damage:</i>	LOW	<i>Exposure:</i>	OCCUPANTS	<i>Analysis:</i>	TILES <7% BITUMEN <8%
<i>Position:</i>	VINYL FLOOR TILE & BITUMEN	<i>Risk Factor</i>	4	<i>Priority Assessment:</i>	MINOR RISK
		<i>Risk Band</i>	D

<i>Recommended Action</i>	REMOVE IDENTIFIED ASBESTOS VINYL TILES & ADHESIVE BEFORE DEMOLITION WORKS COMMENCE, USING A COMPETENT CONTRACTOR
----------------------------------	---

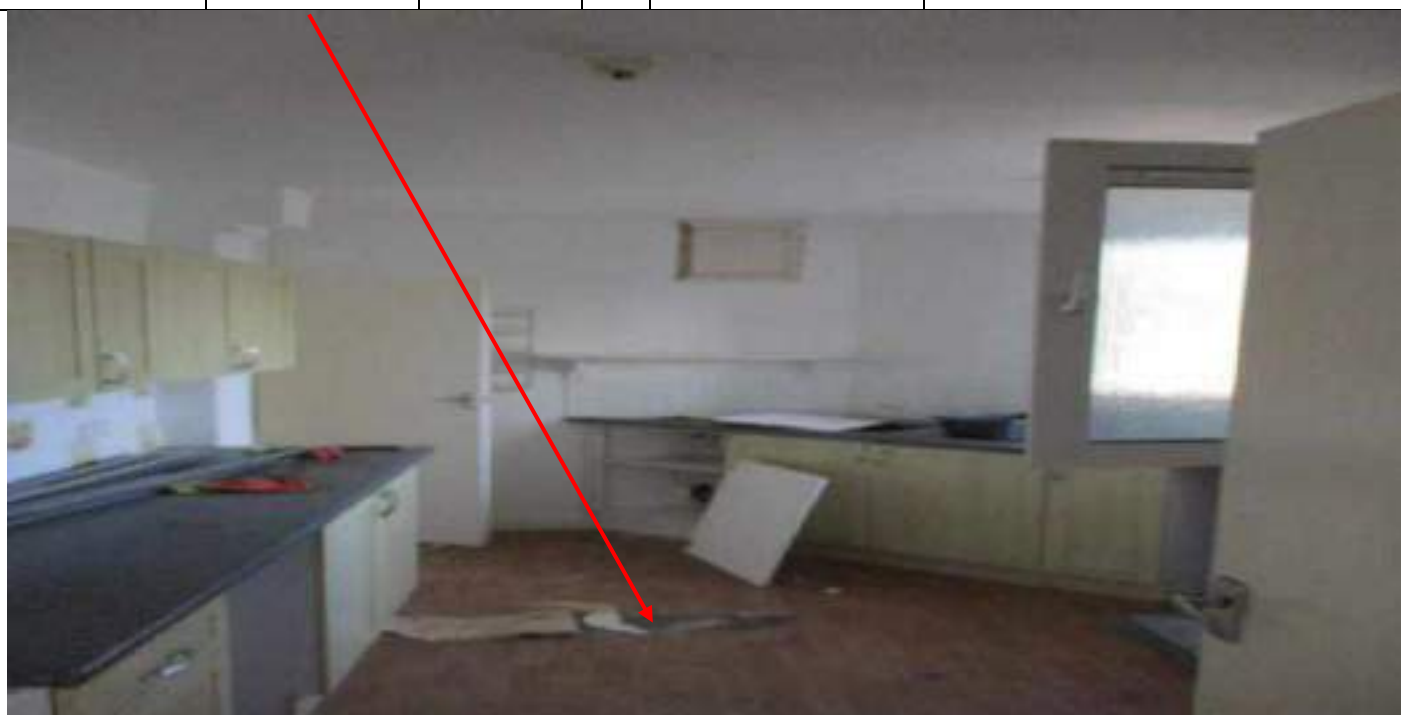
<i>Environmental Inspection Record</i>			ABBOTSBURY, AGAR GROVE, LONDON, NW1 9TB		
<i>Location</i>		<i>Component</i>		<i>Inspection Ref</i>	
FIRST FLOOR FLAT 3 KITCHEN		CONCRETE CEILING CERAMIC TILES TO PLASTERED BRICK/BREEZE BLOCK WALLS MODERN VINYL FLOOR COVERING OVER BITUMEN ADHESIVE TO CONCRETE FLOOR		<i>Surveyor:</i>	PB & MC
				PICTURE 30 AS SAMPLE 2	
				<i>Date:</i>	20/01/21
				<i>Survey Type:</i>	REFURBISHMENT/ DEMOLITION SURVEY
<i>Condition:</i>	FAIR	<i>Access:</i>	DIFFICULT	<i>Asbestos?</i>	YES
				<i>Re Inspection Date:</i>	N/A
<i>Friability:</i>	LOW	<i>Amount:</i>	APPROX: 12M ²	<i>Type:</i>	CHRYSOTILE TO BOTH
<i>Damage:</i>	LOW	<i>Exposure:</i>	OCCUPANTS	<i>Analysis:</i>	<8%
<i>Position:</i>	BITUMEN ADHESIVE	<i>Risk Factor</i>	3	<i>Priority Assessment:</i>	MINOR RISK
		<i>Risk Band</i>	D

<i>Recommended Action</i>	REMOVE IDENTIFIED ASBESTOS BITUMEN ADHESIVE BEFORE DEMOLITION WORKS COMMENCE, USING A COMPETENT CONTRACTOR
----------------------------------	---

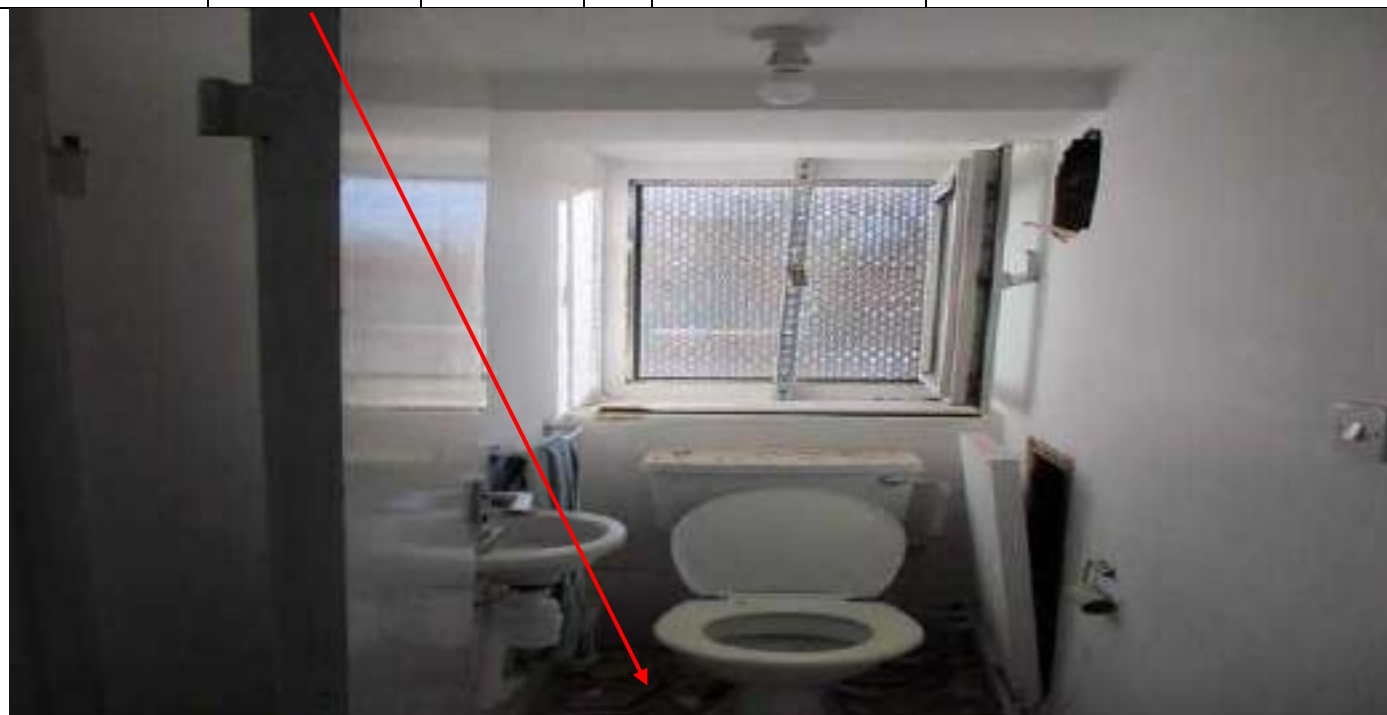
<i>Environmental Inspection Record</i>			ABBOTSBURY, AGAR GROVE, LONDON, NW1 9TB		
<i>Location</i>		<i>Component</i>		<i>Inspection Ref</i>	
FIRST FLOOR FLAT 3 WC		CONCRETE CEILING PLASTERED BRICK/BREEZE BLOCK WALLS MODERN VINYL FLOOR COVERING OVER BITUMEN ADHESIVE TO CONCRETE FLOOR		<i>Surveyor:</i>	PB & MC
				PICTURE 31 AS SAMPLE 2	
				<i>Date:</i>	20/01/21
				<i>Survey Type:</i>	REFURBISHMENT/ DEMOLITION SURVEY
<i>Condition:</i>	FAIR	<i>Access:</i>	DIFFICULT	<i>Asbestos?</i>	YES
				<i>Re Inspection Date:</i>	N/A
<i>Friability:</i>	LOW	<i>Amount:</i>	APPROX: 2M ²	<i>Type:</i>	CHRYSTOLE TO BOTH
<i>Damage:</i>	LOW	<i>Exposure:</i>	OCCUPANTS	<i>Analysis:</i>	<8%
<i>Position:</i>	BITUMEN ADHESIVE	<i>Risk Factor</i>	3	<i>Priority Assessment:</i>	MINOR RISK
		<i>Risk Band</i>	D

<i>Recommended Action</i>	REMOVE IDENTIFIED ASBESTOS BITUMEN ADHESIVE BEFORE DEMOLITION WORKS COMMENCE, USING A COMPETENT CONTRACTOR
----------------------------------	---
