APPENDICES

APPENDIX G

Agar Grove noise policy for Demolition works.

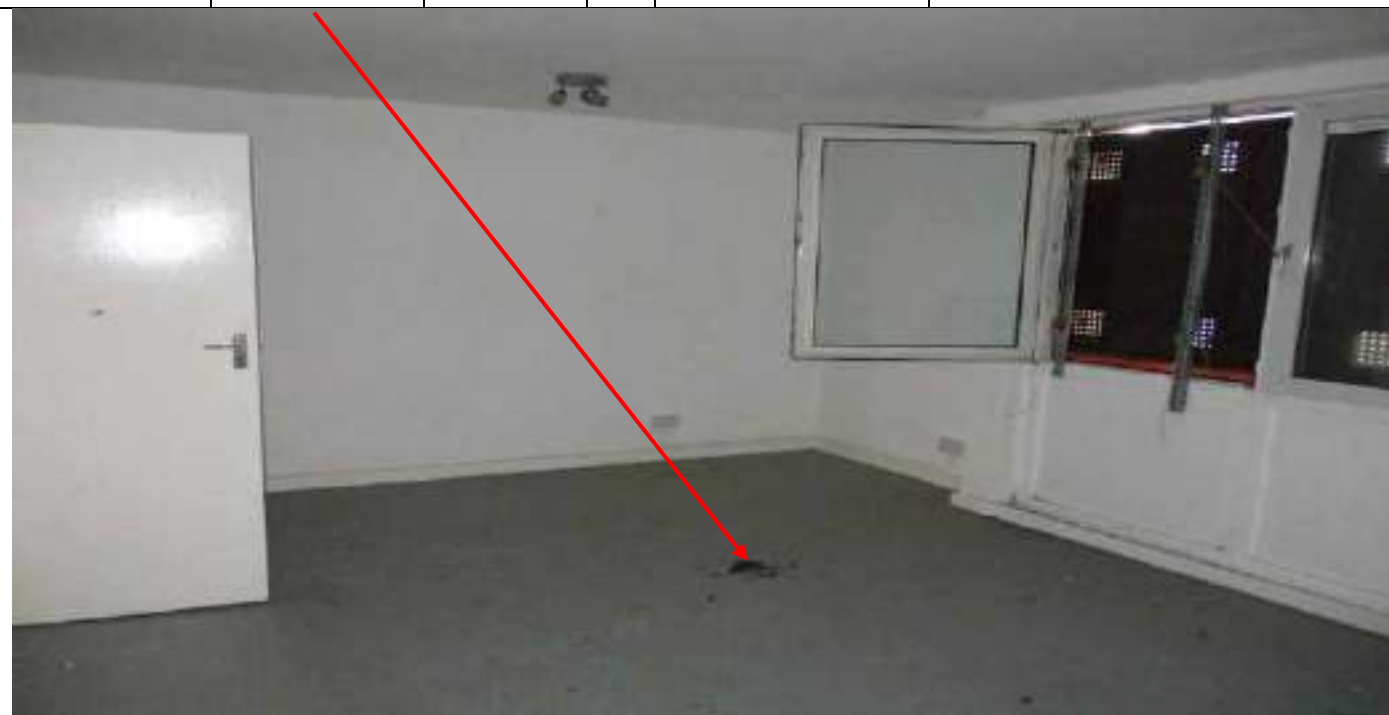
<i>Environmental Inspection Record</i>			ABBOTSBURY, AGAR GROVE, LONDON, NW1 9TB		
<i>Location</i>		<i>Component</i>		<i>Inspection Ref</i>	
FIRST FLOOR FLAT 3 LOUNGE		CONCRETE CEILING PLASTERED BRICK/BREEZE BLOCK WALLS MODERN VINYL FLOORING OVER ASBESTOS VINYL FLOOR TILES & BITUMEN TO CONCRETE FLOOR		<i>Surveyor:</i>	PB & MC
				PICTURE 32 AS SAMPLE 2	
				<i>Date:</i>	20/01/21
				<i>Survey Type:</i>	REFURBISHMENT/ DEMOLITION SURVEY
<i>Condition:</i>	FAIR	<i>Access:</i>	EASY	<i>Asbestos?</i>	YES
				<i>Re Inspection Date:</i>	N/A
<i>Friability:</i>	LOW	<i>Amount:</i>	APPROX: 25M ²	<i>Type:</i>	CHRYBOTILE TO BOTH
<i>Damage:</i>	LOW	<i>Exposure:</i>	OCCUPANTS	<i>Analysis:</i>	TILES <7% BITUMEN <8%
<i>Position:</i>	VINYL FLOOR TILE & BITUMEN	<i>Risk Factor</i>	4	<i>Priority Assessment:</i>	MINOR RISK
		<i>Risk Band</i>	D

<i>Recommended Action</i>	REMOVE IDENTIFIED ASBESTOS VINYL TILES & ADHESIVE BEFORE DEMOLITION WORKS COMMENCE, USING A COMPETENT CONTRACTOR
----------------------------------	---

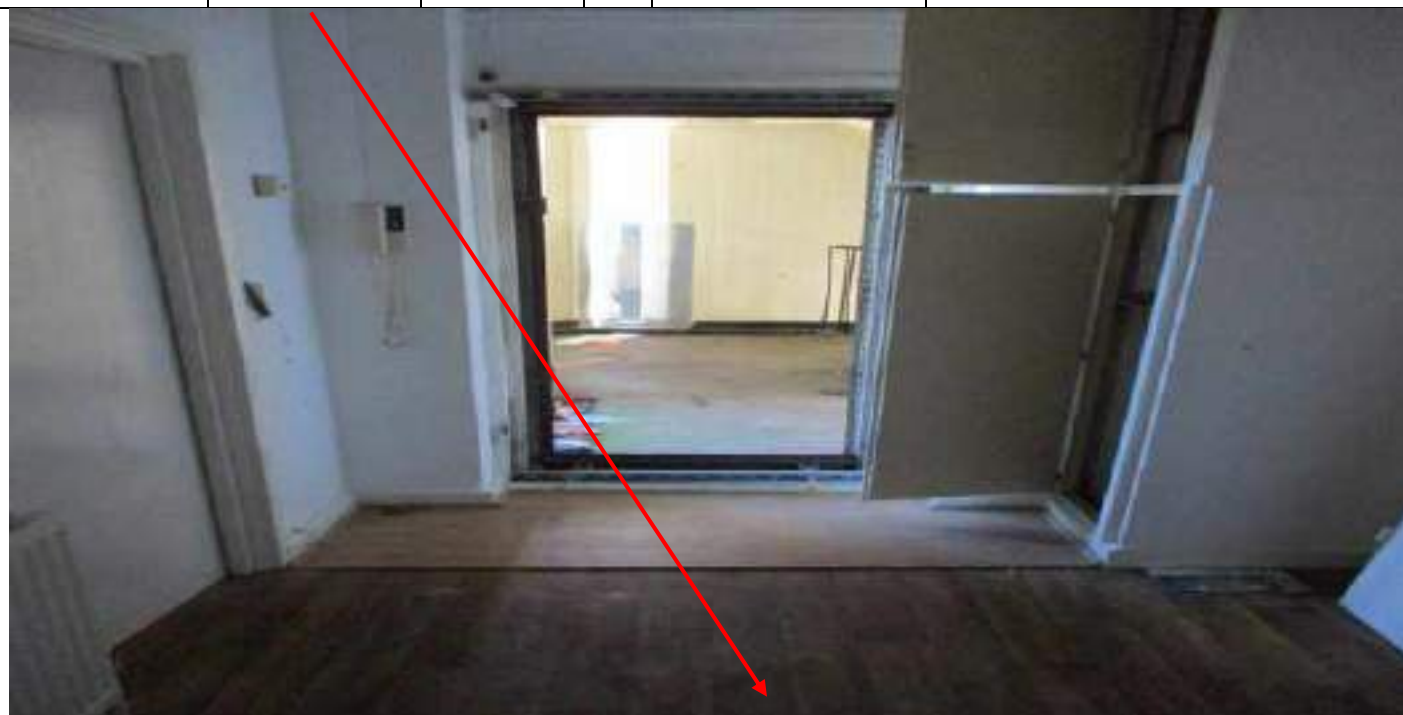
<i>Environmental Inspection Record</i>			ABBOTSBURY, AGAR GROVE, LONDON, NW1 9TB		
<i>Location</i>		<i>Component</i>		<i>Inspection Ref</i>	
FIRST FLOOR FLAT 3 HALLWAY		CONCRETE CEILING CERAMIC TILES TO PLASTERED BRICK/BREEZE BLOCK WALLS CERAMIC TILES OVER ASBESTOS VINYL FLOOR TILES & BITUMEN TO CONCRETE		<i>Surveyor:</i>	PB & MC
				PICTURE 33 AS SAMPLE 2	
				<i>Date:</i>	20/01/21
				<i>Survey Type:</i>	REFURBISHMENT/ DEMOLITION SURVEY
<i>Condition:</i>	FAIR	<i>Access:</i>	EASY	<i>Asbestos?</i>	YES
				<i>Re Inspection Date:</i>	N/A
<i>Friability:</i>	LOW	<i>Amount:</i>	APPROX: 5M ²	<i>Type:</i>	CHRYSO TILE TO BOTH
<i>Damage:</i>	LOW	<i>Exposure:</i>	OCCUPANTS	<i>Analysis:</i>	TILES <7% BITUMEN <8%
<i>Position:</i>	VINYL FLOOR TILE & BITUMEN	<i>Risk Factor</i>	4	<i>Priority Assessment:</i>	MINOR RISK
		<i>Risk Band</i>	D

<i>Recommended Action</i>	REMOVE IDENTIFIED ASBESTOS VINYL TILES & ADHESIVE BEFORE DEMOLITION WORKS COMMENCE, USING A COMPETENT CONTRACTOR
----------------------------------	---

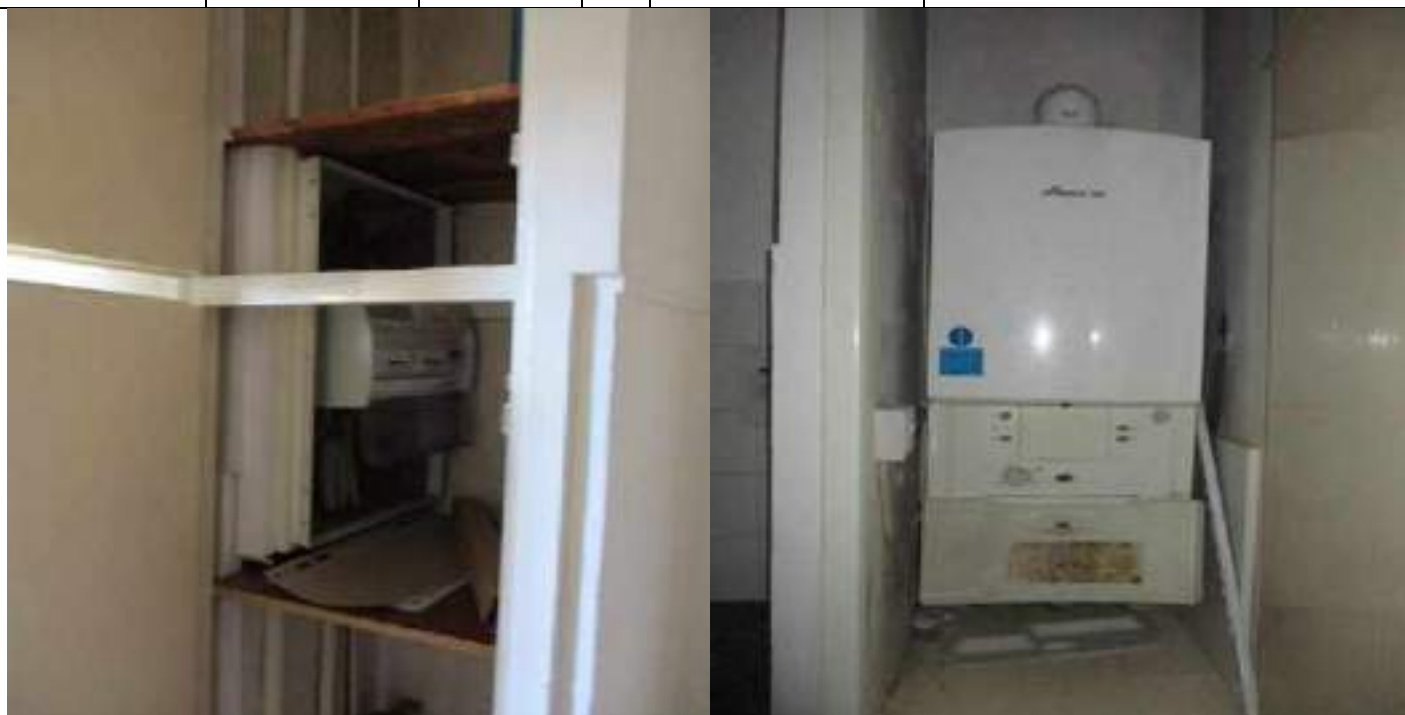
<i>Environmental Inspection Record</i>				ABBOTSBURY, AGAR GROVE, LONDON, NW1 9TB	
<i>Location</i>		<i>Component</i>		<i>Inspection Ref</i>	
FIRST FLOOR FLAT 3 HALLWAY		MODERN BOILER WITH METAL FLUE ELECTRICAL FUSE BOARD		<i>Surveyor:</i>	PB & MC
				PICTURE 34 & 35	
				<i>Date:</i>	20/01/21
				<i>Survey Type:</i>	REFURBISHMENT/ DEMOLITION SURVEY
<i>Condition:</i>	N/A	<i>Access:</i>	N/A	<i>Asbestos?</i>	NO
				<i>Re Inspection Date:</i>	N/A
<i>Friability:</i>	N/A	<i>Amount:</i>	N/A	<i>Type:</i>	NON ASBESTOS
<i>Damage:</i>	N/A	<i>Exposure:</i>	N/A	<i>Analysis:</i>	N/A
<i>Position:</i>	CUPBOARDS	<i>Risk Factor</i>	0	<i>Priority Assessment:</i>	NO RISK
		<i>Risk Band</i>	E

<i>Recommended Action</i>	NO ASBESTOS MATERIALS IDENTIFIED.
---------------------------	--

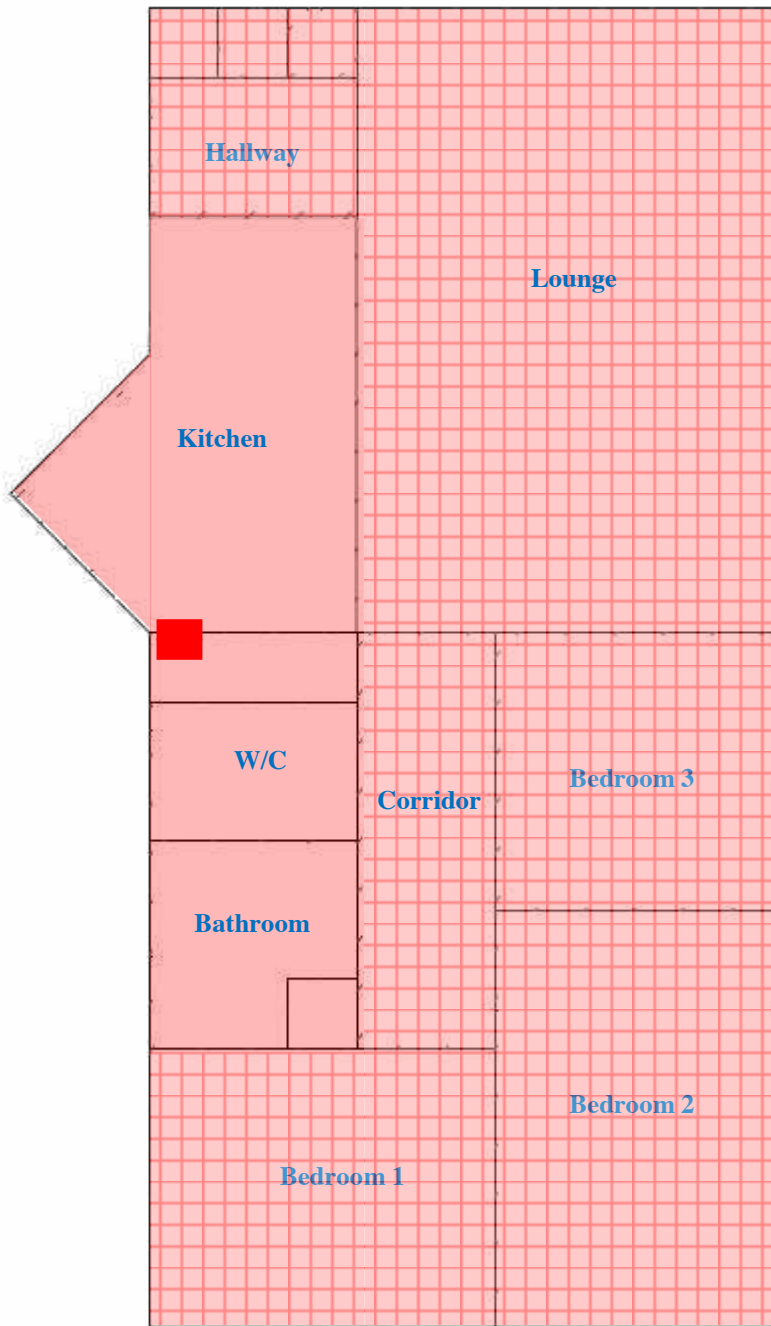
Flat 3

Insulation Board

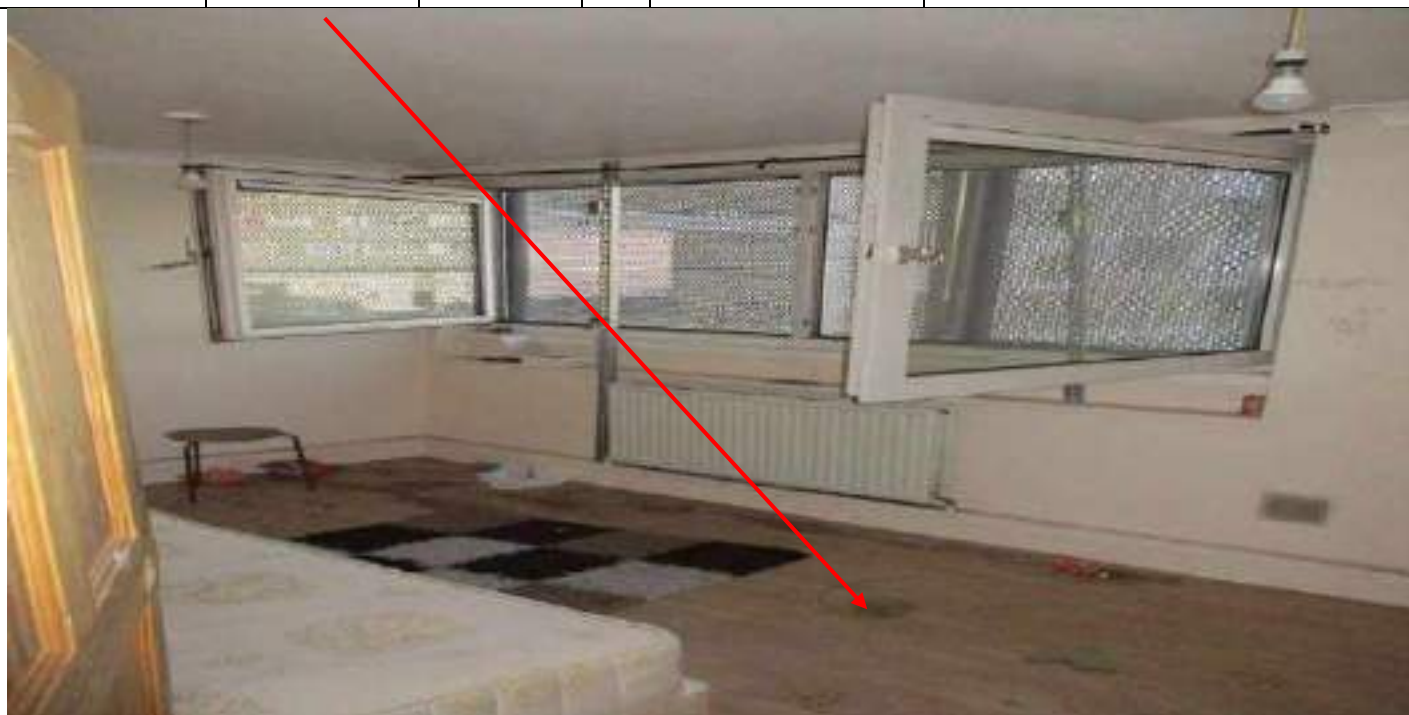
<i>Environmental Inspection Record</i>				ABBOTSBURY, AGAR GROVE, LONDON, NW1 9TB					
<i>Location</i>		<i>Component</i>			<i>Inspection Ref</i>				
FIRST FLOOR FLAT 2 BEDROOM 1		CONCRETE CEILING PLASTERED BRICK/BREEZE BLOCK WALLS CARPET OVER ASBESTOS VINYL FLOOR TILES & BITUMEN TO CONCRETE			<i>Surveyor:</i>		PB & MC		
					PICTURE 36 AS SAMPLE 2				
					<i>Date:</i>		20/01/21		
					<i>Survey Type:</i>		REFURBISHMENT/ DEMOLITION SURVEY		
<i>Condition:</i>	FAIR	<i>Access:</i>	EASY		<i>Asbestos?</i>		YES		
					<i>Re Inspection Date:</i>			N/A	
<i>Friability:</i>	LOW	<i>Amount:</i>	APPROX: 10M ²		<i>Type:</i>	CHRYSO TILE TO BOTH			
<i>Damage:</i>	LOW	<i>Exposure:</i>	OCCUPANTS		<i>Analysis:</i>	TILES	<7%		
					BITUMEN		<8%		
<i>Position:</i>	VINYL FLOOR TILE & BITUMEN	<i>Risk Factor</i>	4	<i>Priority Assessment:</i>	MINOR RISK				
		<i>Risk Band</i>	D

<i>Recommended Action</i>	REMOVE IDENTIFIED ASBESTOS VINYL TILES & ADHESIVE BEFORE DEMOLITION WORKS COMMENCE, USING A COMPETENT CONTRACTOR
----------------------------------	---

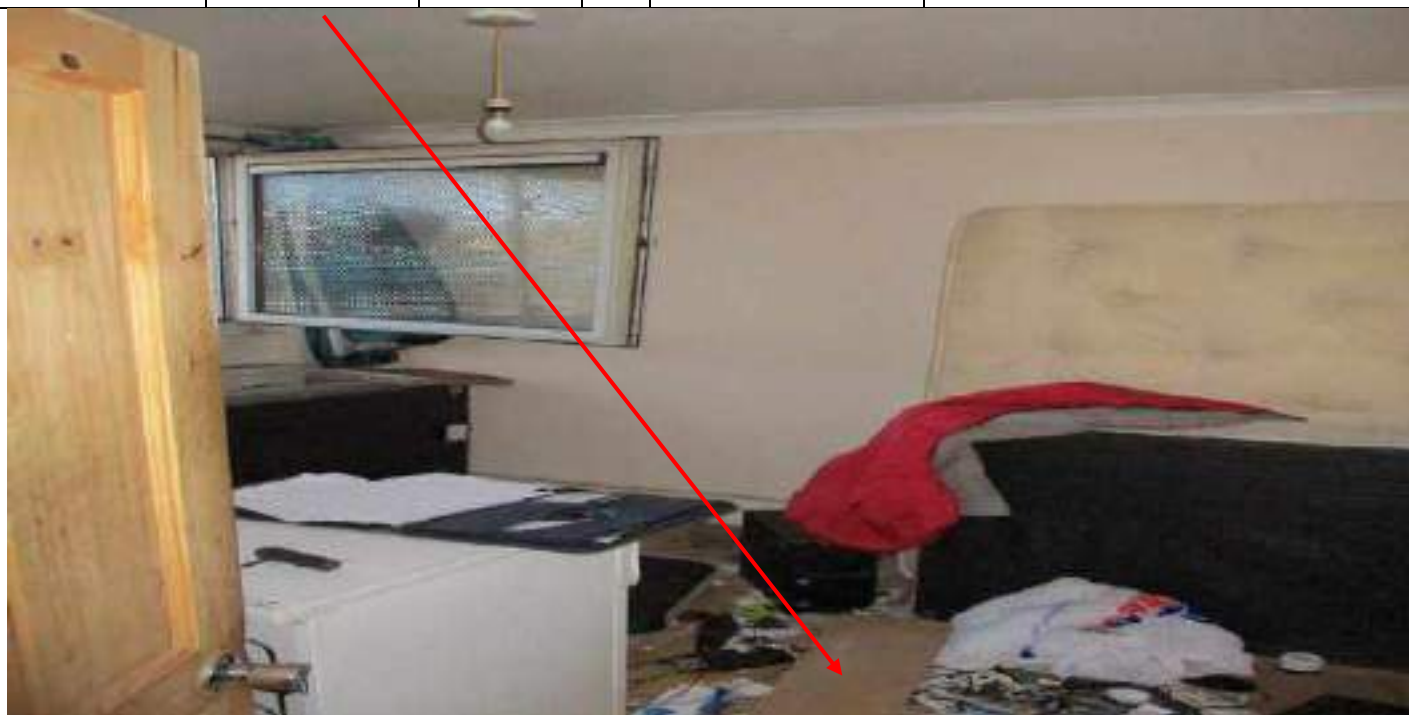
<i>Environmental Inspection Record</i>			ABBOTSBURY, AGAR GROVE, LONDON, NW1 9TB		
<i>Location</i>		<i>Component</i>		<i>Inspection Ref</i>	
FIRST FLOOR FLAT 2 BEDROOM 2		CONCRETE CEILING PLASTERED BRICK/BREEZE BLOCK WALLS CARPET OVER ASBESTOS VINYL FLOOR TILES & BITUMEN TO CONCRETE		<i>Surveyor:</i>	PB & MC
				PICTURE 37 AS SAMPLE 2	
				<i>Date:</i>	20/01/21
				<i>Survey Type:</i>	REFURBISHMENT/ DEMOLITION SURVEY
<i>Condition:</i>	FAIR	<i>Access:</i>	EASY	<i>Asbestos?</i>	YES
				<i>Re Inspection Date:</i>	N/A
<i>Friability:</i>	LOW	<i>Amount:</i>	APPROX: 10M ²	<i>Type:</i>	CHRYBOTILE TO BOTH
<i>Damage:</i>	LOW	<i>Exposure:</i>	OCCUPANTS	<i>Analysis:</i>	TILES <7% BITUMEN <8%
<i>Position:</i>	VINYL FLOOR TILE & BITUMEN	<i>Risk Factor</i>	4	<i>Priority Assessment:</i>	MINOR RISK
		<i>Risk Band</i>	D

<i>Recommended Action</i>	REMOVE IDENTIFIED ASBESTOS VINYL TILES & ADHESIVE BEFORE DEMOLITION WORKS COMMENCE, USING A COMPETENT CONTRACTOR
----------------------------------	---

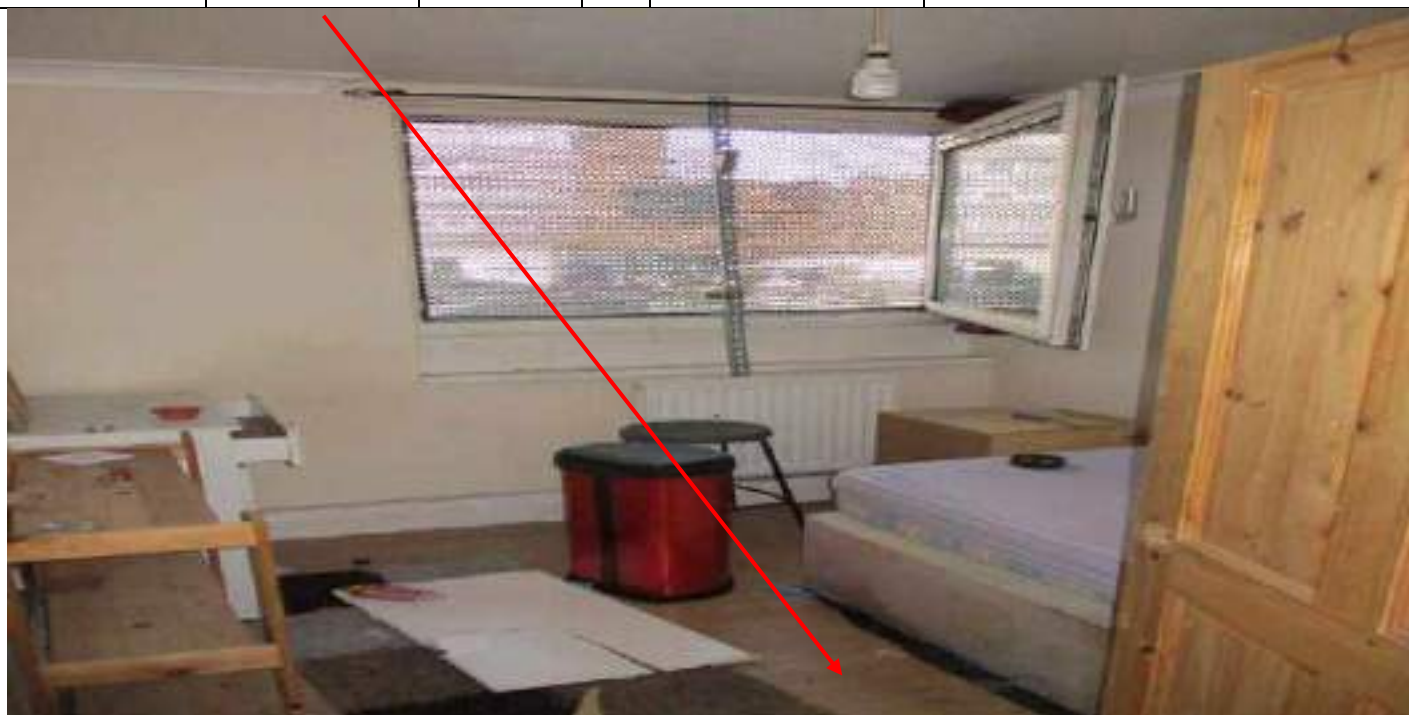
<i>Environmental Inspection Record</i>			ABBOTSBURY, AGAR GROVE, LONDON, NW1 9TB		
<i>Location</i>		<i>Component</i>		<i>Inspection Ref</i>	
FIRST FLOOR FLAT 2 BEDROOM 3		CONCRETE CEILING PLASTERED BRICK/BREEZE BLOCK WALLS CARPET OVER ASBESTOS VINYL FLOOR TILES & BITUMEN TO CONCRETE		<i>Surveyor:</i>	PB & MC
				PICTURE 38 AS SAMPLE 2	
				<i>Date:</i>	20/01/21
				<i>Survey Type:</i>	REFURBISHMENT/ DEMOLITION SURVEY
<i>Condition:</i>	FAIR	<i>Access:</i>	EASY	<i>Asbestos?</i>	YES
				<i>Re Inspection Date:</i>	N/A
<i>Friability:</i>	LOW	<i>Amount:</i>	APPROX: 7M ²	<i>Type:</i>	CHRYSOTILE TO BOTH
<i>Damage:</i>	LOW	<i>Exposure:</i>	OCCUPANTS	<i>Analysis:</i>	TILES <7% BITUMEN <8%
<i>Position:</i>	VINYL FLOOR TILE & BITUMEN	<i>Risk Factor</i>	4	<i>Priority Assessment:</i>	MINOR RISK
		<i>Risk Band</i>	D

<i>Recommended Action</i>	REMOVE IDENTIFIED ASBESTOS VINYL TILES & ADHESIVE BEFORE DEMOLITION WORKS COMMENCE, USING A COMPETENT CONTRACTOR
----------------------------------	---

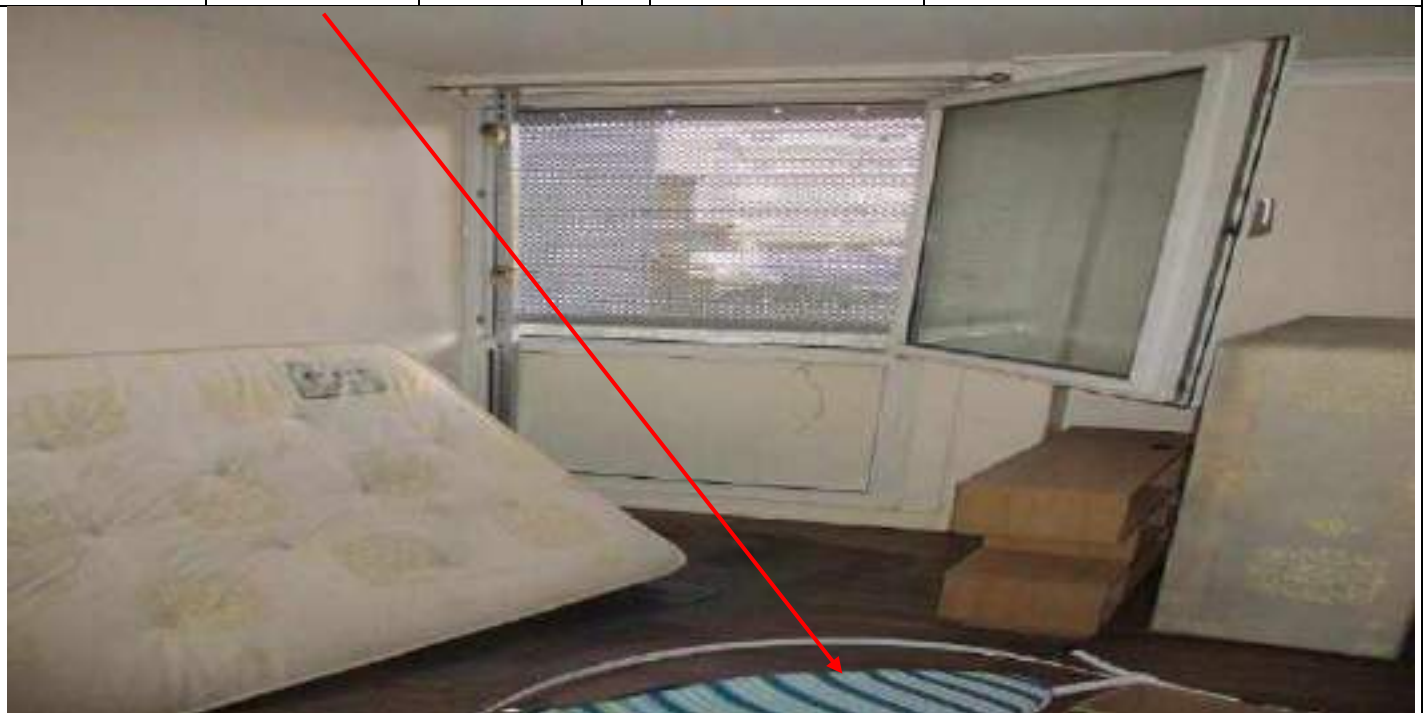
<i>Environmental Inspection Record</i>				ABBOTSBURY, AGAR GROVE, LONDON, NW1 9TB						
<i>Location</i>		<i>Component</i>			<i>Inspection Ref</i>					
FIRST FLOOR FLAT 2 BEDROOM 4		CONCRETE CEILING PLASTERED BRICK/BREEZE BLOCK WALLS CARPET OVER ASBESTOS VINYL FLOOR TILES & BITUMEN TO CONCRETE			<i>Surveyor:</i>		PB & MC			
					PICTURE 39 AS SAMPLE 2					
					<i>Date:</i>		20/01/21			
					<i>Survey Type:</i>		REFURBISHMENT/ DEMOLITION SURVEY			
<i>Condition:</i>	FAIR	<i>Access:</i>	EASY			<i>Asbestos?</i>	YES			
				<i>Re Inspection Date:</i> N/A						
<i>Friability:</i>	LOW	<i>Amount:</i>	APPROX: 7M ²			<i>Type:</i>	CHRYSOTILE TO BOTH			
<i>Damage:</i>	LOW	<i>Exposure:</i>	OCCUPANTS			<i>Analysis:</i>	TILES <7% BITUMEN <8%			
<i>Position:</i>	VINYL FLOOR TILE & BITUMEN	<i>Risk Factor</i>	4	<i>Priority Assessment:</i>		MINOR RISK				
		<i>Risk Band</i>	D

<i>Recommended Action</i>	REMOVE IDENTIFIED ASBESTOS VINYL TILES & ADHESIVE BEFORE DEMOLITION WORKS COMMENCE, USING A COMPETENT CONTRACTOR
----------------------------------	---

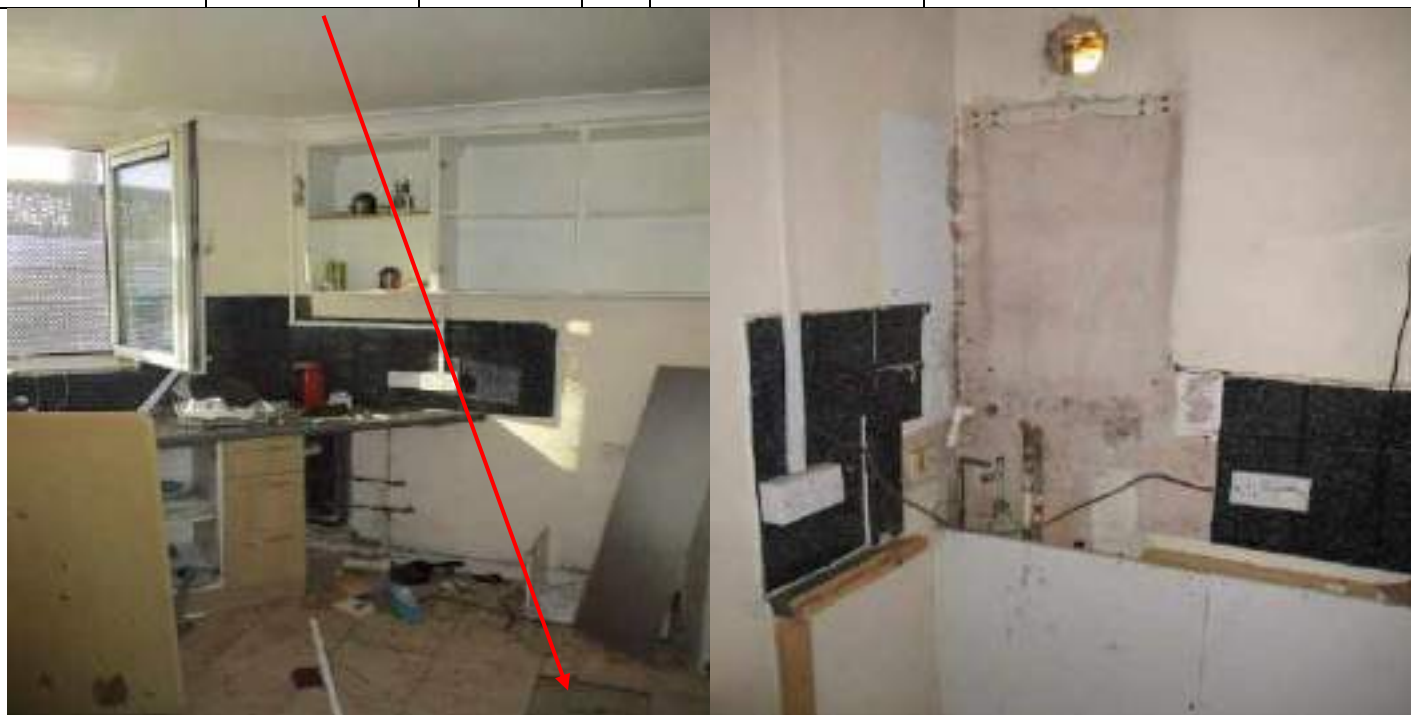
<i>Environmental Inspection Record</i>				ABBOTSBURY, AGAR GROVE, LONDON, NW1 9TB			
<i>Location</i>		<i>Component</i>			<i>Inspection Ref</i>		
FIRST FLOOR FLAT 2 KITCHEN		CONCRETE CEILING PLASTERED BRICK/BREEZE BLOCK WALLS CERAMIC TILES OVER ASBESTOS VINYL FLOOR TILES & BITUMEN TO CONCRETE			Surveyor: PB & MC		PICTURE 40 & 41 AS SAMPLE
					Date: 20/01/21		
					Survey Type: REFURBISHMENT/ DEMOLITION SURVEY		
					Asbestos? YES		
Condition: FAIR	Access: EASY	Re Inspection Date: N/A					
Friability: LOW	Amount: APPROX: 12M ²	Type: CHRYSOTILE TO BOTH					
Damage: LOW	Exposure: OCCUPANTS	Analysis: TILES <7% BITUMEN <8%					
Position: VINYL FLOOR TILE & BITUMEN	Risk Factor 4 Risk Band D	Priority Assessment: MINOR RISK

Recommended Action	REMOVE IDENTIFIED ASBESTOS VINYL TILES & ADHESIVE BEFORE DEMOLITION WORKS COMMENCE, USING A COMPETENT CONTRACTOR
---------------------------	---

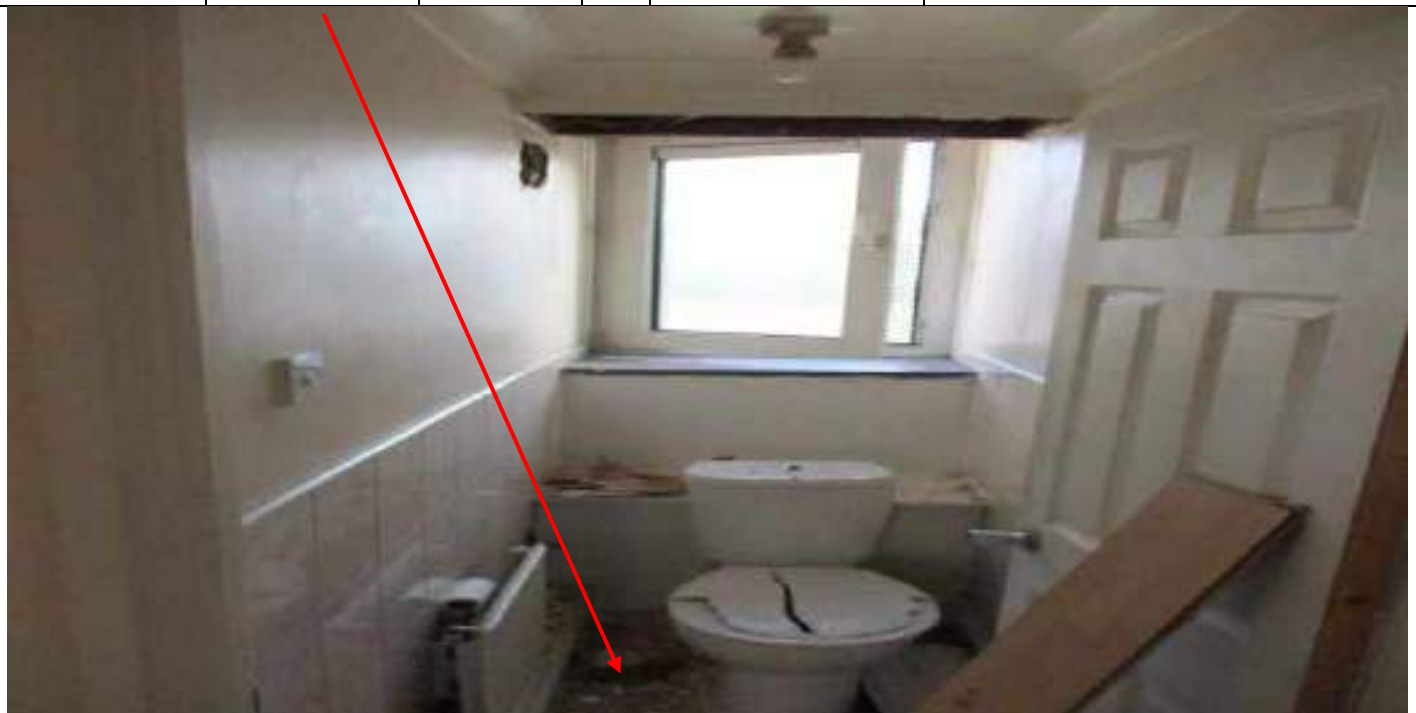
<i>Environmental Inspection Record</i>			ABBOTSBURY, AGAR GROVE, LONDON, NW1 9TB			
<i>Location</i>		<i>Component</i>		<i>Inspection Ref</i>		
FIRST FLOOR FLAT 2 WC		CONCRETE CEILING PLASTERED BRICK/BREEZE BLOCK WALLS TIMBER FLOORING OVER ASBESTOS VINYL FLOOR TILES & BITUMEN TO CONCRETE		<i>Surveyor:</i>	PB & MC	
				PICTURE 42 AS SAMPLE 2		
				<i>Date:</i>	20/01/21	
				<i>Survey Type:</i>	REFURBISHMENT/ DEMOLITION SURVEY	
<i>Condition:</i>	FAIR	<i>Access:</i>	EASY	<i>Asbestos?</i>	YES	
				<i>Re Inspection Date:</i>	N/A	
<i>Friability:</i>	LOW	<i>Amount:</i>	APPROX: 2M ²	<i>Type:</i>	CHRYSOTILE TO BOTH	
<i>Damage:</i>	LOW	<i>Exposure:</i>	OCCUPANTS	<i>Analysis:</i>	TILES	<7%
					BITUMEN	<8%
<i>Position:</i>	VINYL FLOOR TILE & BITUMEN	<i>Risk Factor</i>	4	<i>Priority Assessment:</i>	MINOR RISK	
		<i>Risk Band</i>	D

<i>Recommended Action</i>	REMOVE IDENTIFIED ASBESTOS VINYL TILES & ADHESIVE BEFORE DEMOLITION WORKS COMMENCE, USING A COMPETENT CONTRACTOR
----------------------------------	---

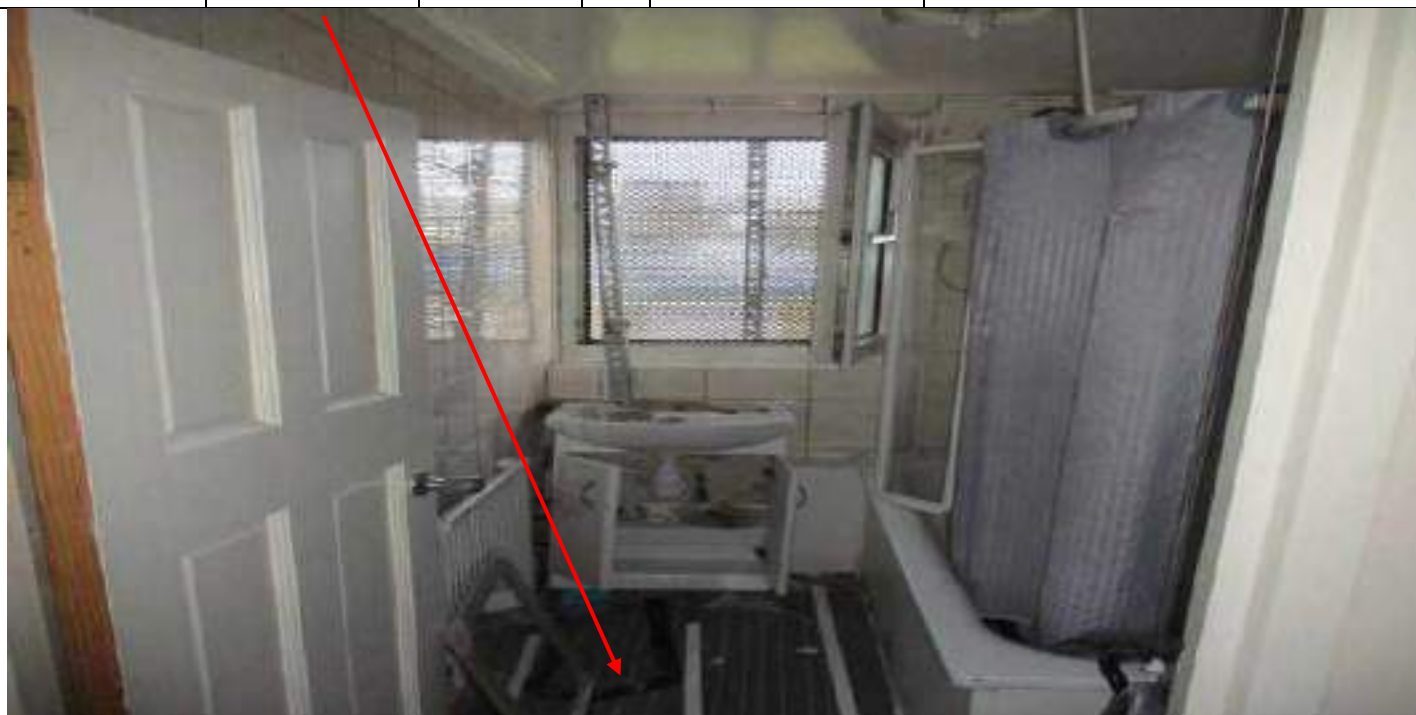
<i>Environmental Inspection Record</i>				ABBOTSBURY, AGAR GROVE, LONDON, NW1 9TB						
<i>Location</i>		<i>Component</i>			<i>Inspection Ref</i>					
FIRST FLOOR FLAT 2 WC		CONCRETE CEILING CERAMIC TILES TO PLASTERED BRICK/BREEZE BLOCK WALLS ASBESTOS VINYL FLOOR TILES & BITUMEN TO CONCRETE			<i>Surveyor:</i>		PB & MC			
					PICTURE 43 AS SAMPLE 2					
					<i>Date:</i>		20/01/21			
					<i>Survey Type:</i>		REFURBISHMENT/ DEMOLITION SURVEY			
<i>Condition:</i>	FAIR	<i>Access:</i>	EASY			<i>Asbestos?</i>	YES			
						<i>Re Inspection Date:</i>	N/A			
<i>Friability:</i>	LOW	<i>Amount:</i>	APPROX: 2M ²			<i>Type:</i>	CHRYSOTILE TO BOTH			
<i>Damage:</i>	LOW	<i>Exposure:</i>	OCCUPANTS			<i>Analysis:</i>	TILES <7% BITUMEN <8%			
<i>Position:</i>	VINYL FLOOR TILE & BITUMEN	<i>Risk Factor</i>	4	<i>Priority Assessment:</i>		MINOR RISK				
		<i>Risk Band</i>	D

<i>Recommended Action</i>	REMOVE IDENTIFIED ASBESTOS VINYL TILES & ADHESIVE BEFORE DEMOLITION WORKS COMMENCE, USING A COMPETENT CONTRACTOR
----------------------------------	---

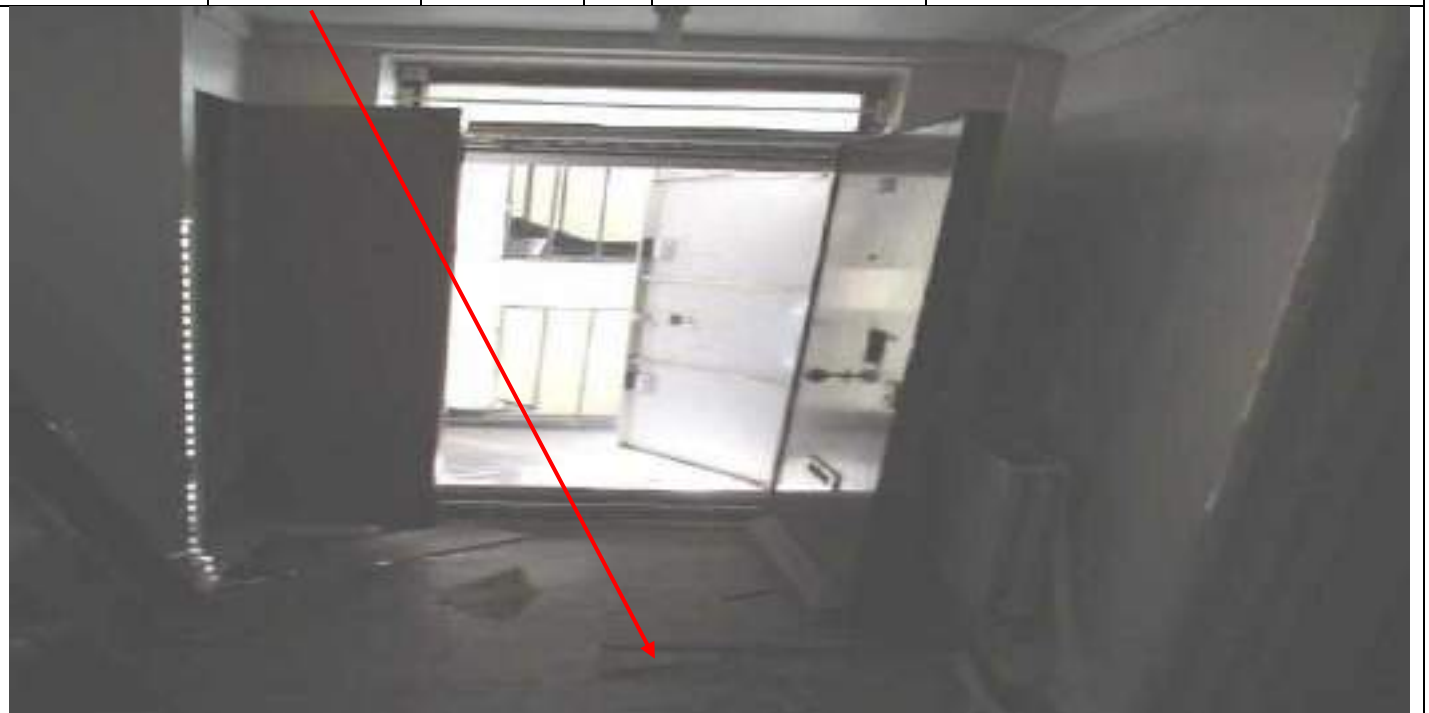
<i>Environmental Inspection Record</i>				ABBOTSBURY, AGAR GROVE, LONDON, NW1 9TB						
<i>Location</i>		<i>Component</i>			<i>Inspection Ref</i>					
FIRST FLOOR FLAT 2 HALLWAY		CONCRETE CEILING CERAMIC TILES TO PLASTERED BRICK/BREEZE BLOCK WALLS TIMBER FLOORING OVER ASBESTOS VINYL FLOOR TILES & BITUMEN TO CONCRETE			<i>Surveyor:</i>		PB & MC			
					PICTURE 44 AS SAMPLE 2					
					<i>Date:</i>		20/01/21			
					<i>Survey Type:</i>		REFURBISHMENT/ DEMOLITION SURVEY			
<i>Condition:</i>	FAIR	<i>Access:</i>	EASY			<i>Asbestos?</i> YES				
						<i>Re Inspection Date:</i> N/A				
<i>Friability:</i>	LOW	<i>Amount:</i>	APPROX: 5M ²			<i>Type:</i>	CHRYSO TILE TO BOTH			
<i>Damage:</i>	LOW	<i>Exposure:</i>	OCCUPANTS			<i>Analysis:</i>	TILES <7% BITUMEN <8%			
<i>Position:</i>	VINYL FLOOR TILE & BITUMEN	<i>Risk Factor</i>	4	<i>Priority Assessment:</i>		MINOR RISK				
		<i>Risk Band</i>	D

Recommended Action	REMOVE IDENTIFIED ASBESTOS VINYL TILES & ADHESIVE BEFORE DEMOLITION WORKS COMMENCE, USING A COMPETENT CONTRACTOR
---------------------------	---

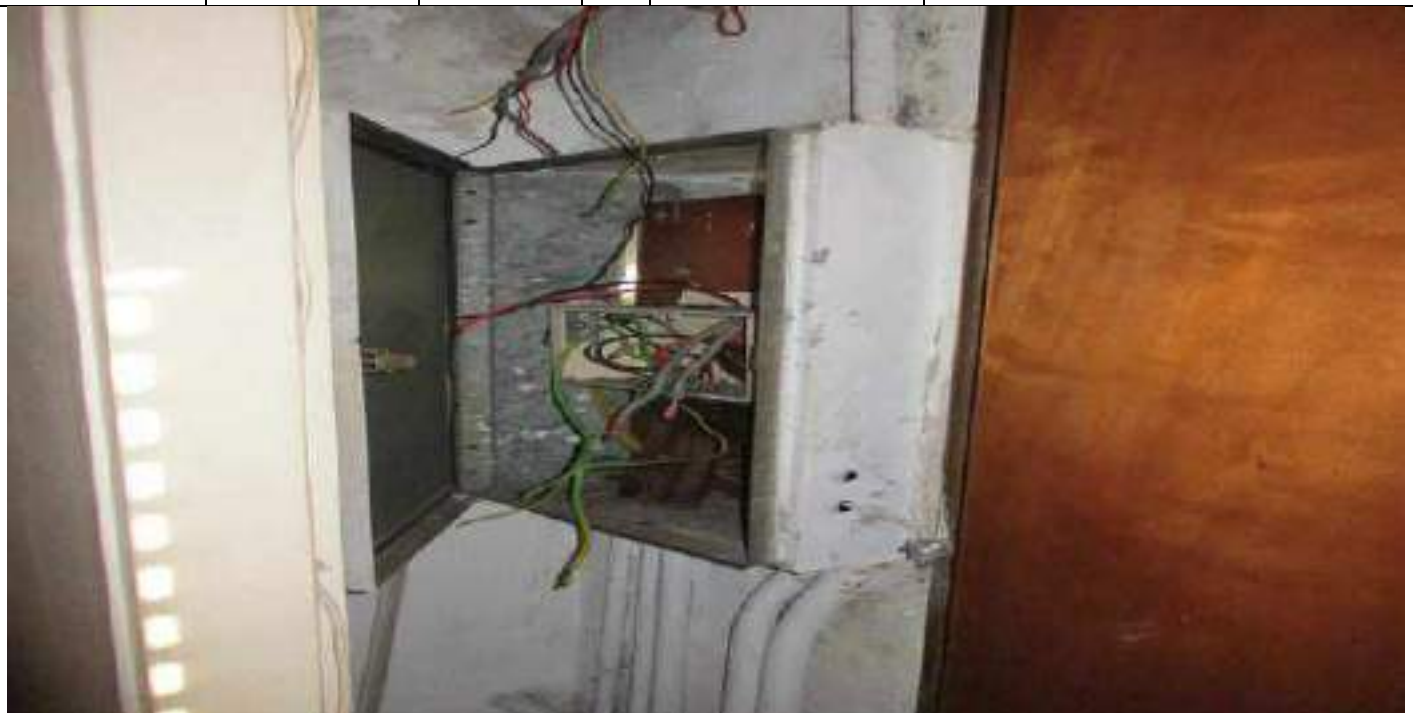
<i>Environmental Inspection Record</i>				ABBOTSBURY, AGAR GROVE, LONDON, NW1 9TB	
<i>Location</i>		<i>Component</i>		<i>Inspection Ref</i>	
FIRST FLOOR FLAT 2 HALLWAY		ELECTRICAL FUSE BOARD		<i>Surveyor:</i>	PB & MC
				PICTURE 45	
				<i>Date:</i>	20/01/21
				<i>Survey Type:</i>	REFURBISHMENT/ DEMOLITION SURVEY
<i>Condition:</i>	N/A	<i>Access:</i>	N/A	<i>Asbestos?</i>	NO
				<i>Re Inspection Date:</i>	N/A
<i>Friability:</i>	N/A	<i>Amount:</i>	N/A	<i>Type:</i>	NON ASBESTOS
<i>Damage:</i>	N/A	<i>Exposure:</i>	N/A	<i>Analysis:</i>	N/A
<i>Position:</i>	CUPBOARDS	<i>Risk Factor</i>	0	<i>Priority Assessment:</i>	NO RISK
		<i>Risk Band</i>	E

<i>Recommended Action</i>	NO ASBESTOS MATERIALS IDENTIFIED.
---------------------------	--

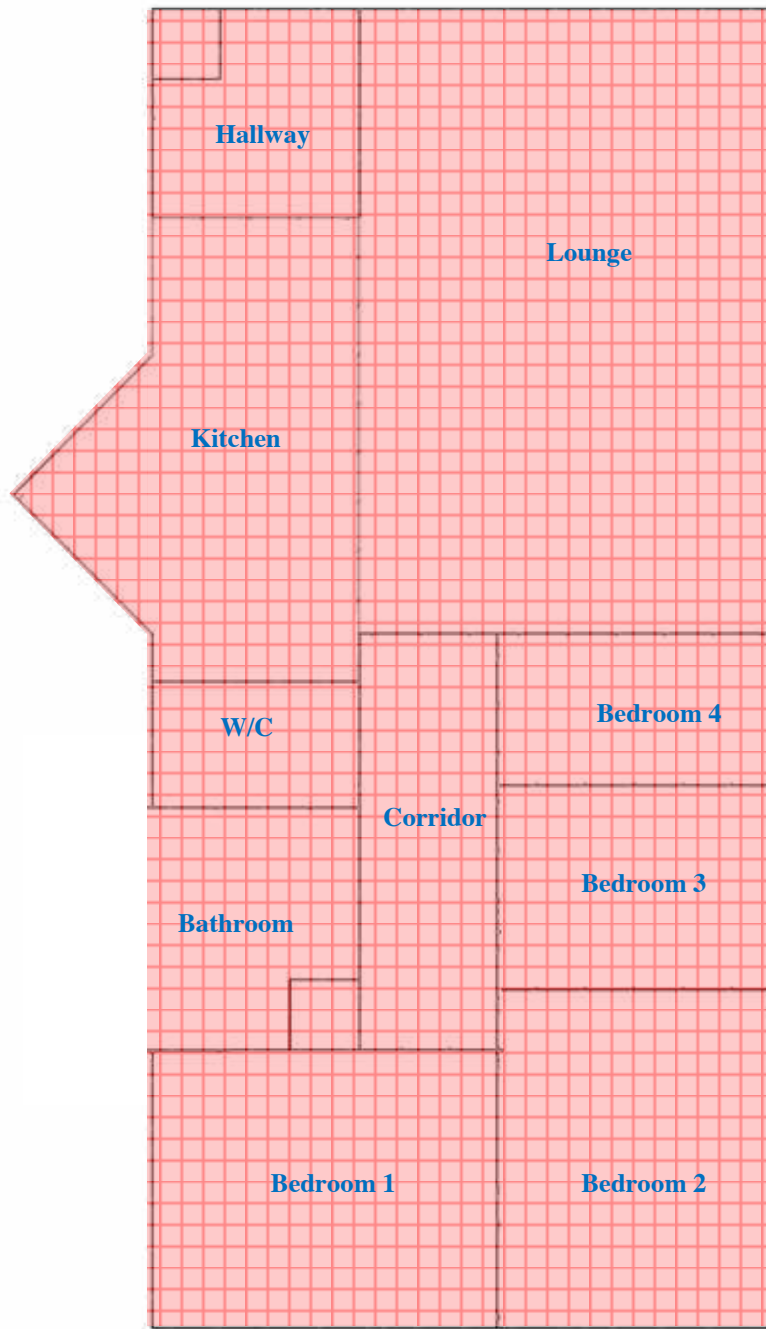
Flat 2

Vinyl Floor Tile

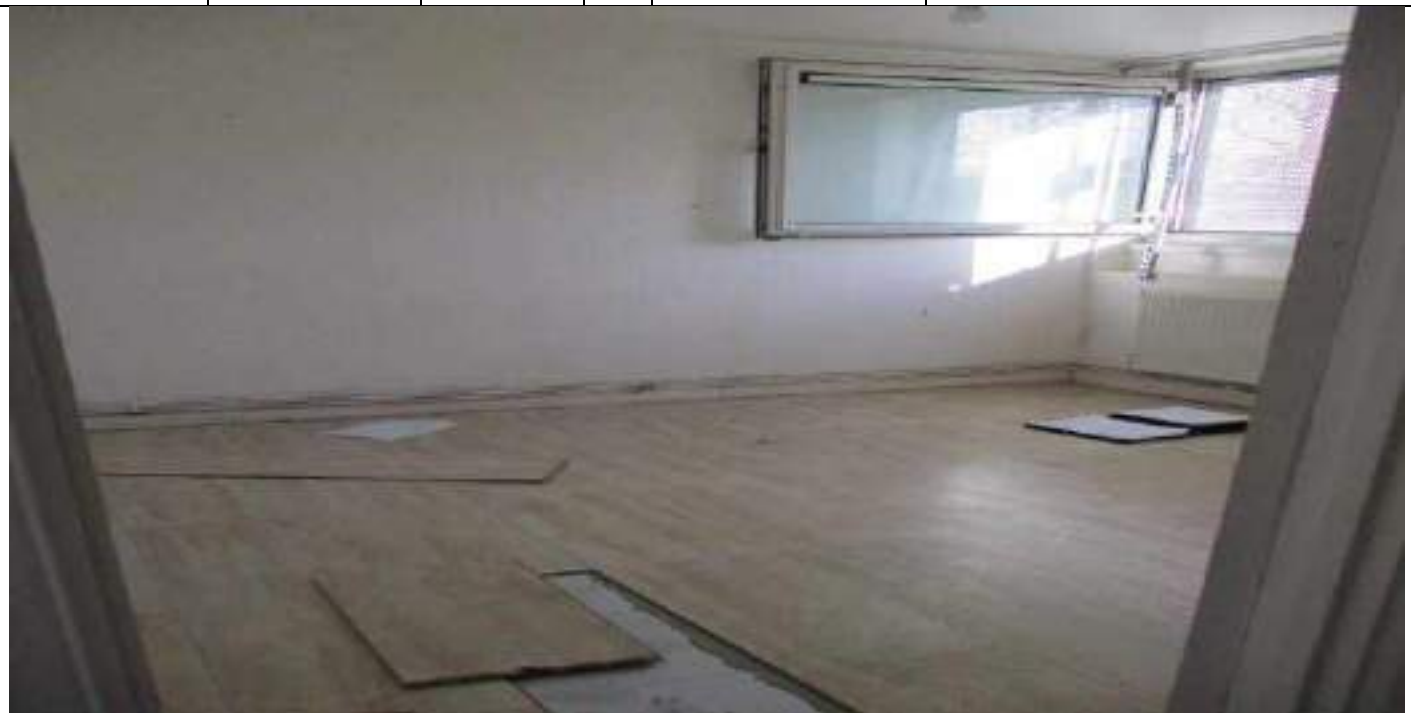
<i>Environmental Inspection Record</i>				ABBOTSBURY, AGAR GROVE, LONDON, NW1 9TB	
<i>Location</i>		<i>Component</i>		<i>Inspection Ref</i>	
GROUND FLOOR FLAT 1 BEDROOM 3		CONCRETE CEILING PLASTERED BRICK WALLS TIMBER FLOORING OVER CONCRETE FLOOR		<i>Surveyor:</i>	PB & MC
				PICTURE 46	
				<i>Date:</i>	20/01/21
				<i>Survey Type:</i>	REFURBISHMENT/ DEMOLITION SURVEY
<i>Condition:</i>	N/A	<i>Access:</i>	N/A	<i>Asbestos?</i>	NO
				<i>Re Inspection Date:</i>	N/A
<i>Friability:</i>	N/A	<i>Amount:</i>	N/A	<i>Type:</i>	NON ASBESTOS
<i>Damage:</i>	N/A	<i>Exposure:</i>	N/A	<i>Analysis:</i>	N/A
<i>Position:</i>	BEDROOM	<i>Risk Factor</i>	0	<i>Priority Assessment:</i>	NO RISK
		<i>Risk Band</i>	E

<i>Recommended Action</i>	NO ASBESTOS MATERIALS IDENTIFIED.
---------------------------	--

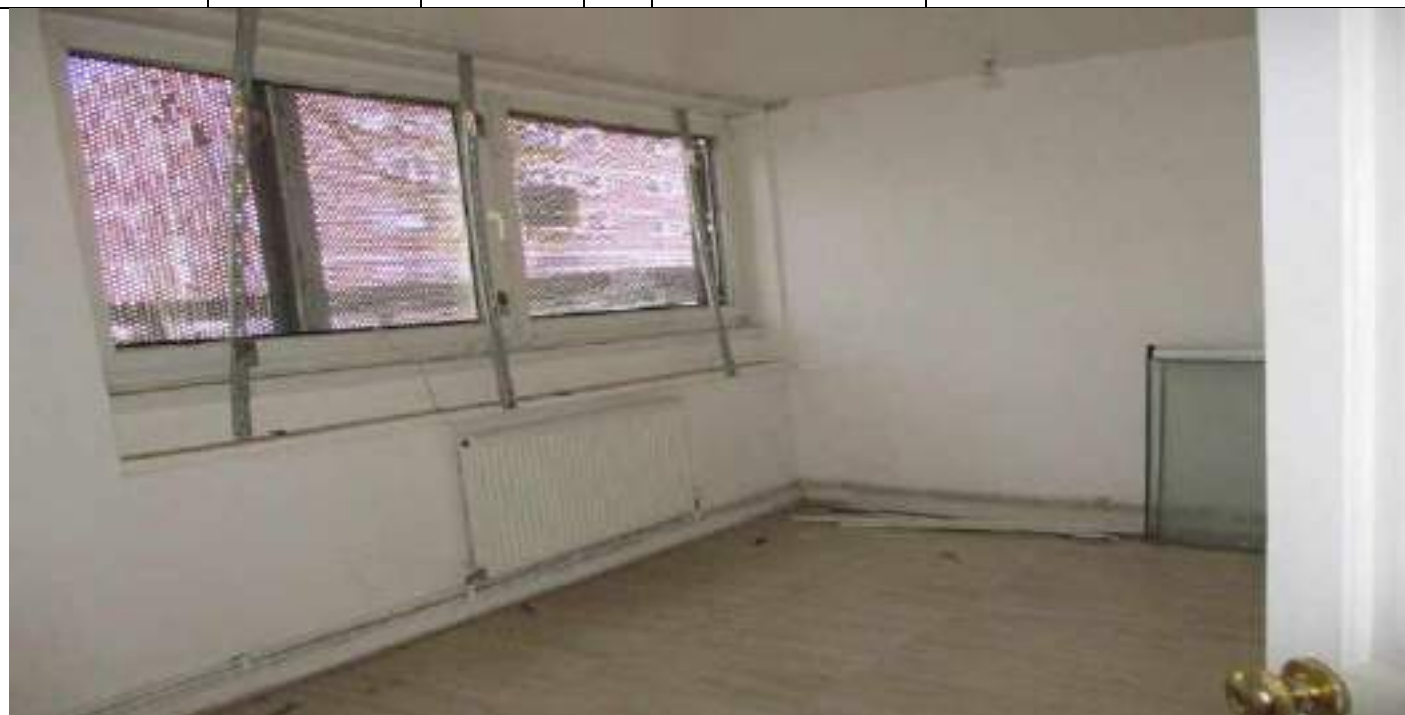
<i>Environmental Inspection Record</i>				ABBOTSBURY, AGAR GROVE, LONDON, NW1 9TB	
<i>Location</i>		<i>Component</i>		<i>Inspection Ref</i>	
GROUND FLOOR FLAT 1 BEDROOM 2		CONCRETE CEILING PLASTERED BRICK WALLS TIMBER FLOORING OVER CONCRETE FLOOR		<i>Surveyor:</i>	PB & MC
				PICTURE 47	
				<i>Date:</i>	20/01/21
				<i>Survey Type:</i>	REFURBISHMENT/ DEMOLITION SURVEY
<i>Condition:</i>	N/A	<i>Access:</i>	N/A	<i>Asbestos?</i>	NO
				<i>Re Inspection Date:</i>	N/A
<i>Friability:</i>	N/A	<i>Amount:</i>	N/A	<i>Type:</i>	NON ASBESTOS
<i>Damage:</i>	N/A	<i>Exposure:</i>	N/A	<i>Analysis:</i>	N/A
<i>Position:</i>	BEDROOM	<i>Risk Factor</i>	0	<i>Priority Assessment:</i>	NO RISK
		<i>Risk Band</i>	E

NO ASBESTOS MATERIALS IDENTIFIED.

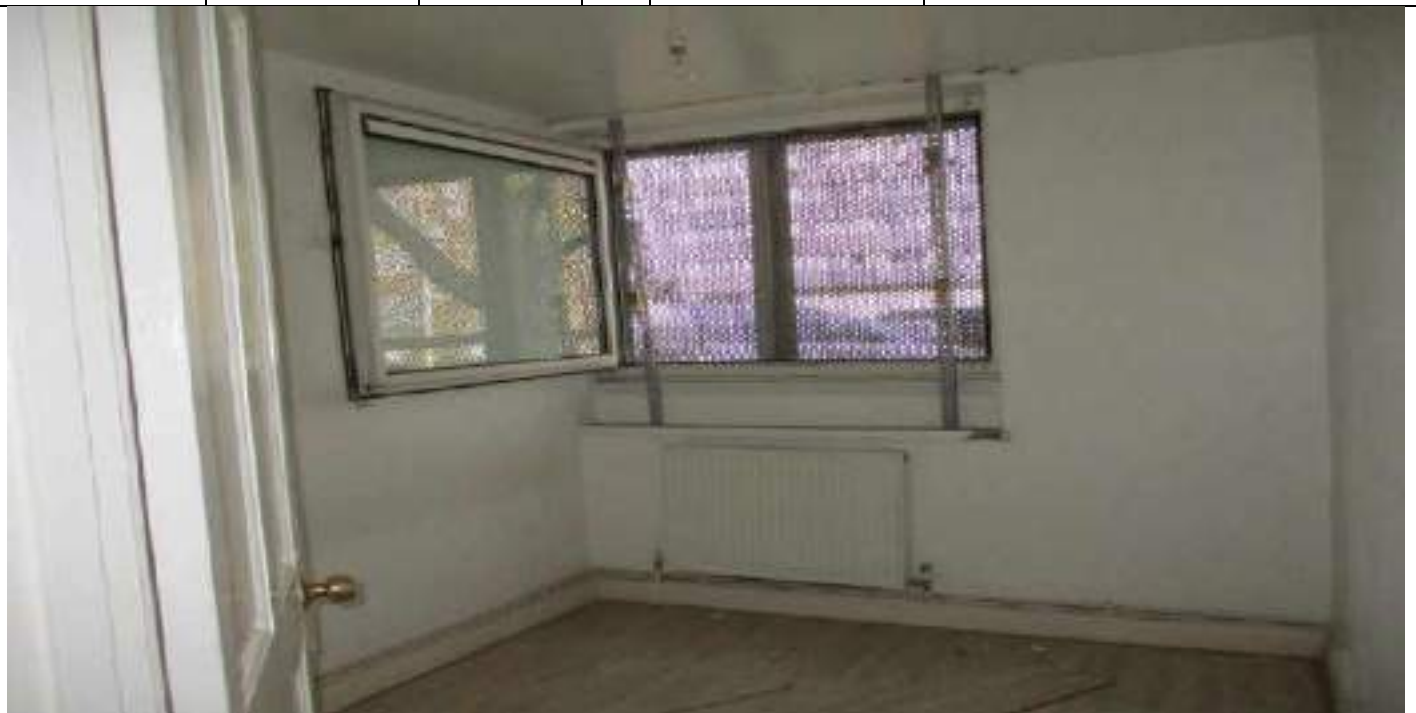
<i>Environmental Inspection Record</i>				ABBOTSBURY, AGAR GROVE, LONDON, NW1 9TB	
<i>Location</i>		<i>Component</i>		<i>Inspection Ref</i>	
GROUND FLOOR FLAT 1 BEDROOM 3		CONCRETE CEILING PLASTERED BRICK WALLS TIMBER FLOORING OVER CONCRETE FLOOR		<i>Surveyor:</i>	PB & MC
				PICTURE 48	
				<i>Date:</i>	20/01/21
				<i>Survey Type:</i>	REFURBISHMENT/ DEMOLITION SURVEY
<i>Condition:</i>	N/A	<i>Access:</i>	N/A	<i>Asbestos?</i>	NO
				<i>Re Inspection Date:</i>	N/A
<i>Friability:</i>	N/A	<i>Amount:</i>	N/A	<i>Type:</i>	NON ASBESTOS
<i>Damage:</i>	N/A	<i>Exposure:</i>	N/A	<i>Analysis:</i>	N/A
<i>Position:</i>	BEDROOM	<i>Risk Factor</i>	0	<i>Priority Assessment:</i>	NO RISK
		<i>Risk Band</i>	E

NO ASBESTOS MATERIALS IDENTIFIED.

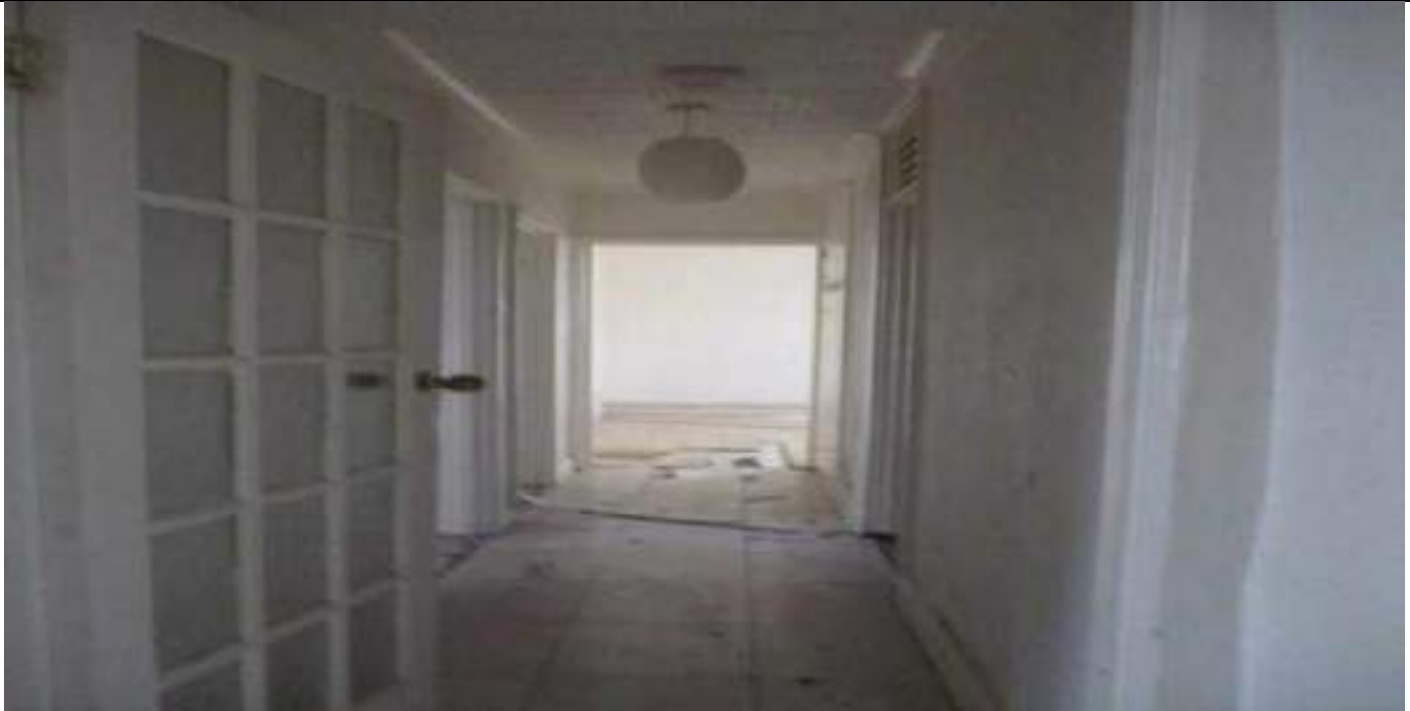
<i>Environmental Inspection Record</i>				ABBOTSBURY, AGAR GROVE, LONDON, NW1 9TB	
<i>Location</i>		<i>Component</i>		<i>Inspection Ref</i>	
GROUND FLOOR FLAT 1 CORRIDOR		CONCRETE CEILING PLASTERED BRICK WALLS TIMBER FLOORING OVER CONCRETE FLOOR		<i>Surveyor:</i>	PB & MC
				PICTURE 49	
				<i>Date:</i>	20/01/21
				<i>Survey Type:</i>	REFURBISHMENT/ DEMOLITION SURVEY
<i>Condition:</i>	N/A	<i>Access:</i>	N/A	<i>Asbestos?</i>	NO
				<i>Re Inspection Date:</i>	N/A
<i>Friability:</i>	N/A	<i>Amount:</i>	N/A	<i>Type:</i>	NON ASBESTOS
<i>Damage:</i>	N/A	<i>Exposure:</i>	N/A	<i>Analysis:</i>	N/A
<i>Position:</i>	BEDROOM	<i>Risk Factor</i>	0	<i>Priority Assessment:</i>	NO RISK
		<i>Risk Band</i>	E

<i>Recommended Action</i>		NO ASBESTOS MATERIALS IDENTIFIED.
