APPENDICES

APPENDIX G

Agar Grove noise policy for Demolition works.

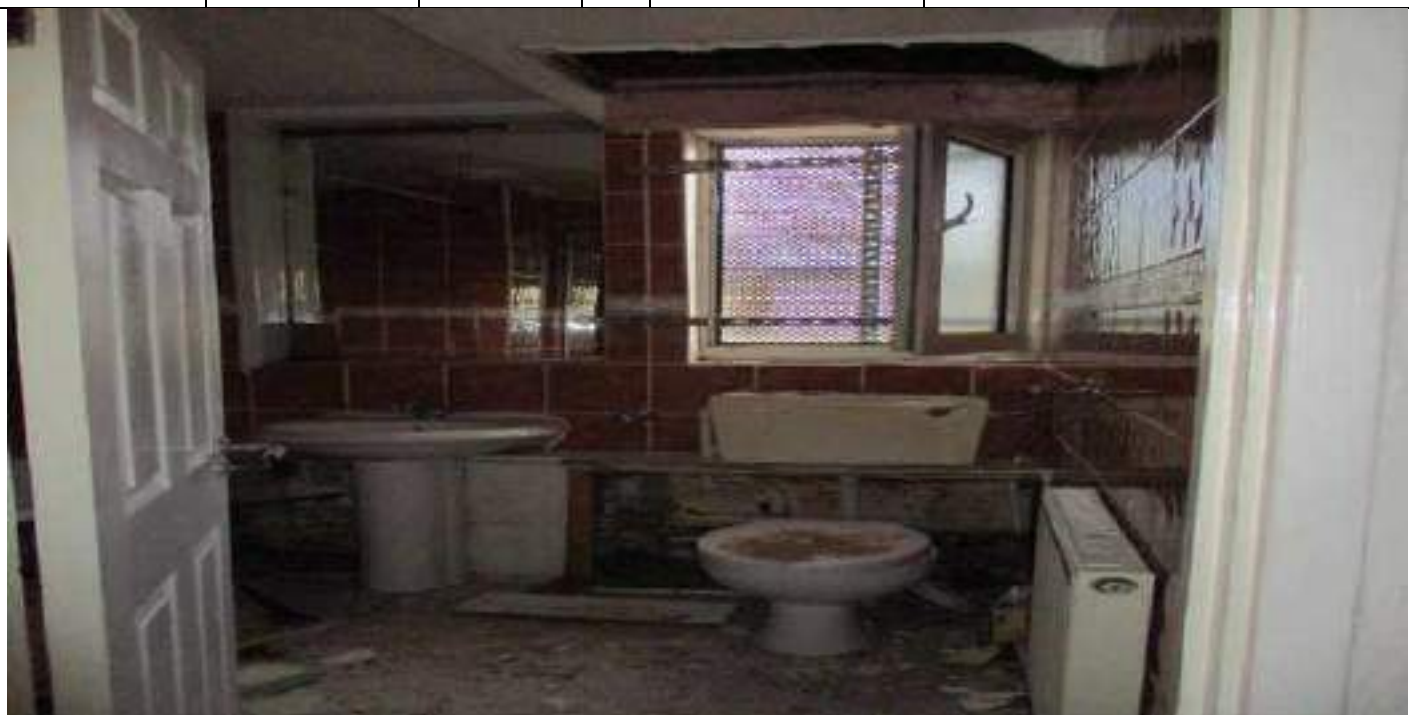
<i>Environmental Inspection Record</i>				ABBOTSBURY, AGAR GROVE, LONDON, NW1 9TB	
<i>Location</i>		<i>Component</i>		<i>Inspection Ref</i>	
GROUND FLOOR FLAT 1 BATHROOM		CONCRETE CEILING CERAMIC TILES PLASTERED BRICK WALLS VINYL FLOOR COVERING OVER CONCRETE FLOOR		<i>Surveyor:</i>	PB & MC
				PICTURE 50	
				<i>Date:</i>	20/01/21
				<i>Survey Type:</i>	REFURBISHMENT/ DEMOLITION SURVEY
<i>Condition:</i>	N/A	<i>Access:</i>	N/A	<i>Asbestos?</i>	NO
				<i>Re Inspection Date:</i>	N/A
<i>Friability:</i>	N/A	<i>Amount:</i>	N/A	<i>Type:</i>	NON ASBESTOS
<i>Damage:</i>	N/A	<i>Exposure:</i>	N/A	<i>Analysis:</i>	N/A
<i>Position:</i>	BATHROOM	<i>Risk Factor</i>	0	<i>Priority Assessment:</i>	NO RISK
		<i>Risk Band</i>	E

<i>Recommended Action</i>	NO ASBESTOS MATERIALS IDENTIFIED.
---------------------------	--

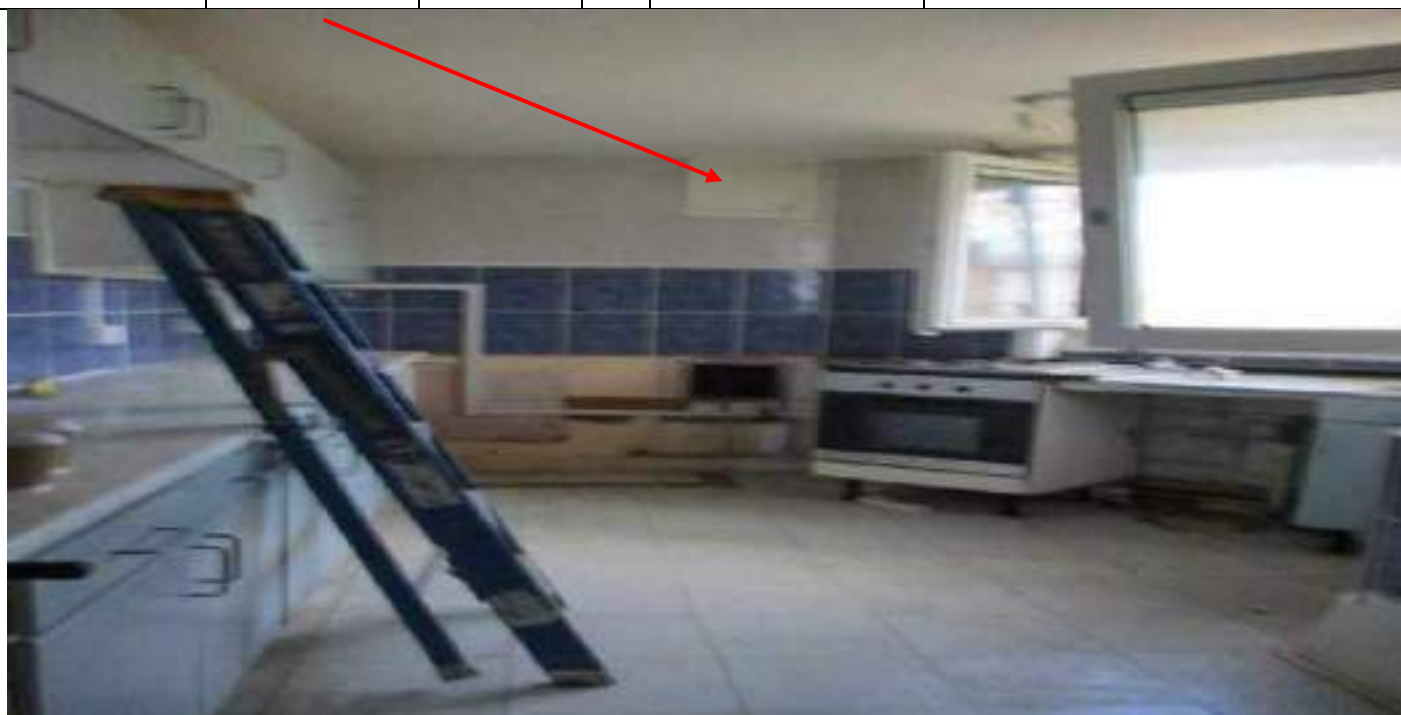
<i>Environmental Inspection Record</i>				ABBOTSBURY, AGAR GROVE, LONDON, NW1 9TB	
<i>Location</i>		<i>Component</i>		<i>Inspection Ref</i>	
GROUND FLOOR FLAT 1 KITCHEN		ASBESTOS INSULATION BOARD PANELS TO KITCHEN WALL PANEL		<i>Surveyor:</i>	PB & MC
				PICTURE 51 AS SAMPLE 3	
				<i>Date:</i>	20/01/21
				<i>Survey Type:</i>	REFURBISHMENT/ DEMOLITION SURVEY
<i>Condition:</i>	FAIR	<i>Access:</i>	EASY	<i>Asbestos?</i>	YES
				<i>Re Inspection Date:</i>	N/A
<i>Friability:</i>	HIGH	<i>Amount:</i>	APPROX: 0.5M ²	<i>Type:</i>	AMOSITE/ CHRYSOTILE
<i>Damage:</i>	LOW	<i>Exposure:</i>	OCCUPANTS	<i>Analysis:</i>	< 40%
<i>Position:</i>	INSULATION BOARD	<i>Risk Factor</i>	19	<i>Priority Assessment:</i>	HIGH RISK
		<i>Risk Band</i>	A

<i>Recommended Action</i>	REMOVE IDENTIFIED ASBESTOS INSULATION BOARD BEFORE DEMOLITION WORKS COMMENCE, USING A COMPETENT CONTRACTOR <u>ONLY!</u>
----------------------------------	--

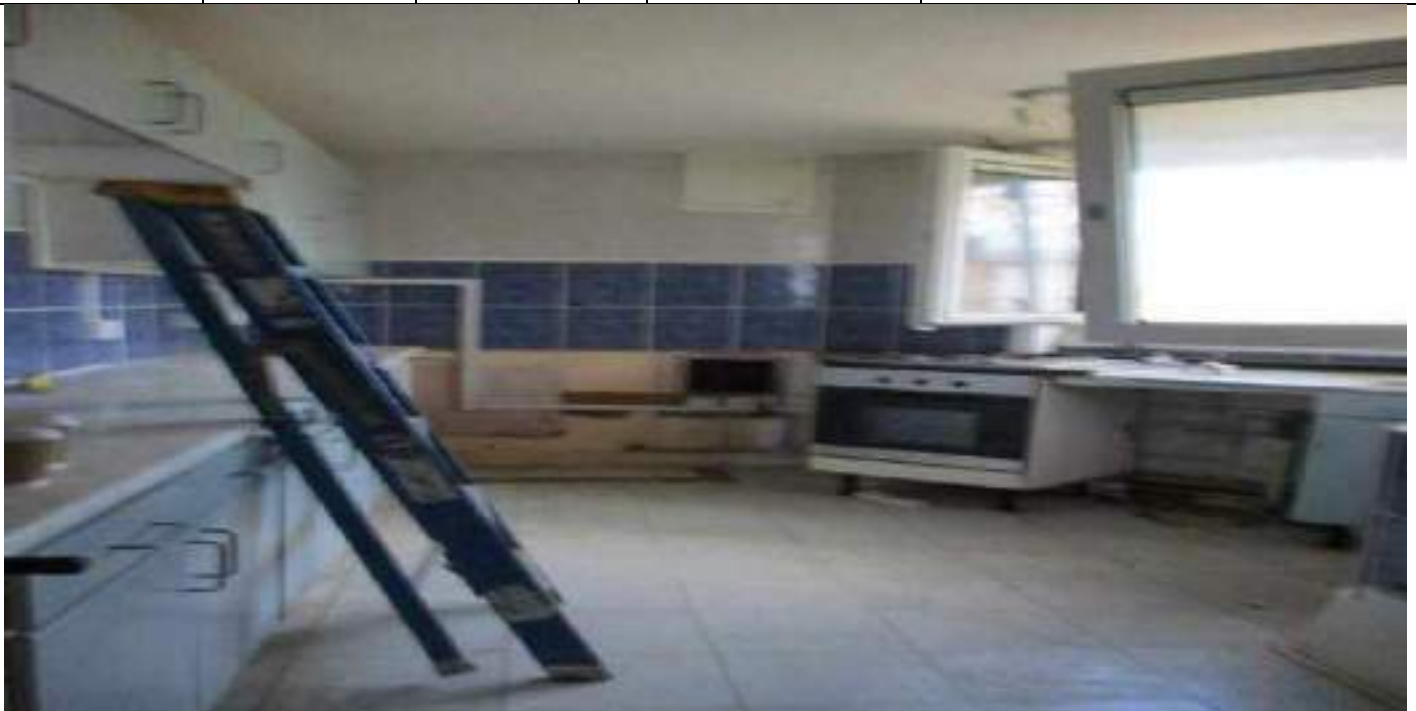
<i>Environmental Inspection Record</i>				ABBOTSBURY, AGAR GROVE, LONDON, NW1 9TB	
<i>Location</i>		<i>Component</i>		<i>Inspection Ref</i>	
GROUND FLOOR FLAT 1 KITCHEN		CONCRETE CEILING PLASTERED BRICK WALLS CERAMIC TILES OVER CONCRETE FLOOR		<i>Surveyor:</i>	PB & MC
				PICTURE 52	
				<i>Date:</i>	20/01/21
				<i>Survey Type:</i>	REFURBISHMENT/ DEMOLITION SURVEY
<i>Condition:</i>	N/A	<i>Access:</i>	N/A	<i>Asbestos?</i>	NO
				<i>Re Inspection Date:</i>	N/A
<i>Friability:</i>	N/A	<i>Amount:</i>	N/A	<i>Type:</i>	NON ASBESTOS
<i>Damage:</i>	N/A	<i>Exposure:</i>	N/A	<i>Analysis:</i>	N/A
<i>Position:</i>	KITCHEN	<i>Risk Factor</i>	0	<i>Priority Assessment:</i>	NO RISK
		<i>Risk Band</i>	E

<i>Recommended Action</i>	NO ASBESTOS MATERIALS IDENTIFIED.
---------------------------	--

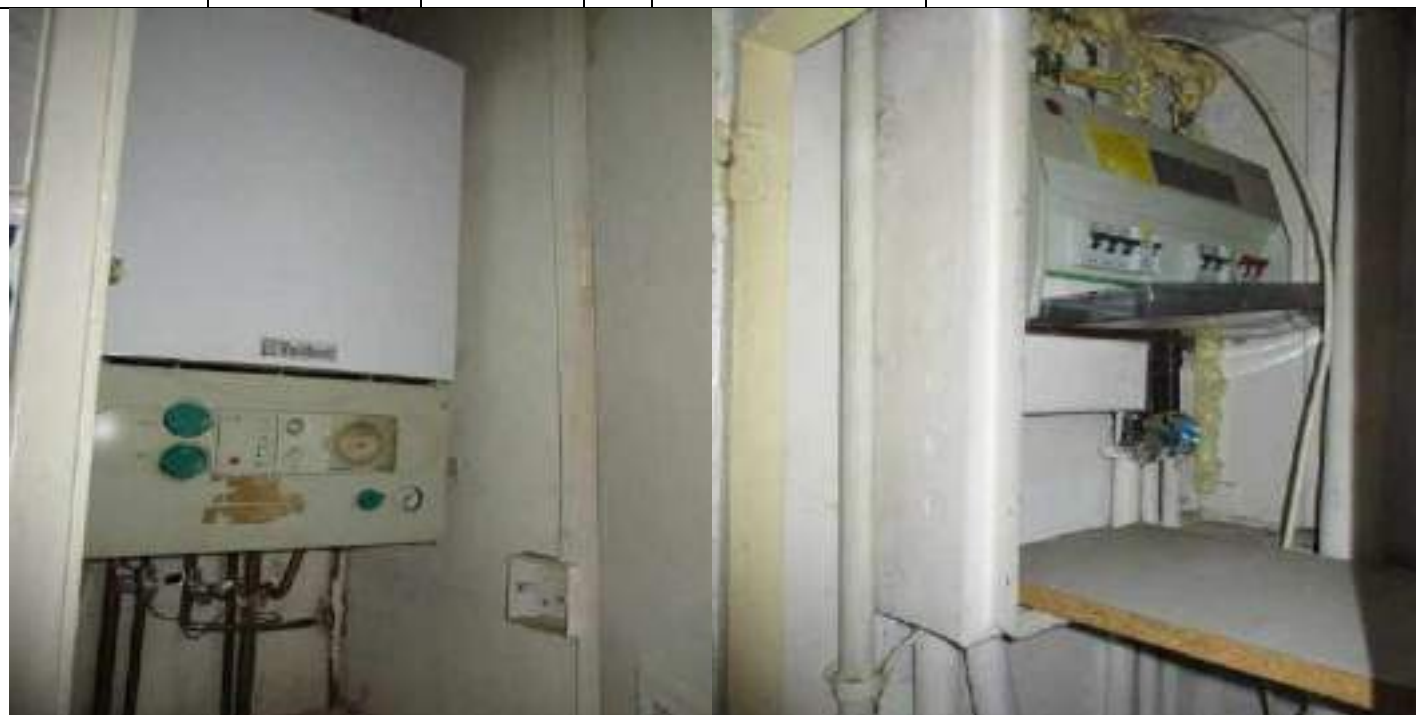
<i>Environmental Inspection Record</i>				ABBOTSBURY, AGAR GROVE, LONDON, NW1 9TB	
<i>Location</i>		<i>Component</i>		<i>Inspection Ref</i>	
GROUND FLOOR FLAT 1 CORRIDOR		BOILER WITH METAL FLUE PIPE ELECTRICAL FUSE BOARD		<i>Surveyor:</i>	PB & MC
				PICTURE 53	
				<i>Date:</i>	20/01/21
				<i>Survey Type:</i>	REFURBISHMENT/ DEMOLITION SURVEY
<i>Condition:</i>	N/A	<i>Access:</i>	N/A	<i>Asbestos?</i>	NO
				<i>Re Inspection Date:</i>	N/A
<i>Friability:</i>	N/A	<i>Amount:</i>	N/A	<i>Type:</i>	NON ASBESTOS
<i>Damage:</i>	N/A	<i>Exposure:</i>	N/A	<i>Analysis:</i>	N/A
<i>Position:</i>	CUPBOARDS	<i>Risk Factor</i>	0	<i>Priority Assessment:</i>	NO RISK
		<i>Risk Band</i>	E

<i>Recommended Action</i>	NO ASBESTOS MATERIALS IDENTIFIED.
---------------------------	--

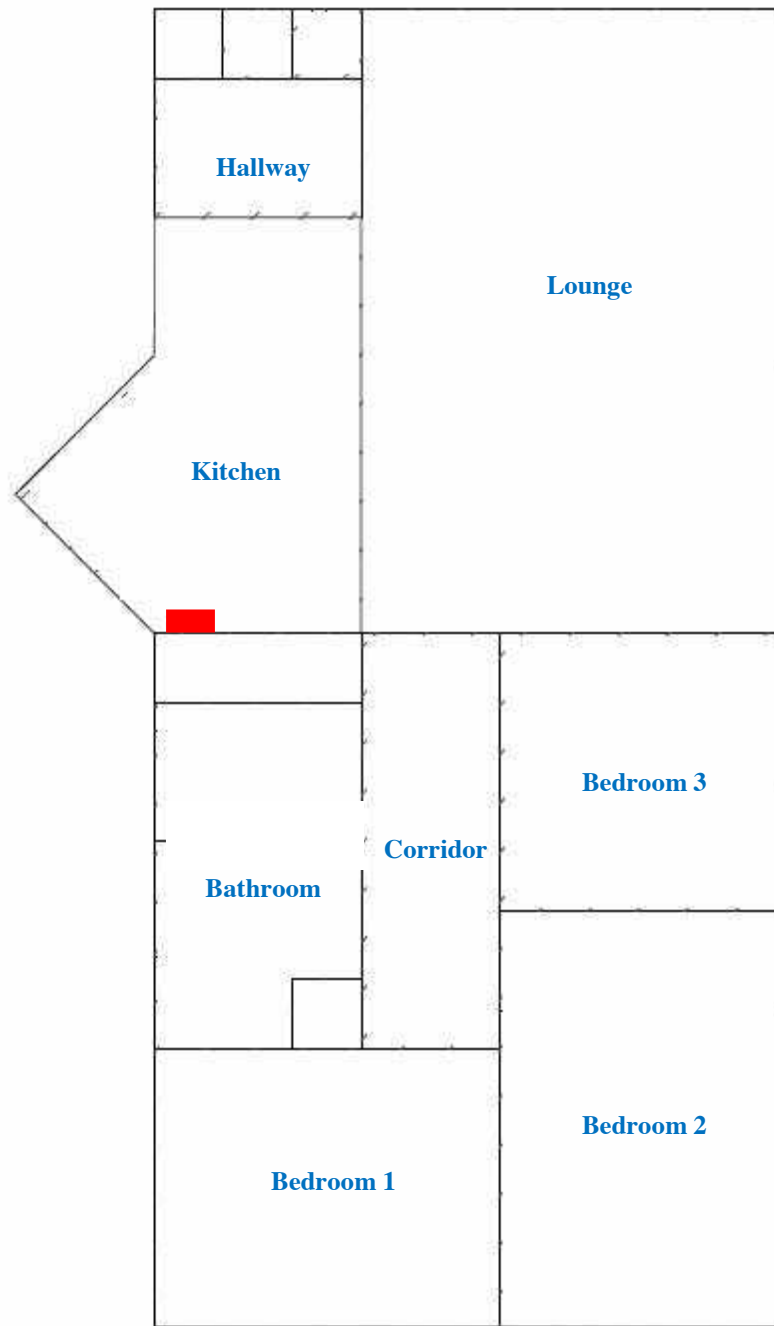
Flat 1

Insulation Board

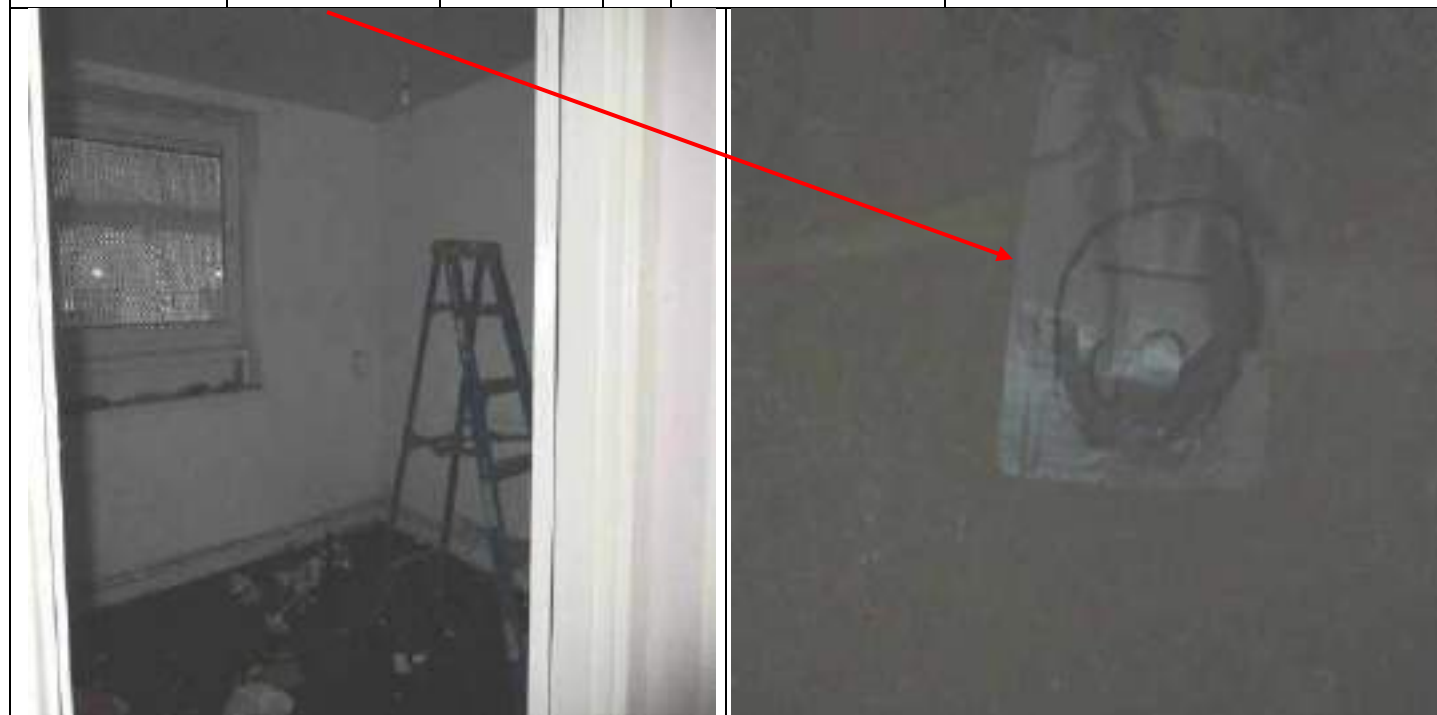
<i>Environmental Inspection Record</i>			FRAMPTON, AGAR GROVE, LONDON, NW1 9SN		
<i>Location</i>		<i>Component</i>		<i>Inspection Ref</i>	
GROUND FLOOR FLAT 1 BEDROOM 4		CONCRETE CEILING PLASTERED BRICK/BREEZE BLOCK WALLS ASBESTOS VINYL FLOOR TILES & BITUMEN TO CONCRETE		<i>Surveyor:</i>	PB & MC
				PICTURE 1 & 2 SAMPLE 1	
				<i>Date:</i>	19/01/21
				<i>Survey Type:</i>	REFURBISHMENT/ DEMOLITION SURVEY
<i>Condition:</i>	FAIR	<i>Access:</i>	EASY	<i>Asbestos?</i>	YES
				<i>Re Inspection Date:</i>	N/A
<i>Friability:</i>	LOW	<i>Amount:</i>	APPROX: 12M ²	<i>Type:</i>	CHRYSOTILE TO BOTH
<i>Damage:</i>	LOW	<i>Exposure:</i>	OCCUPANTS	<i>Analysis:</i>	TILES <7% BITUMEN <8%
<i>Position:</i>	VINYL FLOOR TILE & BITUMEN	<i>Risk Factor</i>	4	<i>Priority Assessment:</i>	MINOR RISK
		<i>Risk Band</i>	D

<i>Recommended Action</i>	REMOVE IDENTIFIED ASBESTOS VINYL TILES & ADHESIVE BEFORE DEMOLITION WORKS COMMENCE, USING A COMPETENT CONTRACTOR
----------------------------------	---

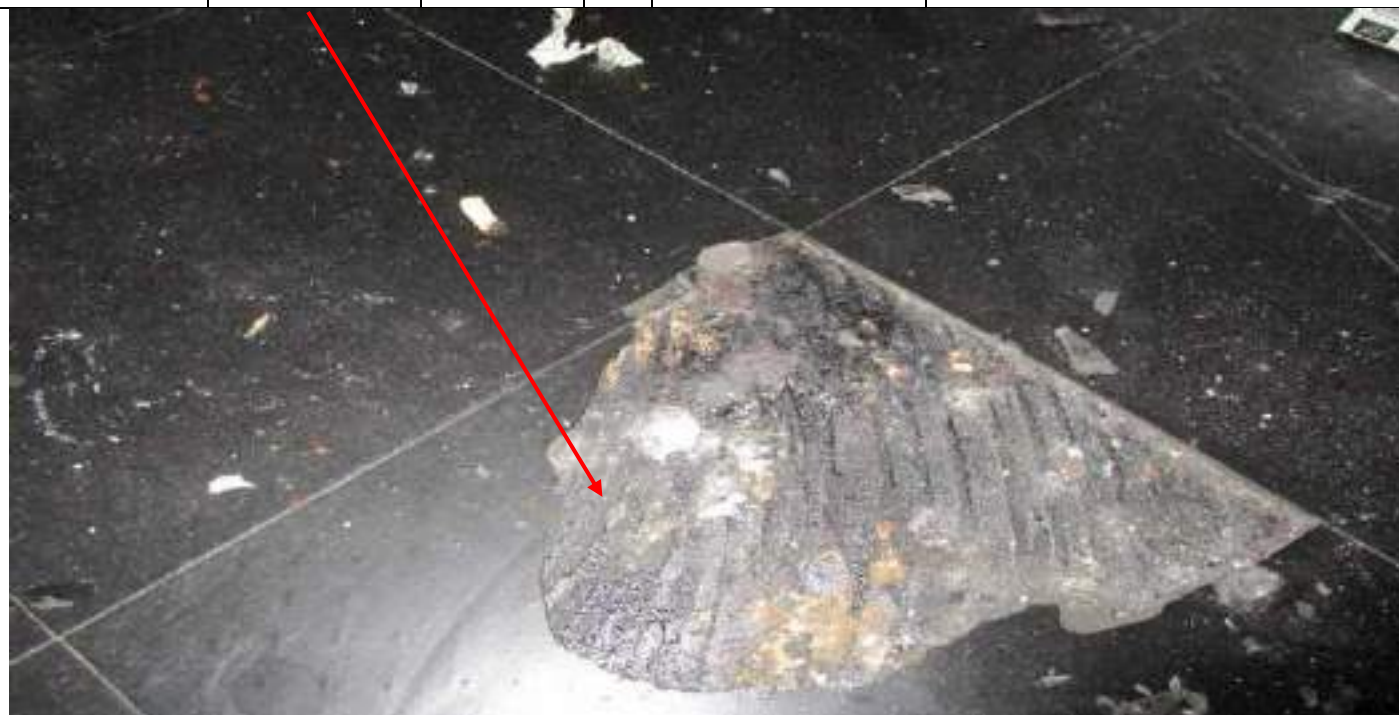
<i>Environmental Inspection Record</i>				FRAMPTON, AGAR GROVE, LONDON, NW1 2SN					
<i>Location</i>		<i>Component</i>			<i>Inspection Ref</i>				
GROUND FLOOR FLAT 1 BEDROOM 4		ASBESTOS VINYL FLOOR TILES & BITUMEN TO CONCRETE			<i>Surveyor:</i>		PB & MC		
					PICTURE 3 SAMPLE 2				
					<i>Date:</i>		19/01/21		
					<i>Survey Type:</i>		REFURBISHMENT/ DEMOLITION SURVEY		
<i>Condition:</i>	FAIR	<i>Access:</i>	EASY		<i>Asbestos?</i>		YES		
					<i>Re Inspection Date:</i>			N/A	
<i>Friability:</i>	LOW	<i>Amount:</i>	APPROX: 12M ²		<i>Type:</i>	CHRYSOTILE TO BOTH			
<i>Damage:</i>	LOW	<i>Exposure:</i>	OCCUPANTS		<i>Analysis:</i>	TILES	<7%		
						BITUMEN	<8%		
<i>Position:</i>	VINYL FLOOR TILE & BITUMEN	<i>Risk Factor</i>	4	<i>Priority Assessment:</i>	MINOR RISK				
		<i>Risk Band</i>	D

<i>Recommended Action</i>	REMOVE IDENTIFIED ASBESTOS VINYL TILES & ADHESIVE BEFORE DEMOLITION WORKS COMMENCE, USING A COMPETENT CONTRACTOR
----------------------------------	---

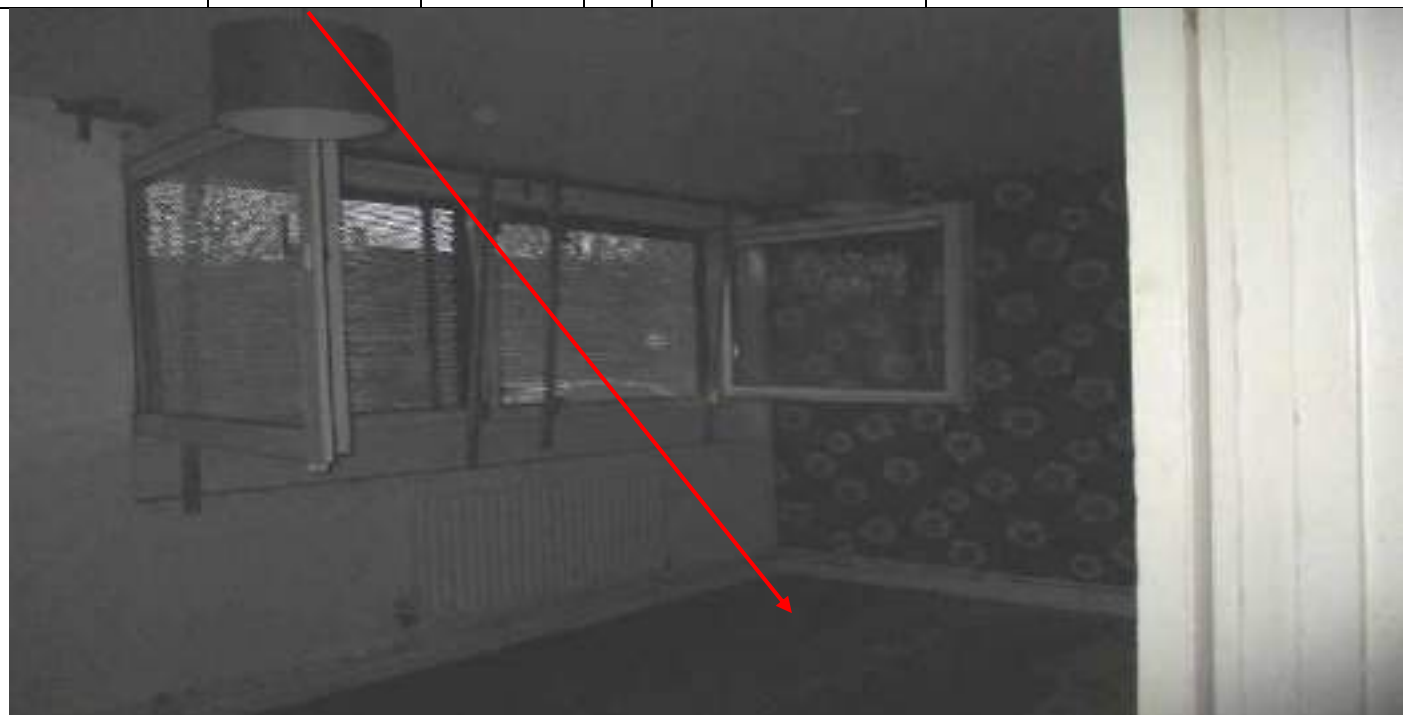
<i>Environmental Inspection Record</i>				FRAMPTON, AGAR GROVE, LONDON, NW1 2SN			
<i>Location</i>		<i>Component</i>			<i>Inspection Ref</i>		
GROUND FLOOR FLAT 1 BEDROOM 3		CONCRETE CEILING PLASTERED BRICK/BREEZE BLOCK WALLS ASBESTOS VINYL FLOOR TILES & BITUMEN TO CONCRETE			<i>Surveyor:</i>	PB & MC	
					PICTURE 4 AS SAMPLE 2		
					<i>Date:</i>	19/01/21	
					<i>Survey Type:</i>	REFURBISHMENT/ DEMOLITION SURVEY	
<i>Condition:</i>	FAIR	<i>Access:</i>	EASY		<i>Asbestos?</i>	YES	
					<i>Re Inspection Date:</i>	N/A	
<i>Friability:</i>	LOW	<i>Amount:</i>	APPROX: 10M ²		<i>Type:</i>	CHRYSOTILE TO BOTH	
<i>Damage:</i>	LOW	<i>Exposure:</i>	OCCUPANTS		<i>Analysis:</i>	TILES	<7%
						BITUMEN	<8%
<i>Position:</i>	VINYL FLOOR TILE & BITUMEN	<i>Risk Factor</i>	4	<i>Priority Assessment:</i>	MINOR RISK		
		<i>Risk Band</i>	D

<i>Recommended Action</i>	REMOVE IDENTIFIED ASBESTOS VINYL TILES & ADHESIVE BEFORE DEMOLITION WORKS COMMENCE, USING A COMPETENT CONTRACTOR
----------------------------------	---

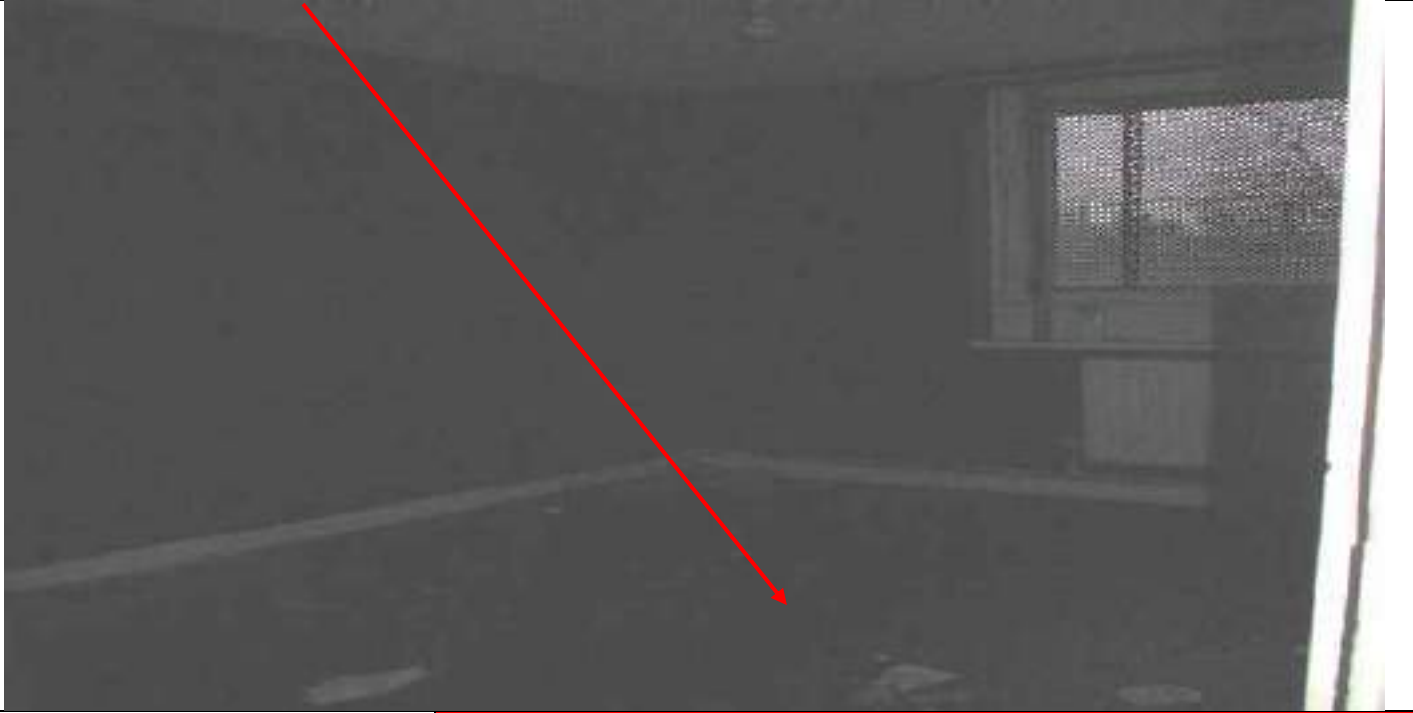
<i>Environmental Inspection Record</i>				FRAMPTON, AGAR GROVE, LONDON, NW1 2SN			
<i>Location</i>		<i>Component</i>			<i>Inspection Ref</i>		
GROUND FLOOR FLAT 1 BEDROOM 2		CONCRETE CEILING PLASTERED BRICK/BREEZE BLOCK WALLS ASBESTOS VINYL FLOOR TILES & BITUMEN TO CONCRETE			<i>Surveyor:</i>	PB & MC	
					PICTURE 5 AS SAMPLE 2		
					<i>Date:</i>	19/01/21	
					<i>Survey Type:</i>	REFURBISHMENT/ DEMOLITION SURVEY	
<i>Condition:</i>	FAIR	<i>Access:</i>	EASY		<i>Asbestos?</i>	YES	
					<i>Re Inspection Date:</i>	N/A	
<i>Friability:</i>	LOW	<i>Amount:</i>	APPROX: 10M ²		<i>Type:</i>	CHRYSO TILE TO BOTH	
<i>Damage:</i>	LOW	<i>Exposure:</i>	OCCUPANTS		<i>Analysis:</i>	TILES	<7%
						BITUMEN	<8%
<i>Position:</i>	VINYL FLOOR TILE & BITUMEN	<i>Risk Factor</i>	4	<i>Priority Assessment:</i>	MINOR RISK		
		<i>Risk Band</i>	D

<i>Recommended Action</i>		REMOVE IDENTIFIED ASBESTOS VINYL TILES & ADHESIVE BEFORE DEMOLITION WORKS COMMENCE, USING A COMPETENT CONTRACTOR

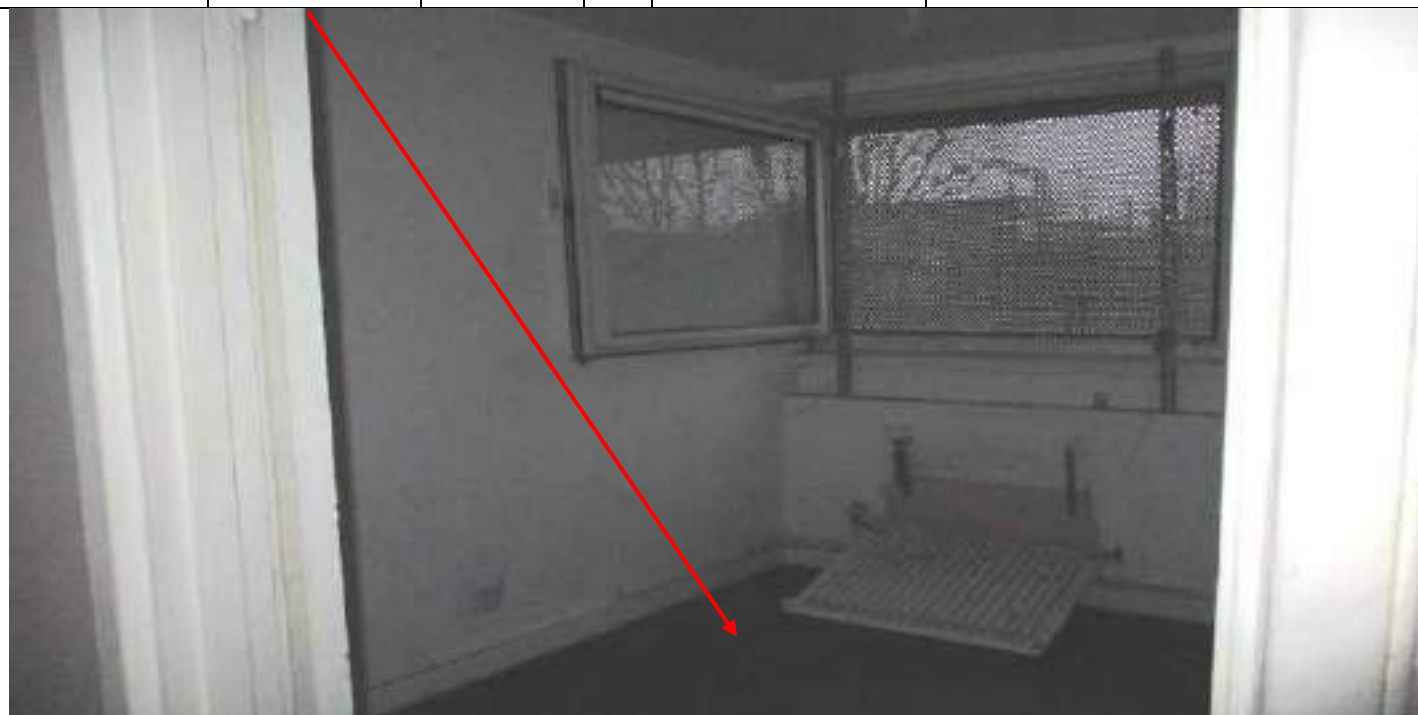
<i>Environmental Inspection Record</i>			FRAMPTON, AGAR GROVE, LONDON, NW1 2SN		
<i>Location</i>		<i>Component</i>		<i>Inspection Ref</i>	
GROUND FLOOR FLAT 1 BEDROOM 1		CONCRETE CEILING PLASTERED BRICK/BREEZE BLOCK WALLS ASBESTOS VINYL FLOOR TILES & BITUMEN TO CONCRETE		<i>Surveyor:</i>	PB & MC
				PICTURE 6 AS SAMPLE 2	
				<i>Date:</i>	19/01/21
				<i>Survey Type:</i>	REFURBISHMENT/ DEMOLITION SURVEY
<i>Condition:</i>	FAIR	<i>Access:</i>	EASY	<i>Asbestos?</i>	YES
				<i>Re Inspection Date:</i>	N/A
<i>Friability:</i>	LOW	<i>Amount:</i>	APPROX: 6M ²	<i>Type:</i>	CHRYSOTILE TO BOTH
<i>Damage:</i>	LOW	<i>Exposure:</i>	OCCUPANTS	<i>Analysis:</i>	TILES <7% BITUMEN <8%
<i>Position:</i>	VINYL FLOOR TILE & BITUMEN	<i>Risk Factor</i>	4	<i>Priority Assessment:</i>	MINOR RISK
		<i>Risk Band</i>	D

<i>Recommended Action</i>	REMOVE IDENTIFIED ASBESTOS VINYL TILES & ADHESIVE BEFORE DEMOLITION WORKS COMMENCE, USING A COMPETENT CONTRACTOR
----------------------------------	---

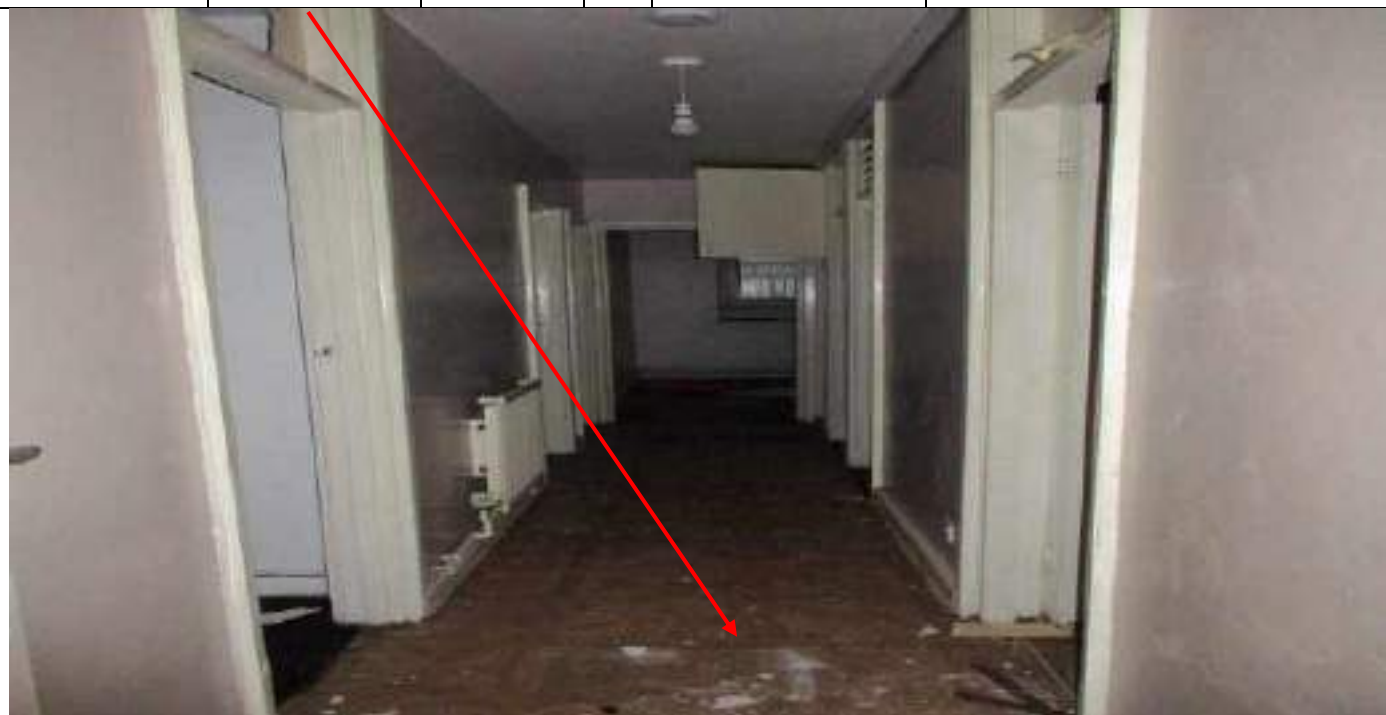
<i>Environmental Inspection Record</i>			FRAMPTON, AGAR GROVE, LONDON, NW1 2SN			
<i>Location</i>		<i>Component</i>		<i>Inspection Ref</i>		
GROUND FLOOR FLAT 1 CORRIDOR		CONCRETE CEILING PLASTERED BRICK/BREEZE BLOCK WALLS ASBESTOS VINYL FLOOR TILES & BITUMEN TO CONCRETE		<i>Surveyor:</i>	PB & MC	
				PICTURE 7 AS SAMPLE 2		
				<i>Date:</i>	19/01/21	
				<i>Survey Type:</i>	REFURBISHMENT/ DEMOLITION SURVEY	
<i>Condition:</i>	FAIR	<i>Access:</i>	EASY	<i>Asbestos?</i>	YES	
				<i>Re Inspection Date:</i>	N/A	
<i>Friability:</i>	LOW	<i>Amount:</i>	APPROX: 6M ²	<i>Type:</i>	CHRYBOTILE TO BOTH	
<i>Damage:</i>	LOW	<i>Exposure:</i>	OCCUPANTS	<i>Analysis:</i>	TILES	<7%
					BITUMEN	<8%
<i>Position:</i>	VINYL FLOOR TILE & BITUMEN	<i>Risk Factor</i>	4	<i>Priority Assessment:</i>	MINOR RISK	
		<i>Risk Band</i>	D

<i>Recommended Action</i>	REMOVE IDENTIFIED ASBESTOS VINYL TILES & ADHESIVE BEFORE DEMOLITION WORKS COMMENCE, USING A COMPETENT CONTRACTOR
----------------------------------	---

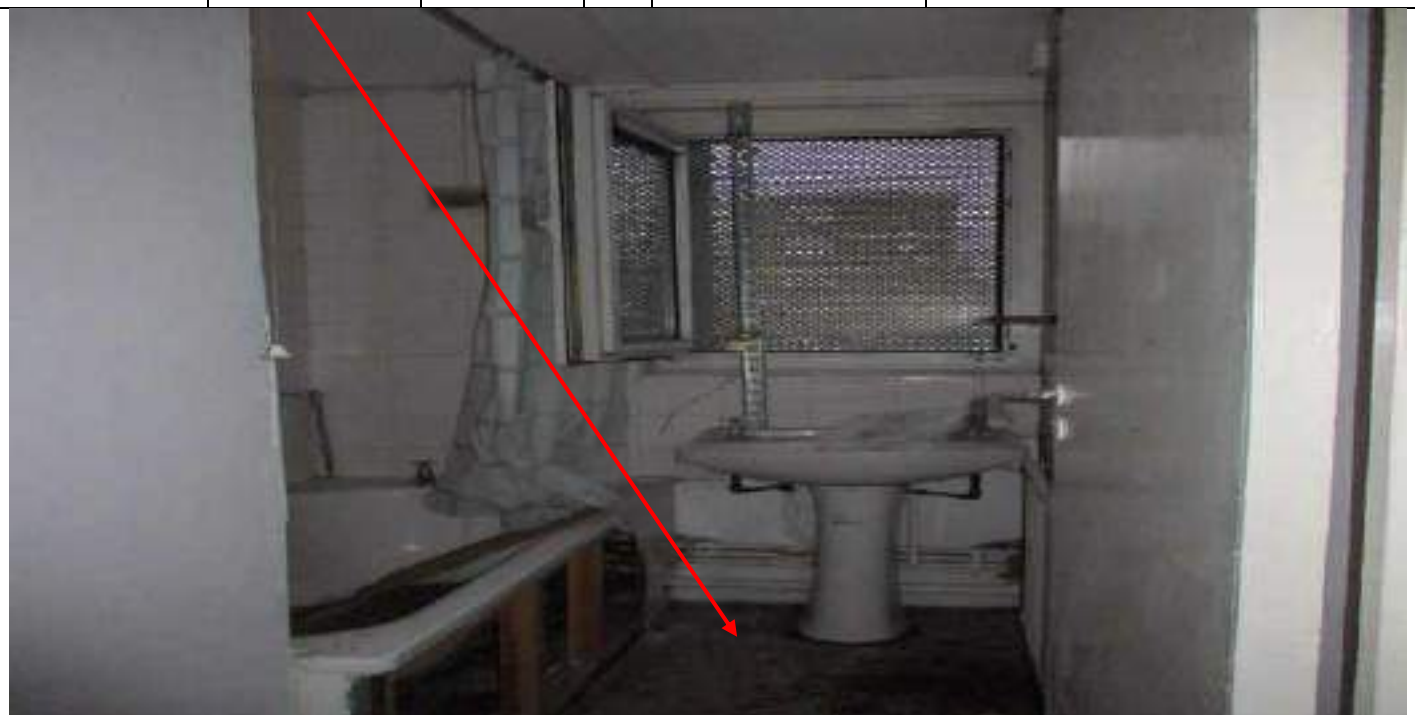
<i>Environmental Inspection Record</i>			FRAMPTON, AGAR GROVE, LONDON, NW1 2SN		
<i>Location</i>		<i>Component</i>		<i>Inspection Ref</i>	
GROUND FLOOR FLAT 1 BATHROOM		CONCRETE CEILING CERAMIC TILES TO PLASTERED BRICK/BREEZE BLOCK WALLS ASBESTOS VINYL FLOOR TILES & BITUMEN TO CONCRETE		<i>Surveyor:</i>	PB & MC
				PICTURE 8 AS SAMPLE 2	
				<i>Date:</i>	19/01/21
				<i>Survey Type:</i>	REFURBISHMENT/ DEMOLITION SURVEY
<i>Condition:</i>	FAIR	<i>Access:</i>	EASY	<i>Asbestos?</i>	YES
				<i>Re Inspection Date:</i>	N/A
<i>Friability:</i>	LOW	<i>Amount:</i>	APPROX: 2M ²	<i>Type:</i>	CHRYBOTILE TO BOTH
<i>Damage:</i>	LOW	<i>Exposure:</i>	OCCUPANTS	<i>Analysis:</i>	TILES <7% BITUMEN <8%
<i>Position:</i>	VINYL FLOOR TILE & BITUMEN	<i>Risk Factor</i>	4	<i>Priority Assessment:</i>	MINOR RISK
		<i>Risk Band</i>	D

<i>Recommended Action</i>	REMOVE IDENTIFIED ASBESTOS VINYL TILES & ADHESIVE BEFORE DEMOLITION WORKS COMMENCE, USING A COMPETENT CONTRACTOR
----------------------------------	---

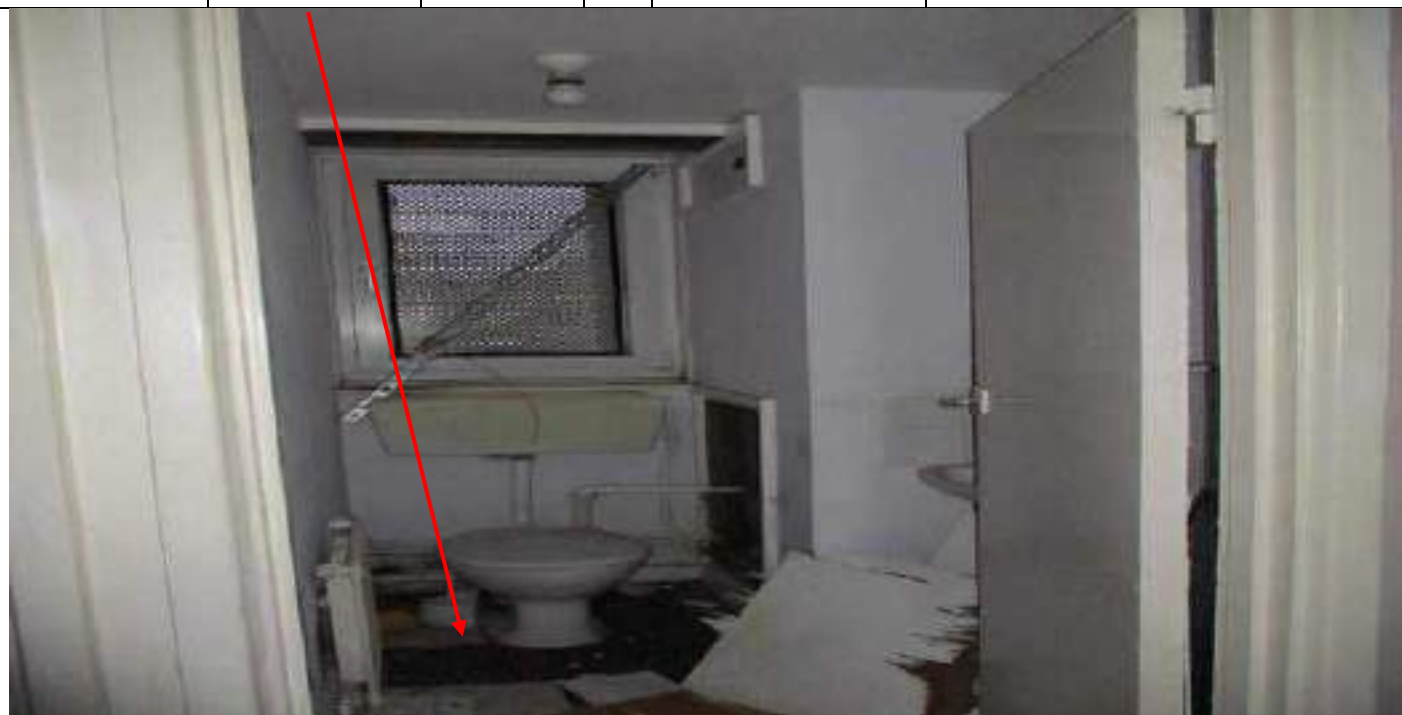
<i>Environmental Inspection Record</i>				FRAMPTON, AGAR GROVE, LONDON, NW1 2SN						
<i>Location</i>		<i>Component</i>			<i>Inspection Ref</i>					
GROUND FLOOR FLAT 1 WC		CONCRETE CEILING CERAMIC TILES TO PLASTERED BRICK/BREEZE BLOCK WALLS ASBESTOS VINYL FLOOR TILES & BITUMEN TO CONCRETE			<i>Surveyor:</i>		PB & MC			
					PICTURE 10 AS SAMPLE 2					
					<i>Date:</i>		19/01/21			
					<i>Survey Type:</i>		REFURBISHMENT/ DEMOLITION SURVEY			
<i>Condition:</i>	FAIR	<i>Access:</i>	EASY			<i>Asbestos?</i> YES				
						<i>Re Inspection Date:</i> N/A				
<i>Friability:</i>	LOW	<i>Amount:</i>	APPROX: 2M ²			<i>Type:</i>	CHRYSOTILE TO BOTH			
<i>Damage:</i>	LOW	<i>Exposure:</i>	OCCUPANTS			<i>Analysis:</i>	TILES <7% BITUMEN <8%			
<i>Position:</i>	VINYL FLOOR TILE & BITUMEN	<i>Risk Factor</i>	4	<i>Priority Assessment:</i>		MINOR RISK				
		<i>Risk Band</i>	D

<i>Recommended Action</i>	REMOVE IDENTIFIED ASBESTOS VINYL TILES & ADHESIVE BEFORE DEMOLITION WORKS COMMENCE, USING A COMPETENT CONTRACTOR
----------------------------------	---

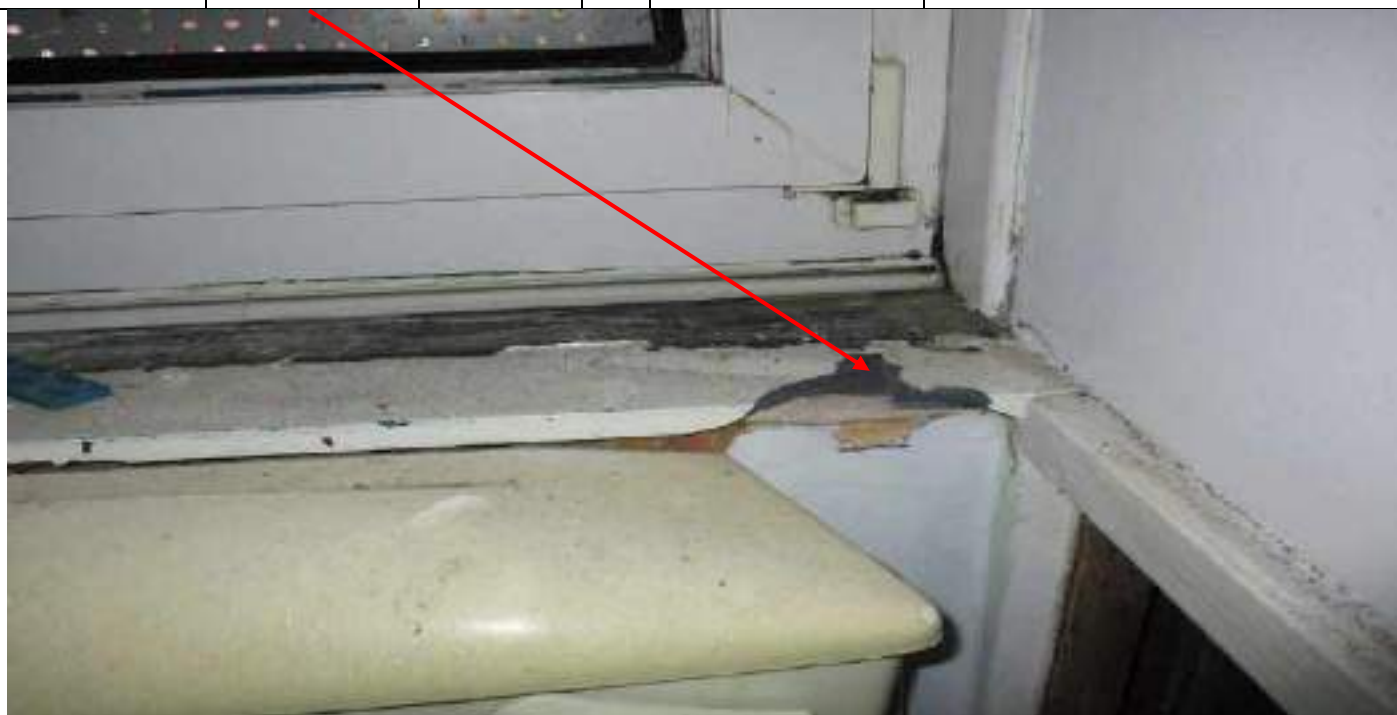
<i>Environmental Inspection Record</i>				FRAMPTON, AGAR GROVE, LONDON, NW1 2SN	
<i>Location</i>		<i>Component</i>		<i>Inspection Ref</i>	
GROUND FLOOR FLAT 1 WC		ASBESTOS CEMENT SHELF		<i>Surveyor:</i>	PB & MC
				PICTURE 13 SAMPLE 4	
				<i>Date:</i>	19/01/21
				<i>Survey Type:</i>	REFURBISHMENT/ DEMOLITION SURVEY
<i>Condition:</i>	FAIR	<i>Access:</i>	EASY	<i>Asbestos?</i>	YES
				<i>Re Inspection Date:</i>	N/A
<i>Friability:</i>	LOW	<i>Amount:</i>	APPROX: 0.5M ²	<i>Type:</i>	CHRYSOTILE
<i>Damage:</i>	LOW	<i>Exposure:</i>	OCCUPANTS	<i>Analysis:</i>	< 25%
<i>Position:</i>	CEMENT SHELF	<i>Risk Factor</i>	5	<i>Priority Assessment:</i>	MINOR RISK
		<i>Risk Band</i>	D

<i>Recommended Action</i>	REMOVE IDENTIFIED ASBESTOS CEMENT SHELF BEFORE DEMOLITION WORKS COMMENCE, USING A COMPETENT CONTRACTOR
----------------------------------	---

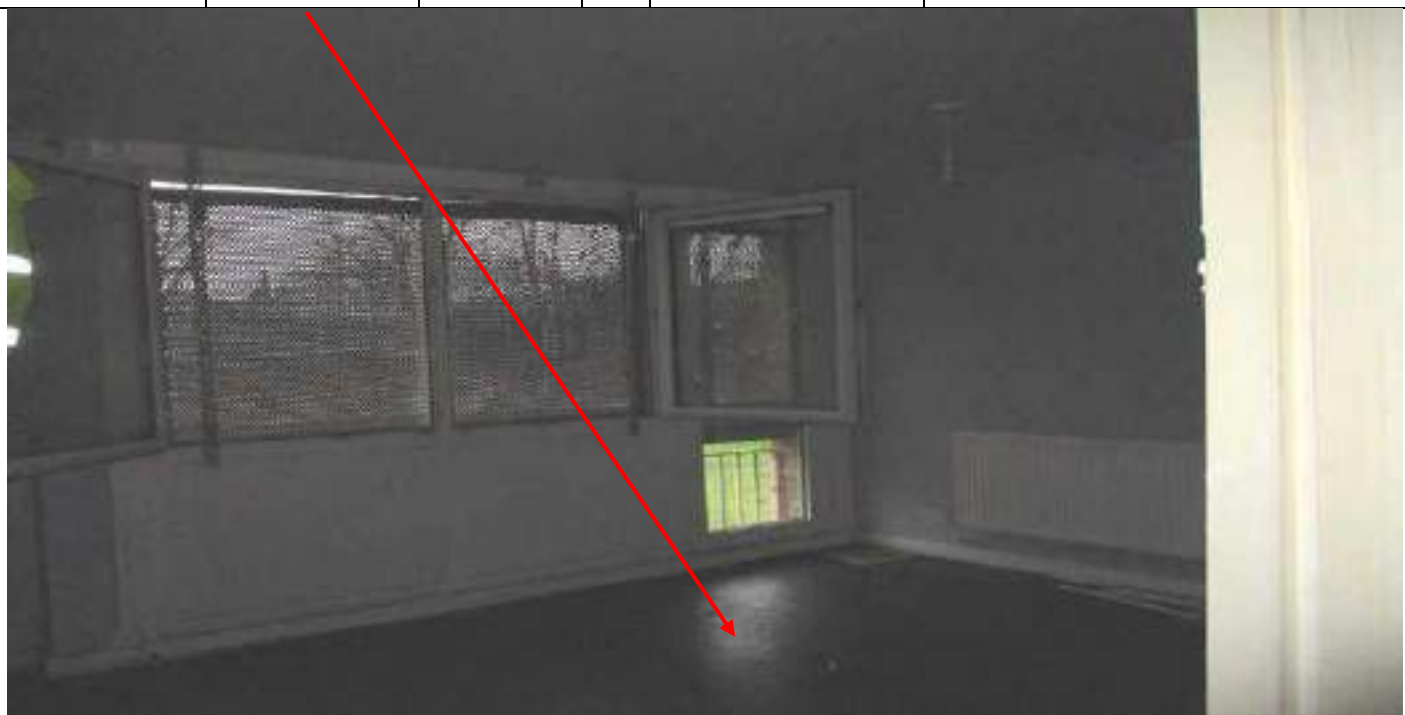
<i>Environmental Inspection Record</i>			FRAMPTON, AGAR GROVE, LONDON, NW1 2SN		
<i>Location</i>		<i>Component</i>		<i>Inspection Ref</i>	
GROUND FLOOR FLAT 1 CORRIDOR		CONCRETE CEILING PLASTERED BRICK/BREEZE BLOCK WALLS ASBESTOS VINYL FLOOR TILES & BITUMEN TO CONCRETE		<i>Surveyor:</i>	PB & MC
				PICTURE 14 AS SAMPLE 2	
				<i>Date:</i>	19/01/21
				<i>Survey Type:</i>	REFURBISHMENT/ DEMOLITION SURVEY
<i>Condition:</i>	FAIR	<i>Access:</i>	EASY	<i>Asbestos?</i>	YES
				<i>Re Inspection Date:</i>	N/A
<i>Friability:</i>	LOW	<i>Amount:</i>	APPROX: 25M ²	<i>Type:</i>	CHRYBOTILE TO BOTH
<i>Damage:</i>	LOW	<i>Exposure:</i>	OCCUPANTS	<i>Analysis:</i>	TILES <7% BITUMEN <8%
<i>Position:</i>	VINYL FLOOR TILE & BITUMEN	<i>Risk Factor</i>	4	<i>Priority Assessment:</i>	MINOR RISK
		<i>Risk Band</i>	D

<i>Recommended Action</i>	REMOVE IDENTIFIED ASBESTOS VINYL TILES & ADHESIVE BEFORE DEMOLITION WORKS COMMENCE, USING A COMPETENT CONTRACTOR
----------------------------------	---

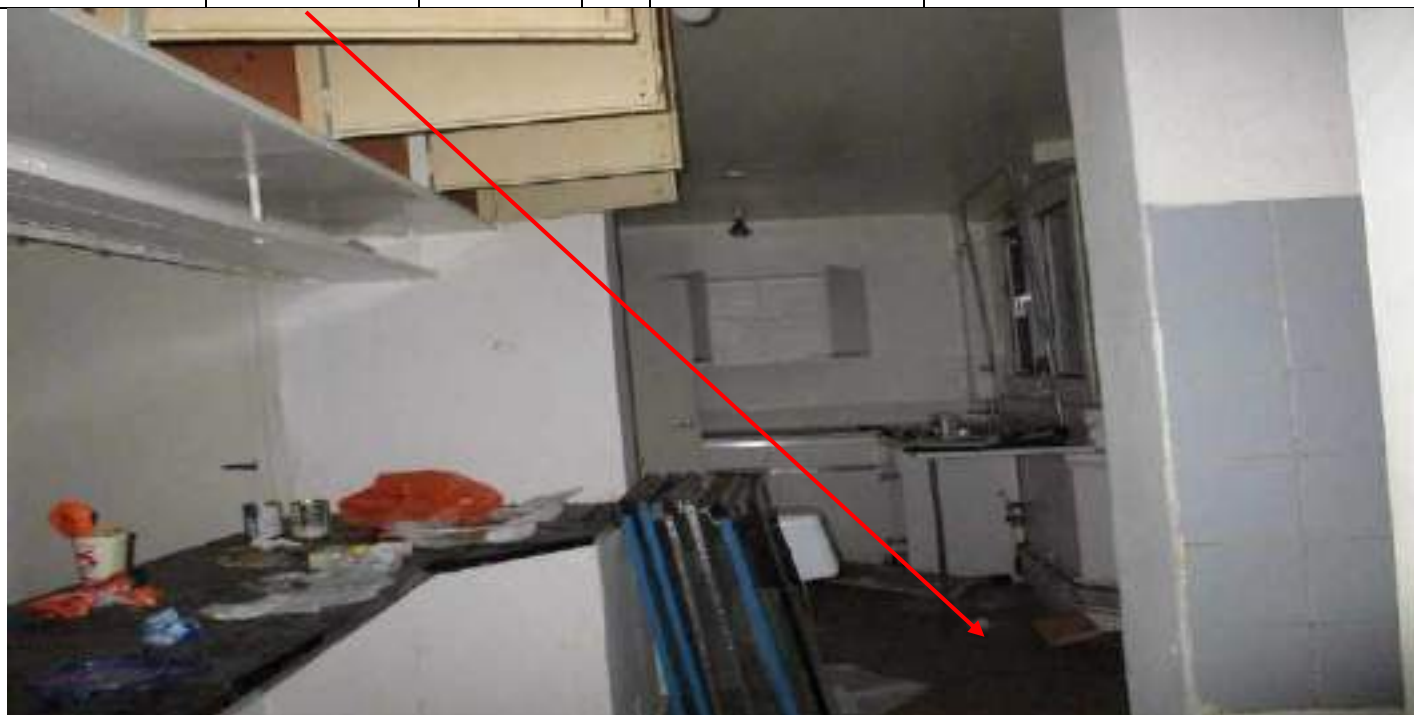
<i>Environmental Inspection Record</i>				FRAMPTON, AGAR GROVE, LONDON, NW1 2SN						
<i>Location</i>		<i>Component</i>			<i>Inspection Ref</i>					
GROUND FLOOR FLAT 1 KITCHEN		CONCRETE CEILING PLASTERED BRICK/BREEZE BLOCK WALLS ASBESTOS VINYL FLOOR TILES & BITUMEN TO CONCRETE			<i>Surveyor:</i>		PB & MC			
					PICTURE 15 AS SAMPLE 2					
					<i>Date:</i>		19/01/21			
					<i>Survey Type:</i>		REFURBISHMENT/ DEMOLITION SURVEY			
<i>Condition:</i>	FAIR	<i>Access:</i>	EASY			<i>Asbestos?</i> YES				
						<i>Re Inspection Date:</i> N/A				
<i>Friability:</i>	LOW	<i>Amount:</i>	APPROX: 12M ²			<i>Type:</i>	CHRYSOTILE TO BOTH			
<i>Damage:</i>	LOW	<i>Exposure:</i>	OCCUPANTS			<i>Analysis:</i>	TILES <7% BITUMEN <8%			
<i>Position:</i>	VINYL FLOOR TILE & BITUMEN	<i>Risk Factor</i>	4	<i>Priority Assessment:</i>		MINOR RISK				
		<i>Risk Band</i>	D

<i>Recommended Action</i>	REMOVE IDENTIFIED ASBESTOS VINYL TILES & ADHESIVE BEFORE DEMOLITION WORKS COMMENCE, USING A COMPETENT CONTRACTOR
----------------------------------	---

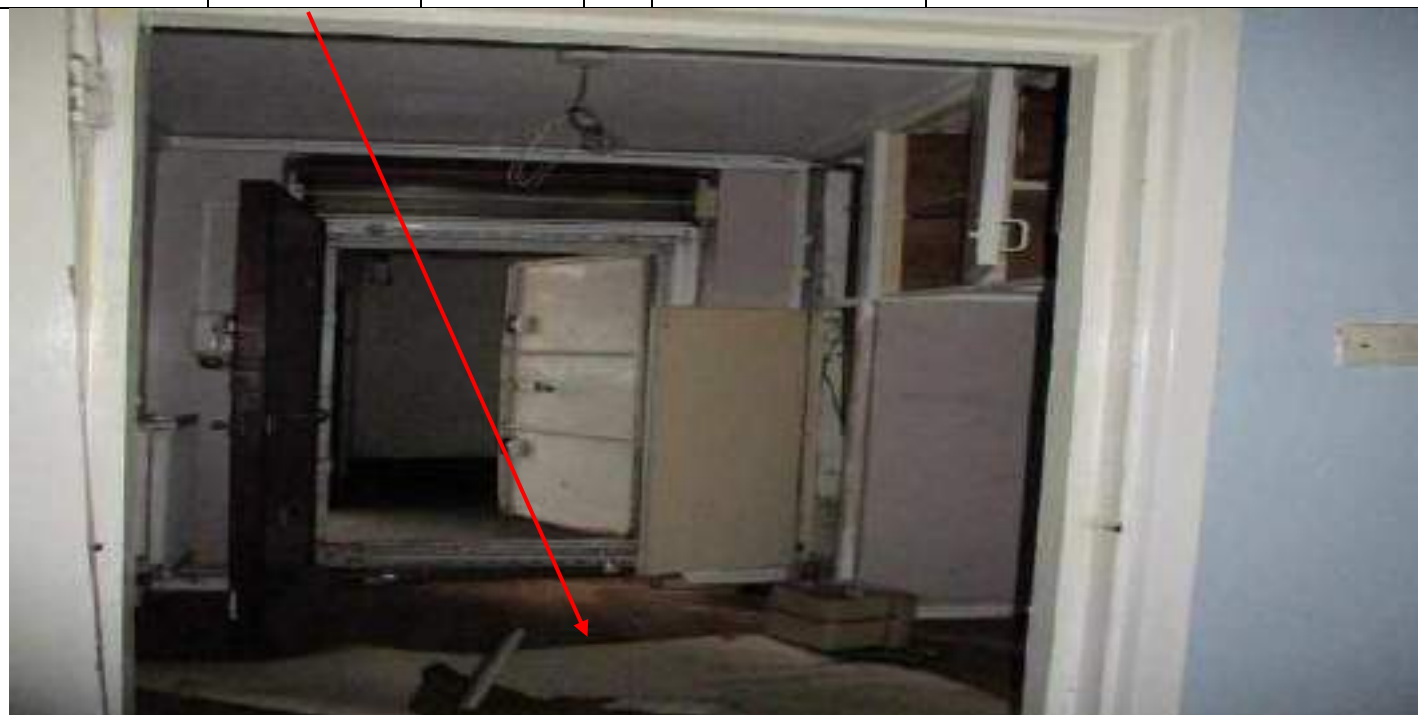
<i>Environmental Inspection Record</i>				FRAMPTON, AGAR GROVE, LONDON, NW1 2SN			
<i>Location</i>		<i>Component</i>			<i>Inspection Ref</i>		
GROUND FLOOR FLAT 1 HALLWAY		CONCRETE CEILING PLASTERED BRICK/BREEZE BLOCK WALLS ASBESTOS VINYL FLOOR TILES & BITUMEN TO CONCRETE			<i>Surveyor:</i>	PB & MC	
					PICTURE 16 AS SAMPLE 2		
					<i>Date:</i>	19/01/21	
					<i>Survey Type:</i>	REFURBISHMENT/ DEMOLITION SURVEY	
<i>Condition:</i>	FAIR	<i>Access:</i>	EASY		<i>Asbestos?</i>	YES	
					<i>Re Inspection Date:</i>	N/A	
<i>Friability:</i>	LOW	<i>Amount:</i>	APPROX: 5M ²		<i>Type:</i>	CHRYSOTILE TO BOTH	
<i>Damage:</i>	LOW	<i>Exposure:</i>	OCCUPANTS		<i>Analysis:</i>	TILES	<7%
						BITUMEN	<8%
<i>Position:</i>	VINYL FLOOR TILE & BITUMEN	<i>Risk Factor</i>	4	<i>Priority Assessment:</i>	MINOR RISK		
		<i>Risk Band</i>	D

<i>Recommended Action</i>	REMOVE IDENTIFIED ASBESTOS VINYL TILES & ADHESIVE BEFORE DEMOLITION WORKS COMMENCE, USING A COMPETENT CONTRACTOR
----------------------------------	---

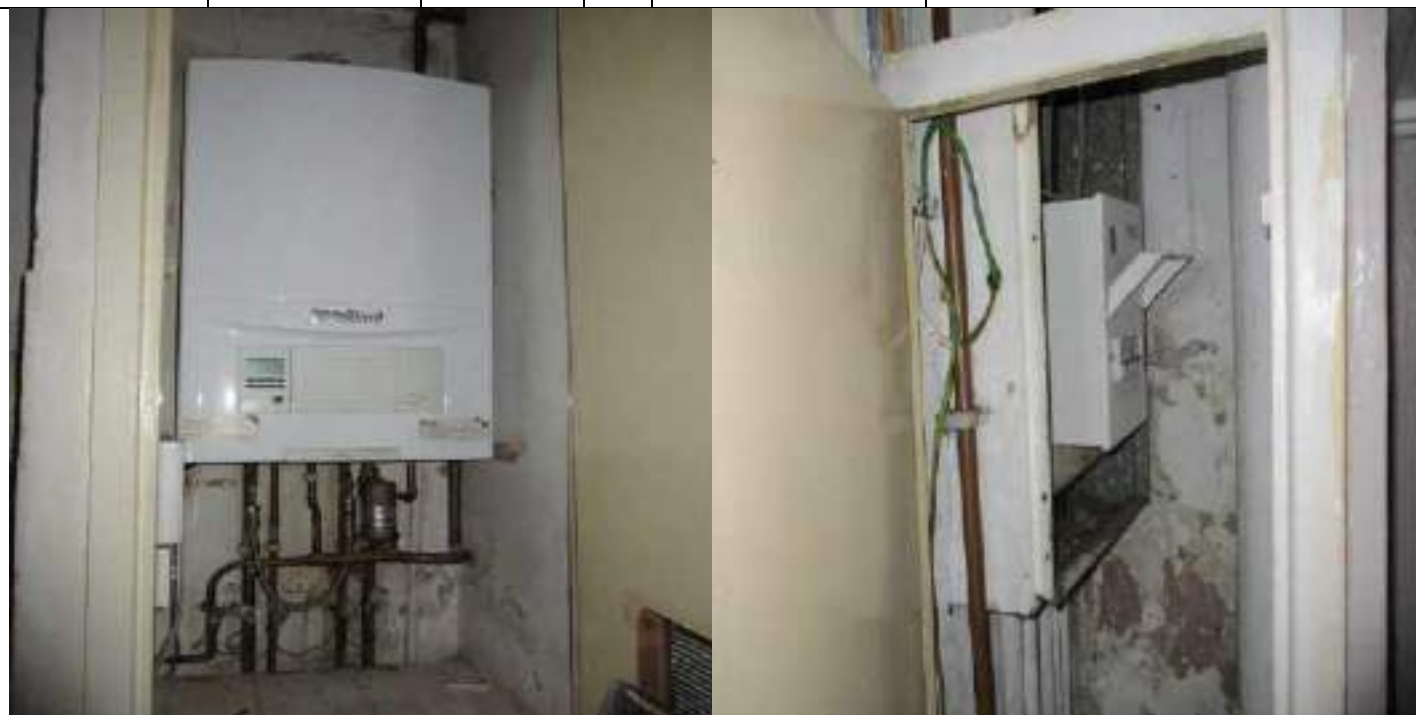
<i>Environmental Inspection Record</i>			FRAMPTON, AGAR GROVE, LONDON, NW1 2SN		
<i>Location</i>		<i>Component</i>		<i>Inspection Ref</i>	
GROUND FLOOR FLAT 1 HALLWAY		MODERN BOILER WITH METAL FLUE ELECTRICAL FUSE BOARD		<i>Surveyor:</i>	PB & MC
				PICTURE 17 & 18	
				<i>Date:</i>	19/01/21
				<i>Survey Type:</i>	REFURBISHMENT/ DEMOLITION SURVEY
<i>Condition:</i>	N/A	<i>Access:</i>	N/A	<i>Asbestos?</i>	NO
				<i>Re Inspection Date:</i>	N/A
<i>Friability:</i>	N/A	<i>Amount:</i>	N/A	<i>Type:</i>	NON ASBESTOS
<i>Damage:</i>	N/A	<i>Exposure:</i>	N/A	<i>Analysis:</i>	N/A
<i>Position:</i>	CUPBOARDS	<i>Risk Factor</i>	0	<i>Priority Assessment:</i>	NO RISK
		<i>Risk Band</i>	E

<i>Recommended Action</i>	NO ASBESTOS MATERIALS IDENTIFIED.
---------------------------	--
