APPENDICES

APPENDIX G

Agar Grove noise policy for Demolition works.

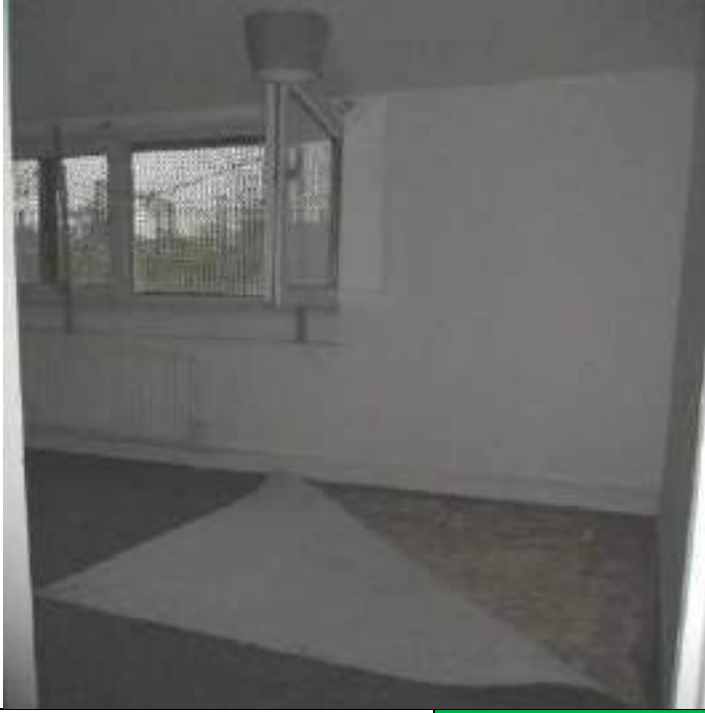
<i>Environmental Inspection Record</i>				FRAMPTON, AGAR GROVE, LONDON, NW1 2SN	
<i>Location</i>		<i>Component</i>		<i>Inspection Ref</i>	
GROUND FLOOR FLAT 2 BEDROOM 2 & BATHROOM		ROOM EXAMPLE – NO ASBESTOS MATERIALS DETECTED WITHIN FLAT 2 ASIDE FROM CEMENT SHELF IN WC - CONCRETE CEILINGS PLASTERED BRICK WALLS CARPET & MODERN VINYL FLOOR COVERING TO CONCRETE FLOORS		<i>Surveyor:</i>	PB & MC
				PICTURE 20 & 21	
				<i>Date:</i>	19/01/21
				<i>Survey Type:</i>	REFURBISHMENT/ DEMOLITION SURVEY
<i>Condition:</i>	N/A	<i>Access:</i>	N/A	<i>Asbestos?</i>	NO
				<i>Re Inspection Date:</i>	N/A
<i>Friability:</i>	N/A	<i>Amount:</i>	N/A	<i>Type:</i>	NON ASBESTOS
<i>Damage:</i>	N/A	<i>Exposure:</i>	N/A	<i>Analysis:</i>	N/A
<i>Position:</i>	BEDROOM & BATHROOM	<i>Risk Factor</i>	0	<i>Priority Assessment:</i>	NO RISK
		<i>Risk Band</i>	E

<i>Recommended Action</i>		NO ASBESTOS MATERIALS IDENTIFIED.

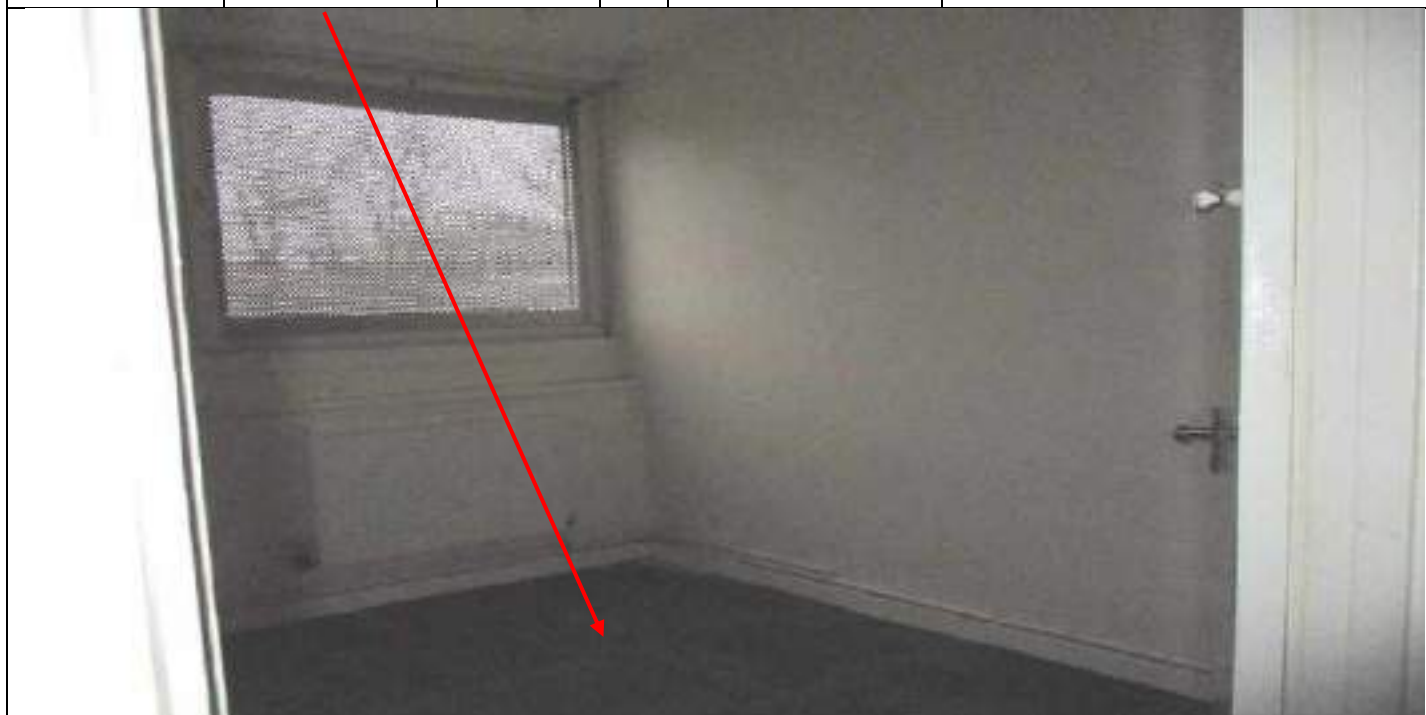
<i>Environmental Inspection Record</i>				FRAMPTON, AGAR GROVE, LONDON, NW1 2SN						
<i>Location</i>		<i>Component</i>			<i>Inspection Ref</i>					
FIRST FLOOR FLAT 6 BEDROOM 3		CONCRETE CEILING PLASTERED BRICK/BREEZE BLOCK WALLS CARPET OVER ASBESTOS VINYL FLOOR TILES & BITUMEN TO CONCRETE			<i>Surveyor:</i>		PB & MC			
					PICTURE 22 AS SAMPLE 2					
					<i>Date:</i>		19/01/21			
					<i>Survey Type:</i>		REFURBISHMENT/ DEMOLITION SURVEY			
<i>Condition:</i>	FAIR	<i>Access:</i>	EASY			<i>Asbestos?</i> YES				
		<i>Re Inspection Date:</i> N/A								
<i>Friability:</i>	LOW	<i>Amount:</i>	APPROX: 6M ²			<i>Type:</i>	CHRYSOTILE TO BOTH			
<i>Damage:</i>	LOW	<i>Exposure:</i>	OCCUPANTS			<i>Analysis:</i>	TILES <7% BITUMEN <8%			
<i>Position:</i>	VINYL FLOOR TILE & BITUMEN	<i>Risk Factor</i>	4	<i>Priority Assessment:</i>		MINOR RISK				
		<i>Risk Band</i>	D

<i>Recommended Action</i>	REMOVE IDENTIFIED ASBESTOS VINYL TILES & ADHESIVE BEFORE DEMOLITION WORKS COMMENCE, USING A COMPETENT CONTRACTOR
----------------------------------	---

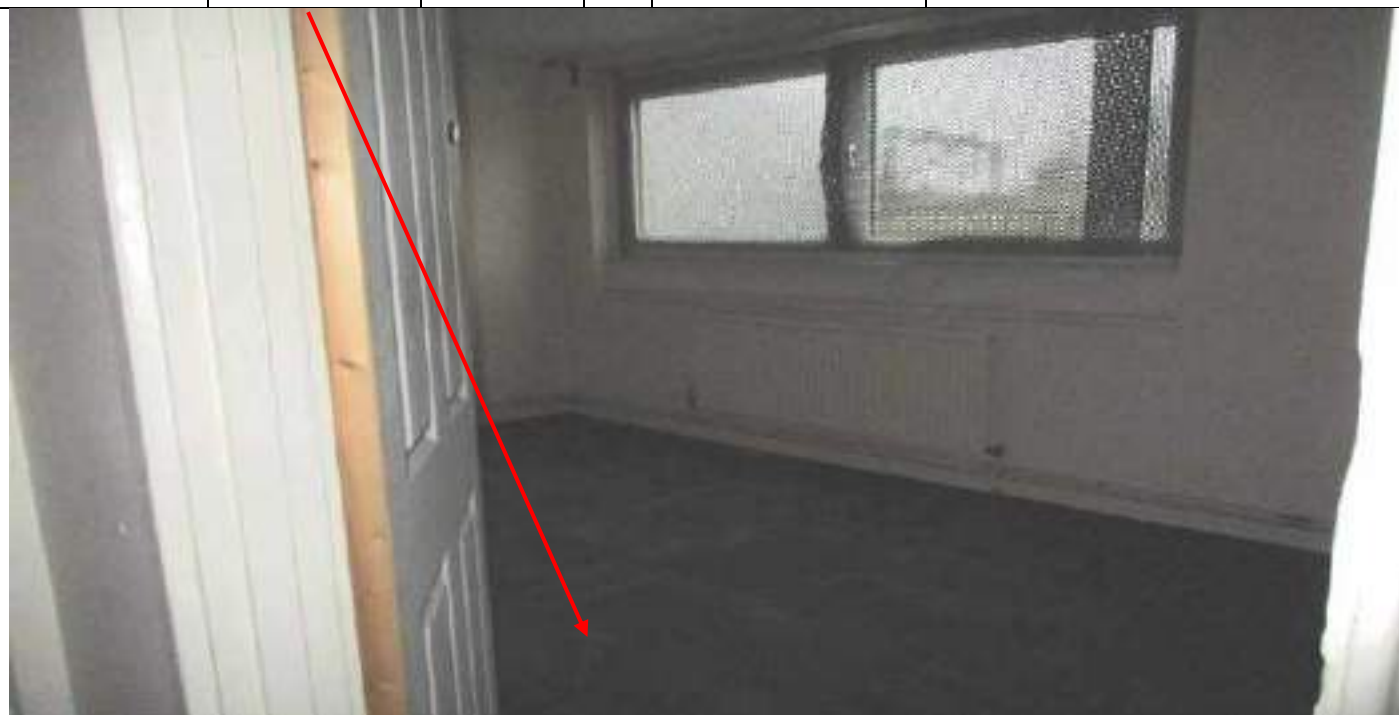
<i>Environmental Inspection Record</i>			FRAMPTON, AGAR GROVE, LONDON, NW1 2SN		
<i>Location</i>		<i>Component</i>		<i>Inspection Ref</i>	
FIRST FLOOR FLAT 6 BEDROOM 2		CONCRETE CEILING PLASTERED BRICK/BREEZE BLOCK WALLS CARPET OVER ASBESTOS VINYL FLOOR TILES & BITUMEN TO CONCRETE		<i>Surveyor:</i>	PB & MC
				PICTURE 23 AS SAMPLE 2	
				<i>Date:</i>	19/01/21
				<i>Survey Type:</i>	REFURBISHMENT/ DEMOLITION SURVEY
<i>Condition:</i>	FAIR	<i>Access:</i>	EASY	<i>Asbestos?</i>	YES
				<i>Re Inspection Date:</i>	N/A
<i>Friability:</i>	LOW	<i>Amount:</i>	APPROX: 18M ²	<i>Type:</i>	CHRYSOTILE TO BOTH
<i>Damage:</i>	LOW	<i>Exposure:</i>	OCCUPANTS	<i>Analysis:</i>	TILES <7% BITUMEN <8%
<i>Position:</i>	VINYL FLOOR TILE & BITUMEN	<i>Risk Factor</i>	4	<i>Priority Assessment:</i>	MINOR RISK
		<i>Risk Band</i>	D

<i>Recommended Action</i>	REMOVE IDENTIFIED ASBESTOS VINYL TILES & ADHESIVE BEFORE DEMOLITION WORKS COMMENCE, USING A COMPETENT CONTRACTOR
----------------------------------	---

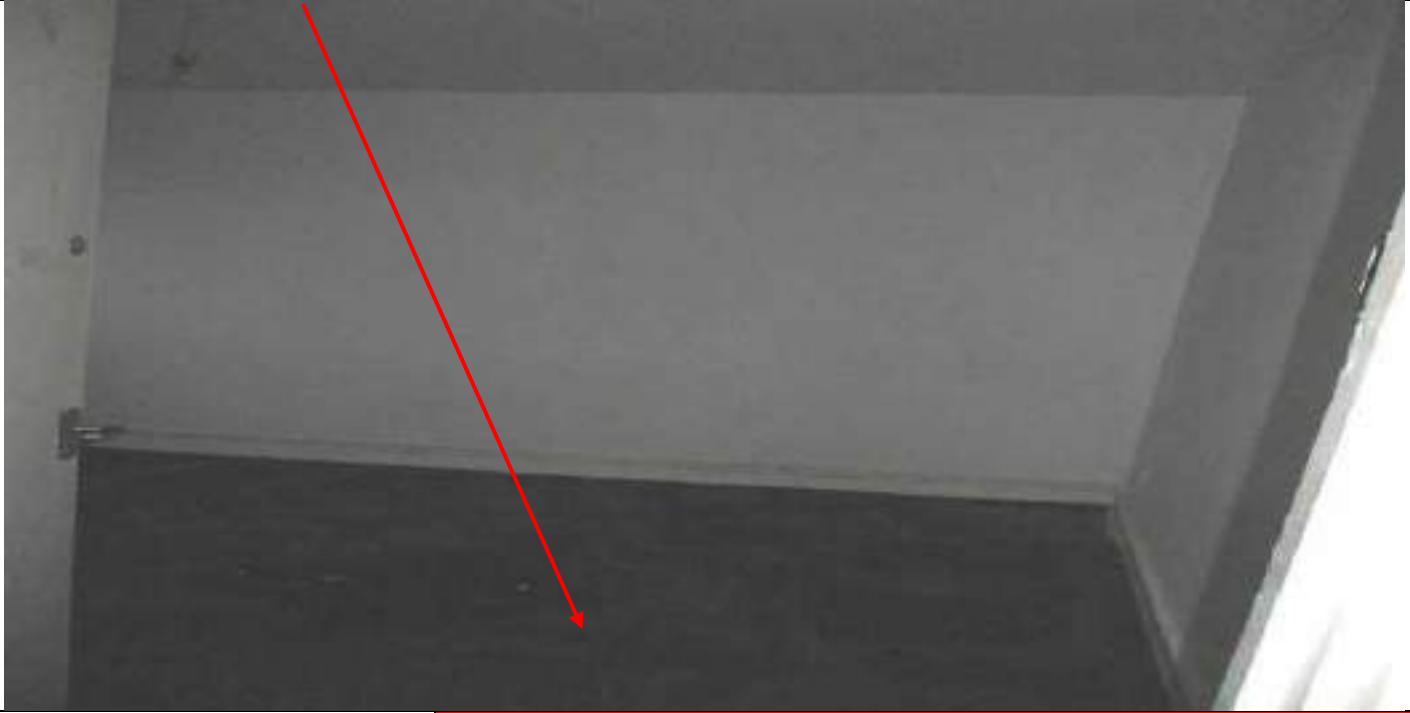
<i>Environmental Inspection Record</i>				FRAMPTON, AGAR GROVE, LONDON, NW1 2SN						
<i>Location</i>		<i>Component</i>			<i>Inspection Ref</i>					
FIRST FLOOR FLAT 6 BEDROOM 1		CONCRETE CEILING PLASTERED BRICK/BREEZE BLOCK WALLS CARPET OVER ASBESTOS VINYL FLOOR TILES & BITUMEN TO CONCRETE			<i>Surveyor:</i>		PB & MC			
					PICTURE 24 AS SAMPLE 2					
					<i>Date:</i>		19/01/21			
					<i>Survey Type:</i>		REFURBISHMENT/ DEMOLITION SURVEY			
<i>Condition:</i>	FAIR	<i>Access:</i>	EASY			<i>Asbestos?</i> YES				
						<i>Re Inspection Date:</i> N/A				
<i>Friability:</i>	LOW	<i>Amount:</i>	APPROX: 10M ²			<i>Type:</i>	CHRYSTOLE TO BOTH			
<i>Damage:</i>	LOW	<i>Exposure:</i>	OCCUPANTS			<i>Analysis:</i>	TILES <7% BITUMEN <8%			
<i>Position:</i>	VINYL FLOOR TILE & BITUMEN	<i>Risk Factor</i>	4	<i>Priority Assessment:</i>		MINOR RISK				
		<i>Risk Band</i>	D

<i>Recommended Action</i>				REMOVE IDENTIFIED ASBESTOS VINYL TILES & ADHESIVE BEFORE DEMOLITION WORKS COMMENCE, USING A COMPETENT CONTRACTOR

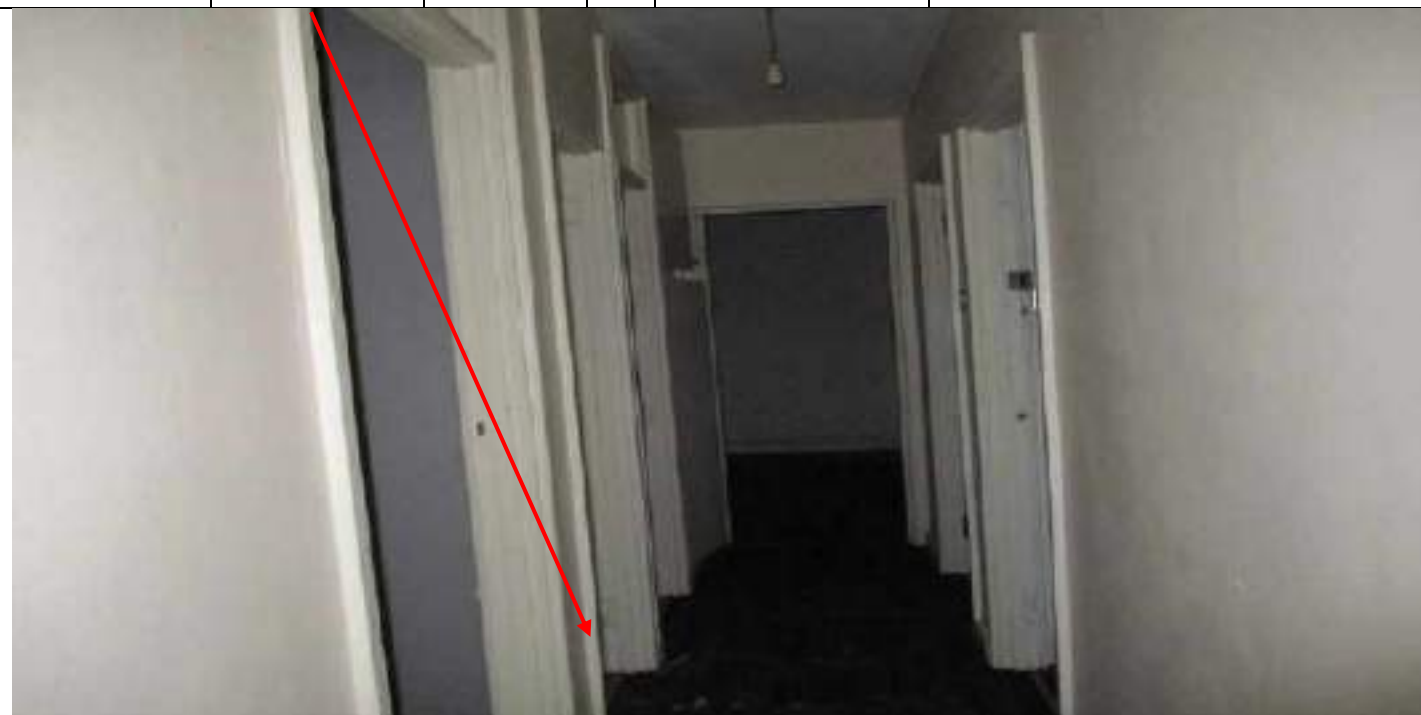
<i>Environmental Inspection Record</i>			FRAMPTON, AGAR GROVE, LONDON, NW1 2SN		
<i>Location</i>		<i>Component</i>		<i>Inspection Ref</i>	
FIRST FLOOR FLAT 6 CORRIDOR		CONCRETE CEILING PLASTERED BRICK/BREEZE BLOCK WALLS CARPET OVER ASBESTOS VINYL FLOOR TILES & BITUMEN TO CONCRETE		<i>Surveyor:</i>	PB & MC
				PICTURE 25 AS SAMPLE 2	
				<i>Date:</i>	19/01/21
				<i>Survey Type:</i>	REFURBISHMENT/ DEMOLITION SURVEY
<i>Condition:</i>	FAIR	<i>Access:</i>	EASY	<i>Asbestos?</i>	YES
				<i>Re Inspection Date:</i>	N/A
<i>Friability:</i>	LOW	<i>Amount:</i>	APPROX: 5M ²	<i>Type:</i>	CHRYSO TILE TO BOTH
<i>Damage:</i>	LOW	<i>Exposure:</i>	OCCUPANTS	<i>Analysis:</i>	TILES <7% BITUMEN <8%
<i>Position:</i>	VINYL FLOOR TILE & BITUMEN	<i>Risk Factor</i>	4	<i>Priority Assessment:</i>	MINOR RISK
		<i>Risk Band</i>	D

<i>Recommended Action</i>	REMOVE IDENTIFIED ASBESTOS VINYL TILES & ADHESIVE BEFORE DEMOLITION WORKS COMMENCE, USING A COMPETENT CONTRACTOR
----------------------------------	---

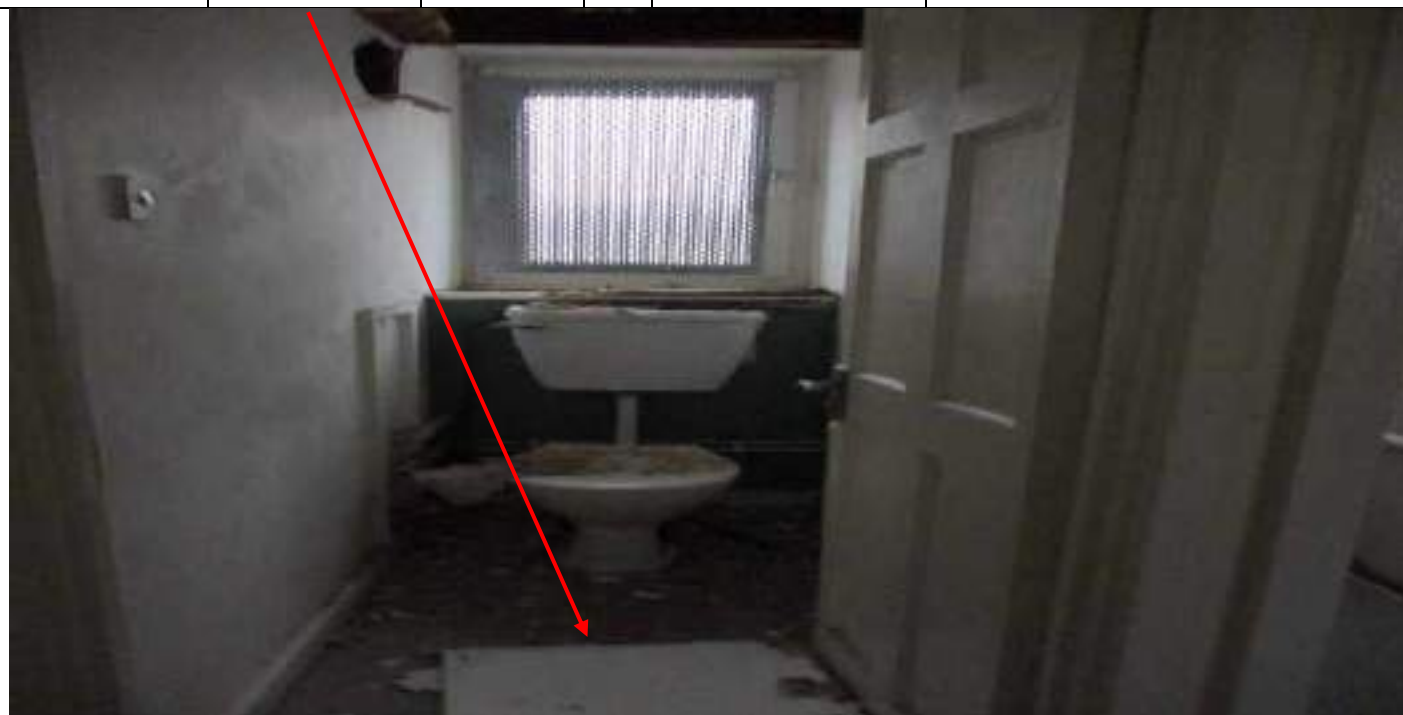
<i>Environmental Inspection Record</i>			FRAMPTON, AGAR GROVE, LONDON, NW1 2SN		
<i>Location</i>		<i>Component</i>		<i>Inspection Ref</i>	
FIRST FLOOR FLAT 6 WC		CONCRETE CEILING CERAMIC TILES TO PLASTERED BRICK/BREEZE BLOCK WALLS MODERN VINYL FLOOR COVERING OVER ASBESTOS BITUMEN ADHESIVE TO CONCRETE		<i>Surveyor:</i>	PB & MC
				PICTURE 27 AS SAMPLE 2	
				<i>Date:</i>	19/01/21
				<i>Survey Type:</i>	REFURBISHMENT/ DEMOLITION SURVEY
<i>Condition:</i>	FAIR	<i>Access:</i>	MEDIUM	<i>Asbestos?</i>	YES
				<i>Re Inspection Date:</i>	N/A
<i>Friability:</i>	LOW	<i>Amount:</i>	APPROX: 2M ²	<i>Type:</i>	CHRYSOTILE
<i>Damage:</i>	LOW	<i>Exposure:</i>	OCCUPANTS	<i>Analysis:</i>	< 8%
<i>Position:</i>	BITUMEN ADHESIVE	<i>Risk Factor</i>	4	<i>Priority Assessment:</i>	MINOR RISK
		<i>Risk Band</i>	D

<i>Recommended Action</i>	REMOVE IDENTIFIED ASBESTOS BITUMEN ADHESIVE BEFORE DEMOLITION WORKS COMMENCE, USING A COMPETENT CONTRACTOR
----------------------------------	---

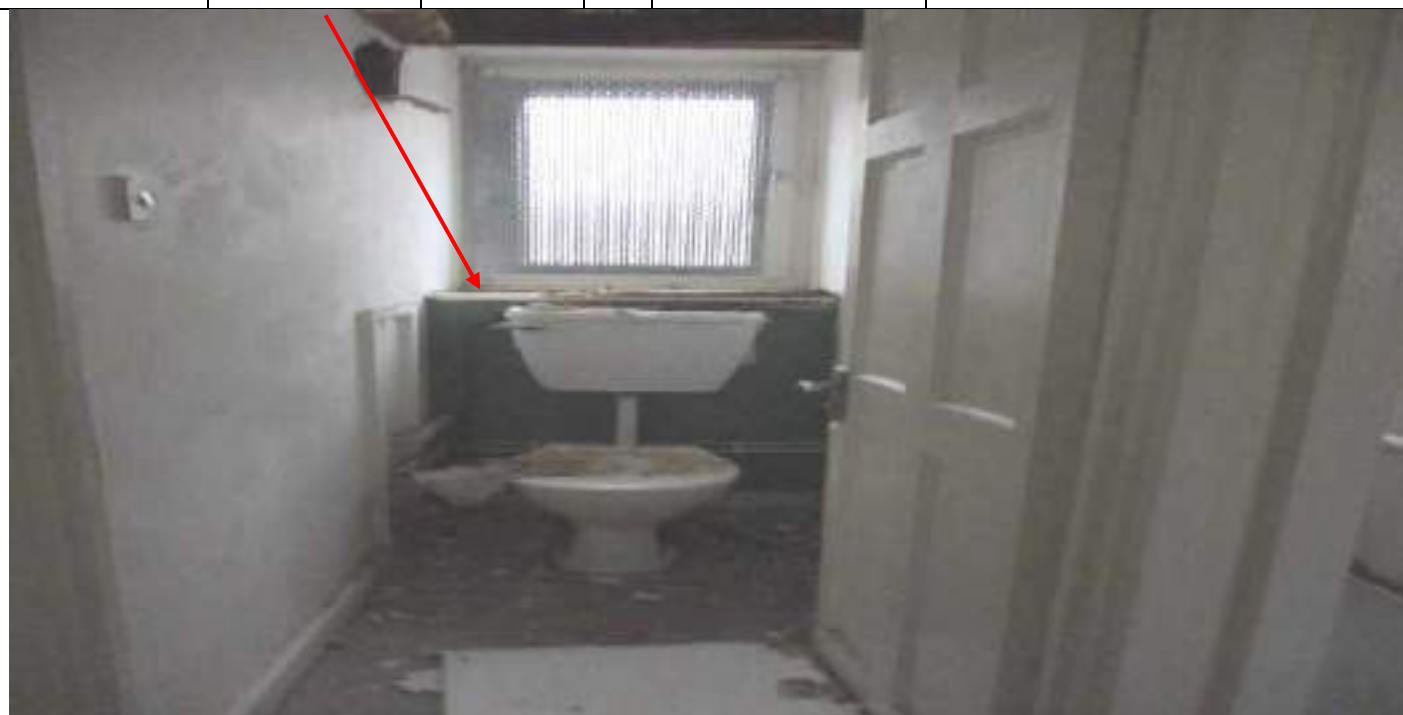
<i>Environmental Inspection Record</i>			FRAMPTON, AGAR GROVE, LONDON, NW1 2SN		
<i>Location</i>		<i>Component</i>		<i>Inspection Ref</i>	
FIRST FLOOR FLAT 6 WC		ASBESTOS CEMENT SHELF		<i>Surveyor:</i>	PB & MC
				PICTURE 28 AS SAMPLE 4	
				<i>Date:</i>	19/01/21
				<i>Survey Type:</i>	REFURBISHMENT/ DEMOLITION SURVEY
<i>Condition:</i>	FAIR	<i>Access:</i>	EASY	<i>Asbestos?</i>	YES
				<i>Re Inspection Date:</i>	N/A
<i>Friability:</i>	LOW	<i>Amount:</i>	APPROX: 0.5M ²	<i>Type:</i>	CHRYSOTILE
<i>Damage:</i>	LOW	<i>Exposure:</i>	OCCUPANTS	<i>Analysis:</i>	< 25%
<i>Position:</i>	CEMENT SHELF	<i>Risk Factor</i>	5	<i>Priority Assessment:</i>	MINOR RISK
		<i>Risk Band</i>	D

<i>Recommended Action</i>	REMOVE IDENTIFIED ASBESTOS CEMENT SHELF BEFORE DEMOLITION WORKS COMMENCE, USING A COMPETENT CONTRACTOR
----------------------------------	---

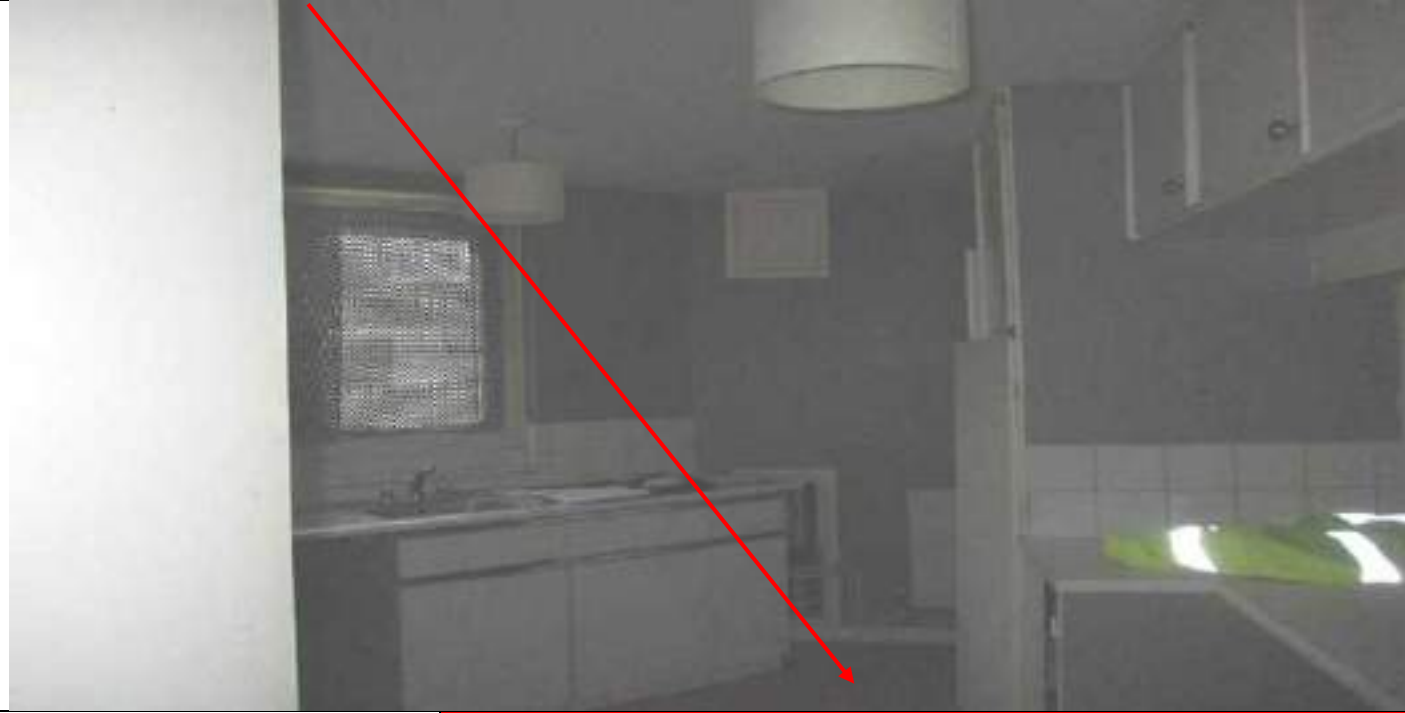
<i>Environmental Inspection Record</i>			FRAMPTON, AGAR GROVE, LONDON, NW1 2SN		
<i>Location</i>		<i>Component</i>		<i>Inspection Ref</i>	
FIRST FLOOR FLAT 6 KITCHEN		CONCRETE CEILING CERAMIC TILES TO PLASTERED BRICK/BREEZE BLOCK WALLS MODERN VINYL FLOOR COVERING OVER ASBESTOS BITUMEN ADHESIVE TO CONCRETE		<i>Surveyor:</i>	PB & MC
				PICTURE 29 AS SAMPLE 2	
				<i>Date:</i>	19/01/21
				<i>Survey Type:</i>	REFURBISHMENT/ DEMOLITION SURVEY
<i>Condition:</i>	FAIR	<i>Access:</i>	MEDIUM	<i>Asbestos?</i>	YES
				<i>Re Inspection Date:</i>	N/A
<i>Friability:</i>	LOW	<i>Amount:</i>	APPROX: 12M ²	<i>Type:</i>	CHRYSOTILE
<i>Damage:</i>	LOW	<i>Exposure:</i>	OCCUPANTS	<i>Analysis:</i>	< 8%
<i>Position:</i>	BITUMEN ADHESIVE	<i>Risk Factor</i>	4	<i>Priority Assessment:</i>	MINOR RISK
		<i>Risk Band</i>	D

<i>Recommended Action</i>		REMOVE IDENTIFIED ASBESTOS BITUMEN ADHESIVE BEFORE DEMOLITION WORKS COMMENCE, USING A COMPETENT CONTRACTOR

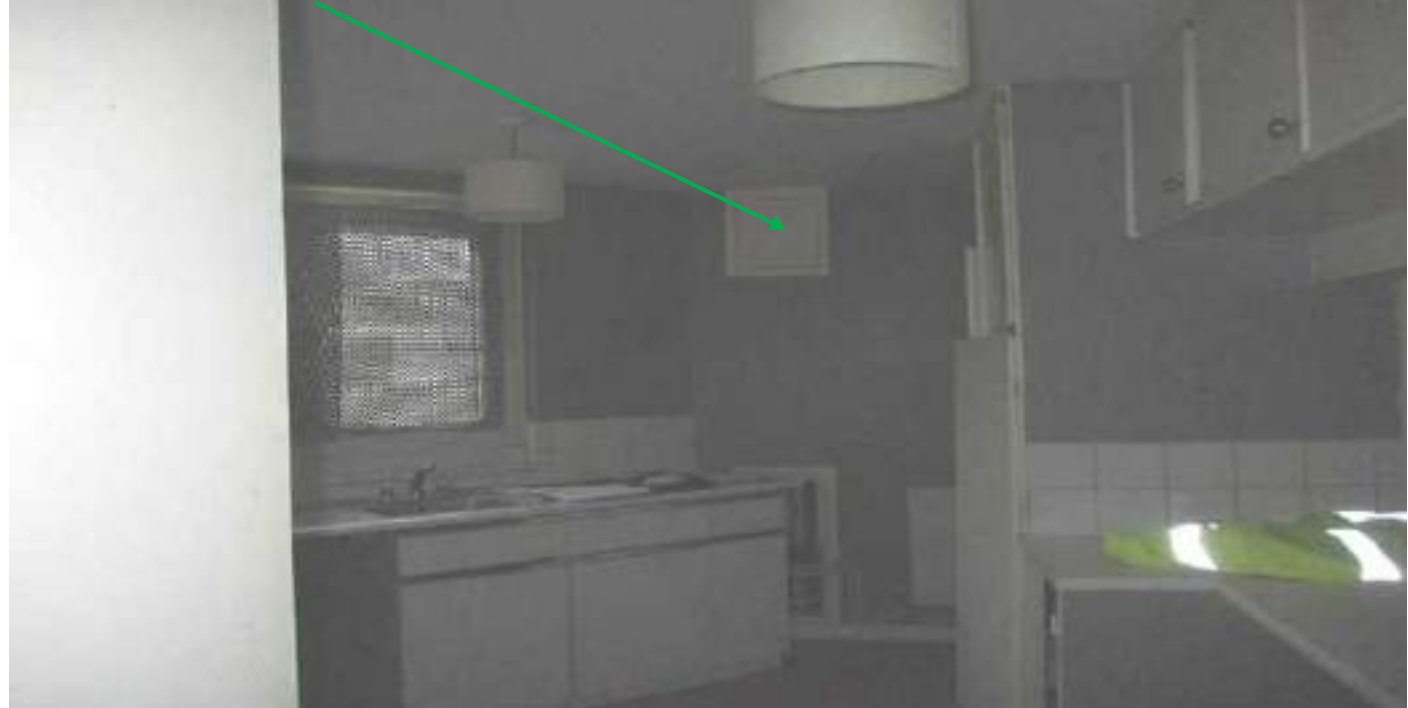
<i>Environmental Inspection Record</i>				FRAMPTON, AGAR GROVE, LONDON, NW1 2SN	
<i>Location</i>		<i>Component</i>		<i>Inspection Ref</i>	
FIRST FLOOR FLAT 6 KITCHEN		NON-ASBESTOS INSULATION BOARD PANELS		<i>Surveyor:</i>	PB & MC
				PICTURE 30 SAMPLE 5	
				<i>Date:</i>	19/01/21
				<i>Survey Type:</i>	REFURBISHMENT/ DEMOLITION SURVEY
<i>Condition:</i>	N/A	<i>Access:</i>	N/A	<i>Asbestos?</i>	NO
				<i>Re Inspection Date:</i>	N/A
<i>Friability:</i>	N/A	<i>Amount:</i>	N/A	<i>Type:</i>	NON ASBESTOS
<i>Damage:</i>	N/A	<i>Exposure:</i>	N/A	<i>Analysis:</i>	NADIS
<i>Position:</i>	INSULATION BOARD	<i>Risk Factor</i>	0	<i>Priority Assessment:</i>	NO RISK
		<i>Risk Band</i>	E

<i>Recommended Action</i>		NO ASBESTOS MATERIALS IDENTIFIED.

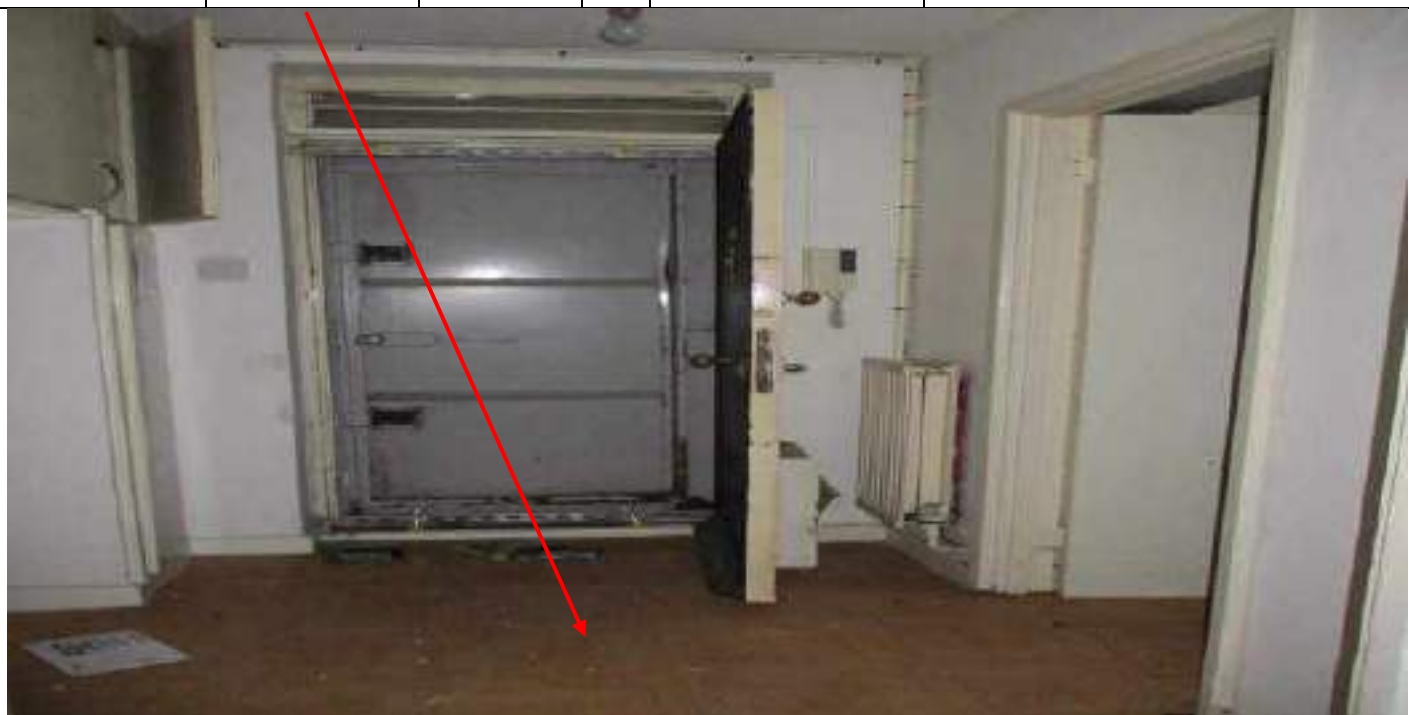
<i>Environmental Inspection Record</i>				FRAMPTON, AGAR GROVE, LONDON, NW1 2SN			
<i>Location</i>		<i>Component</i>			<i>Inspection Ref</i>		
FIRST FLOOR FLAT 6 HALLWAY		CONCRETE CEILING PLASTERED BRICK/BREEZE BLOCK WALLS TIMBER FLOORING OVER ASBESTOS VINYL FLOOR TILES & BITUMEN TO CONCRETE			<i>Surveyor:</i>	PB & MC	
					PICTURE 31 AS SAMPLE 2		
					<i>Date:</i>	19/01/21	
					<i>Survey Type:</i>	REFURBISHMENT/ DEMOLITION SURVEY	
<i>Condition:</i>	FAIR	<i>Access:</i>	EASY		<i>Asbestos?</i>	YES	
					<i>Re Inspection Date:</i>	N/A	
<i>Friability:</i>	LOW	<i>Amount:</i>	APPROX: 5M ²		<i>Type:</i>	CHRYBOTILE TO BOTH	
<i>Damage:</i>	LOW	<i>Exposure:</i>	OCCUPANTS		<i>Analysis:</i>	TILES	<7%
						BITUMEN	<8%
<i>Position:</i>	VINYL FLOOR TILE & BITUMEN	<i>Risk Factor</i>	4	<i>Priority Assessment:</i>	MINOR RISK		
		<i>Risk Band</i>	D

<i>Recommended Action</i>	REMOVE IDENTIFIED ASBESTOS VINYL TILES & ADHESIVE BEFORE DEMOLITION WORKS COMMENCE, USING A COMPETENT CONTRACTOR
----------------------------------	---

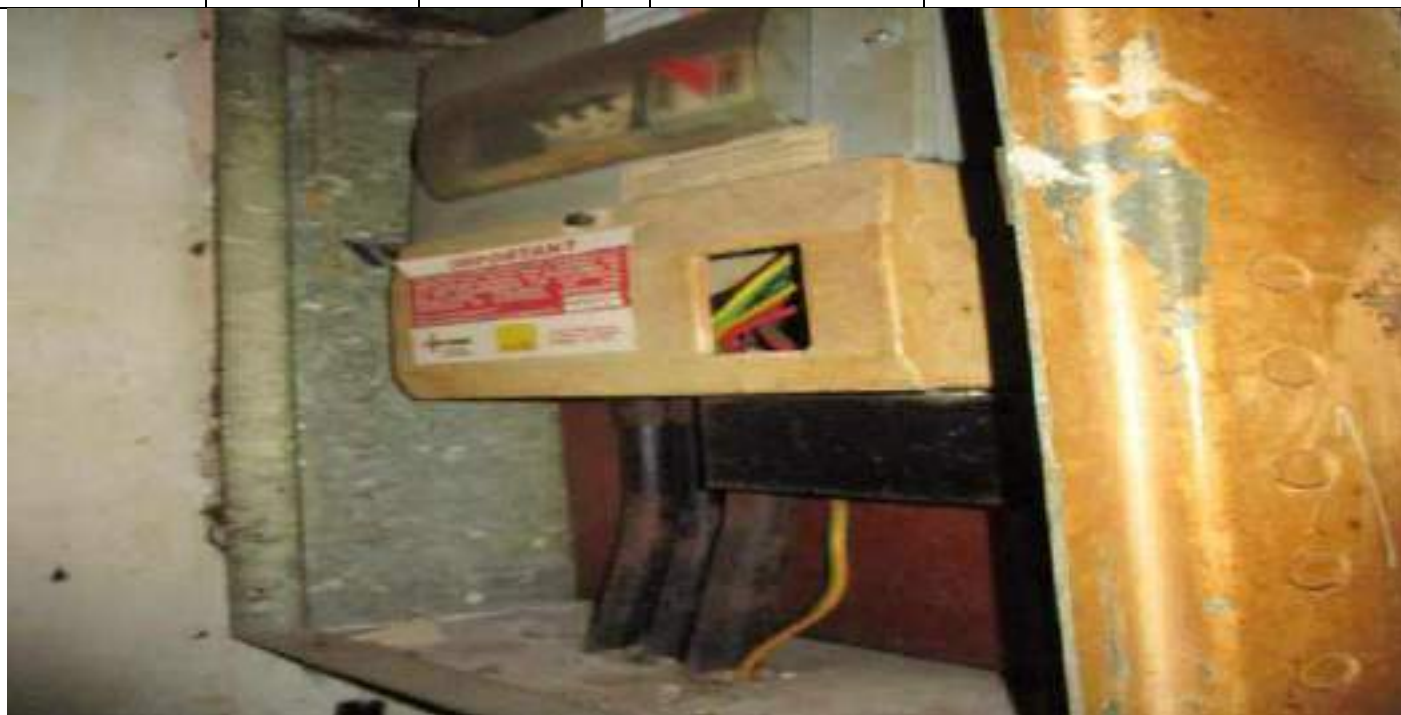
<i>Environmental Inspection Record</i>				FRAMPTON, AGAR GROVE, LONDON, NW1 2SN	
<i>Location</i>		<i>Component</i>		<i>Inspection Ref</i>	
FIRST FLOOR FLAT 6 HALLWAY		ELECTRICAL FUSE BOARD		<i>Surveyor:</i>	PB & MC
				PICTURE 32	
				<i>Date:</i>	19/01/21
				<i>Survey Type:</i>	REFURBISHMENT/ DEMOLITION SURVEY
<i>Condition:</i>	N/A	<i>Access:</i>	N/A	<i>Asbestos?</i>	NO
				<i>Re Inspection Date:</i>	N/A
<i>Friability:</i>	N/A	<i>Amount:</i>	N/A	<i>Type:</i>	NON ASBESTOS
<i>Damage:</i>	N/A	<i>Exposure:</i>	N/A	<i>Analysis:</i>	N/A
<i>Position:</i>	CUPBOARDS	<i>Risk Factor</i>	0	<i>Priority Assessment:</i>	NO RISK
		<i>Risk Band</i>	E

<i>Recommended Action</i>	NO ASBESTOS MATERIALS IDENTIFIED.
---------------------------	--

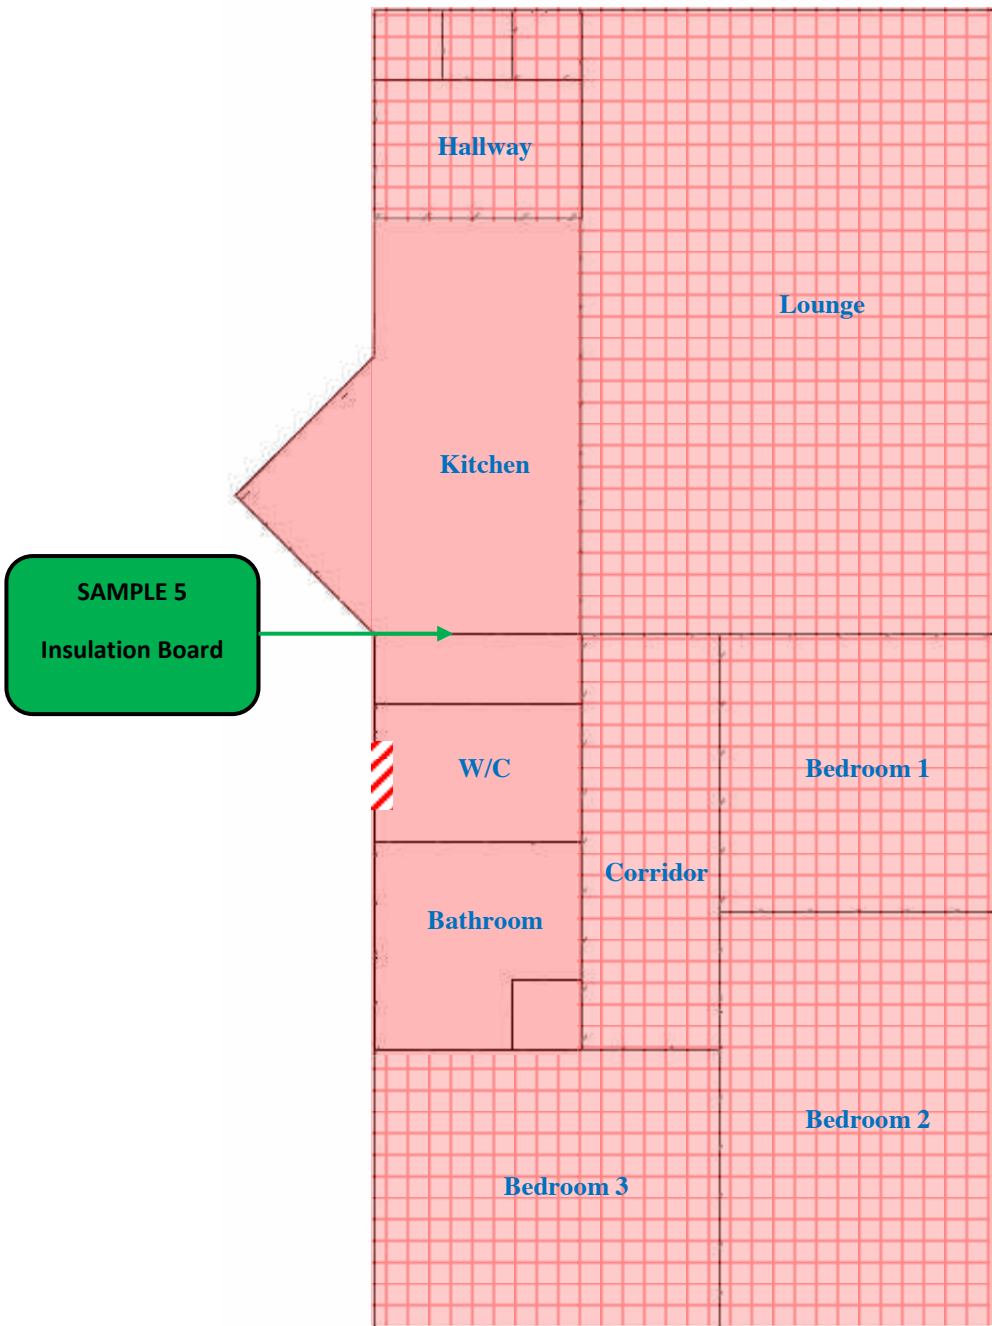
Flat 6

Cement Shelf

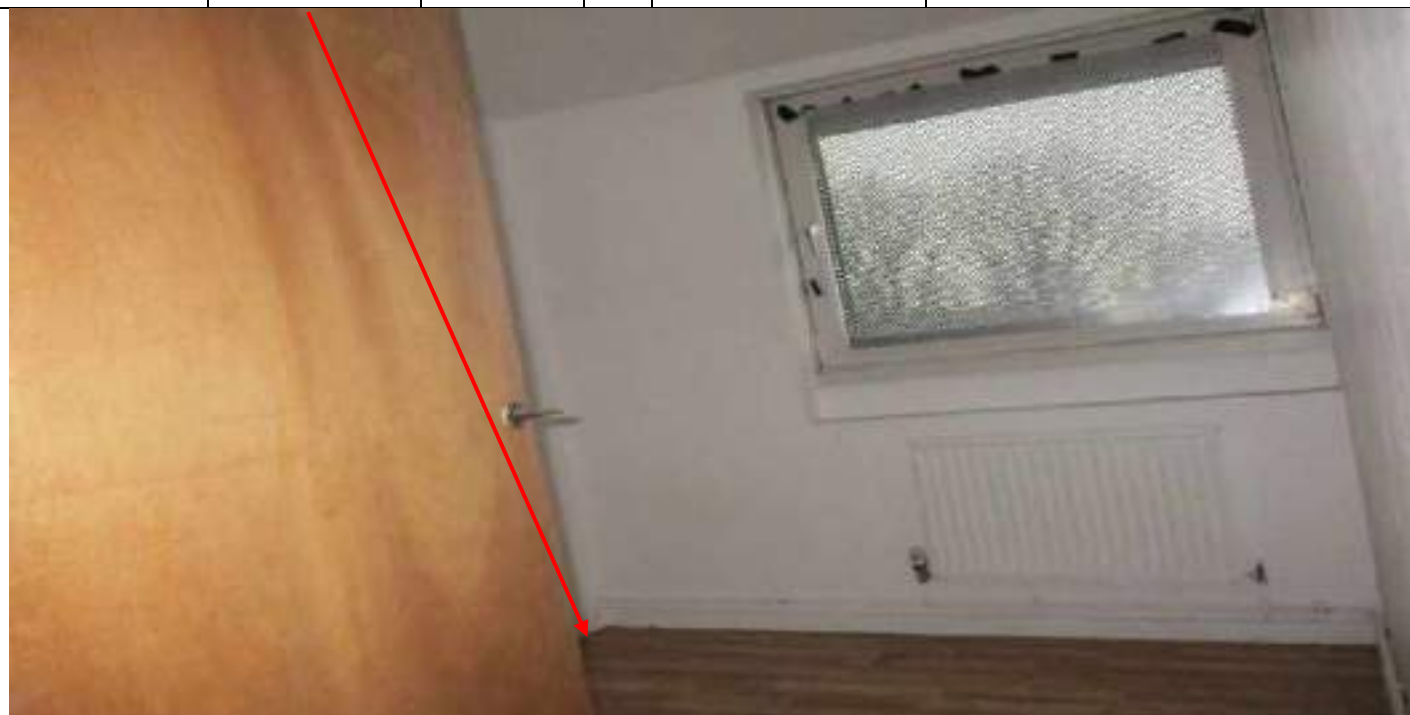
<i>Environmental Inspection Record</i>				FRAMPTON, AGAR GROVE, LONDON, NW1 2SN			
<i>Location</i>		<i>Component</i>			<i>Inspection Ref</i>		
SECOND FLOOR FLAT 10 BEDROOM 3		CONCRETE CEILING PLASTERED BRICK/BREEZE BLOCK WALLS TIMBER FLOORING OVER ASBESTOS VINYL FLOOR TILES & BITUMEN TO CONCRETE			<i>Surveyor:</i>		PB & MC
					PICTURE 33 AS SAMPLE 2		
					<i>Date:</i>		19/01/21
					<i>Survey Type:</i>		REFURBISHMENT/ DEMOLITION SURVEY
<i>Condition:</i>	FAIR	<i>Access:</i>	EASY	<i>Asbestos?</i>		YES	
				<i>Re Inspection Date:</i>			N/A
<i>Friability:</i>	LOW	<i>Amount:</i>	APPROX: 6M ²	<i>Type:</i>	CHRYBOTILE TO BOTH		
<i>Damage:</i>	LOW	<i>Exposure:</i>	OCCUPANTS	<i>Analysis:</i>	TILES	<7%	
					BITUMEN	<8%	
<i>Position:</i>	VINYL FLOOR TILE & BITUMEN	<i>Risk Factor</i>	4	<i>Priority Assessment:</i>	MINOR RISK		
		<i>Risk Band</i>	D

<i>Recommended Action</i>	REMOVE IDENTIFIED ASBESTOS VINYL TILES & ADHESIVE BEFORE DEMOLITION WORKS COMMENCE, USING A COMPETENT CONTRACTOR
----------------------------------	---

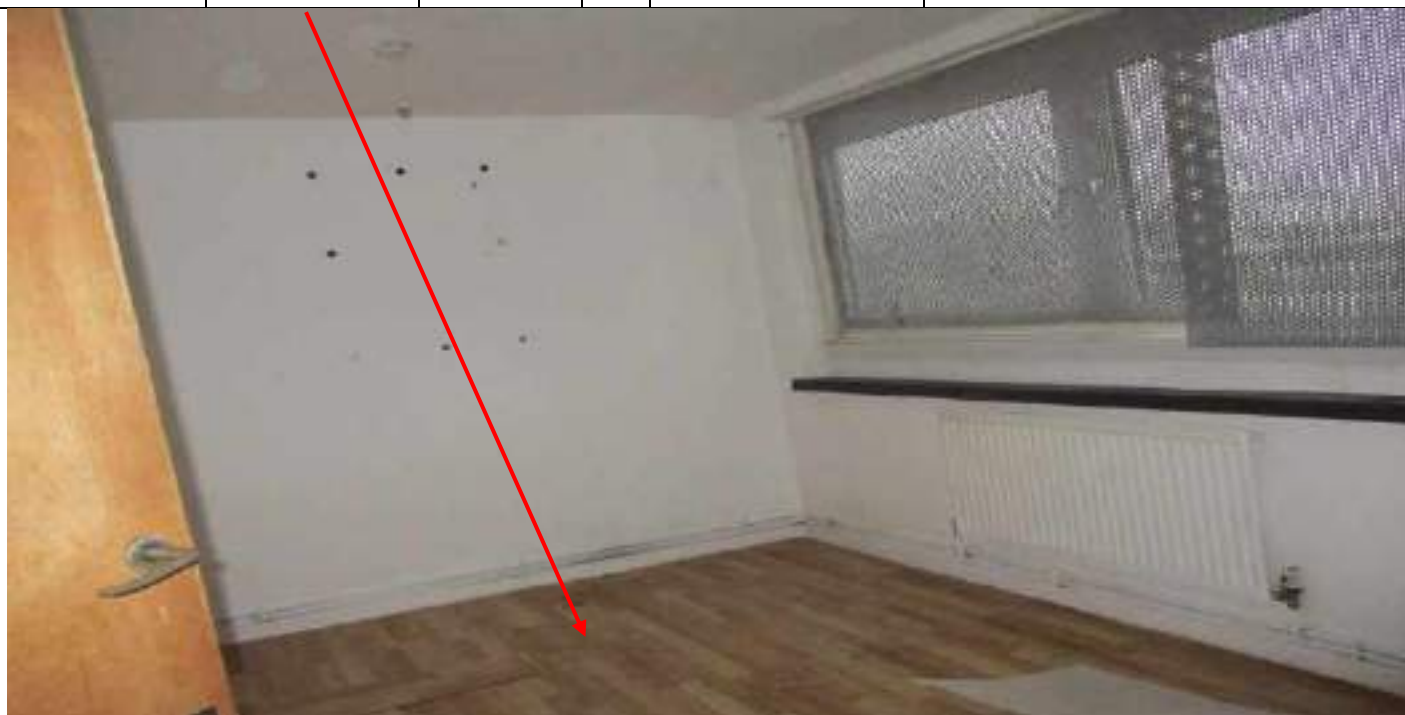
<i>Environmental Inspection Record</i>			FRAMPTON, AGAR GROVE, LONDON, NW1 2SN		
<i>Location</i>		<i>Component</i>		<i>Inspection Ref</i>	
SECOND FLOOR FLAT 10 BEDROOM 2		CONCRETE CEILING PLASTERED BRICK/BREEZE BLOCK WALLS TIMBER FLOORING OVER ASBESTOS VINYL FLOOR TILES & BITUMEN TO CONCRETE		<i>Surveyor:</i>	PB & MC
				PICTURE 34 AS SAMPLE 2	
				<i>Date:</i>	19/01/21
				<i>Survey Type:</i>	REFURBISHMENT/ DEMOLITION SURVEY
<i>Condition:</i>	FAIR	<i>Access:</i>	EASY	<i>Asbestos?</i>	YES
				<i>Re Inspection Date:</i>	N/A
<i>Friability:</i>	LOW	<i>Amount:</i>	APPROX: 18M ²	<i>Type:</i>	CHRYSOTILE TO BOTH
<i>Damage:</i>	LOW	<i>Exposure:</i>	OCCUPANTS	<i>Analysis:</i>	TILES <7% BITUMEN <8%
<i>Position:</i>	VINYL FLOOR TILE & BITUMEN	<i>Risk Factor</i>	4	<i>Priority Assessment:</i>	MINOR RISK
		<i>Risk Band</i>	D

<i>Recommended Action</i>	REMOVE IDENTIFIED ASBESTOS VINYL TILES & ADHESIVE BEFORE DEMOLITION WORKS COMMENCE, USING A COMPETENT CONTRACTOR
----------------------------------	---

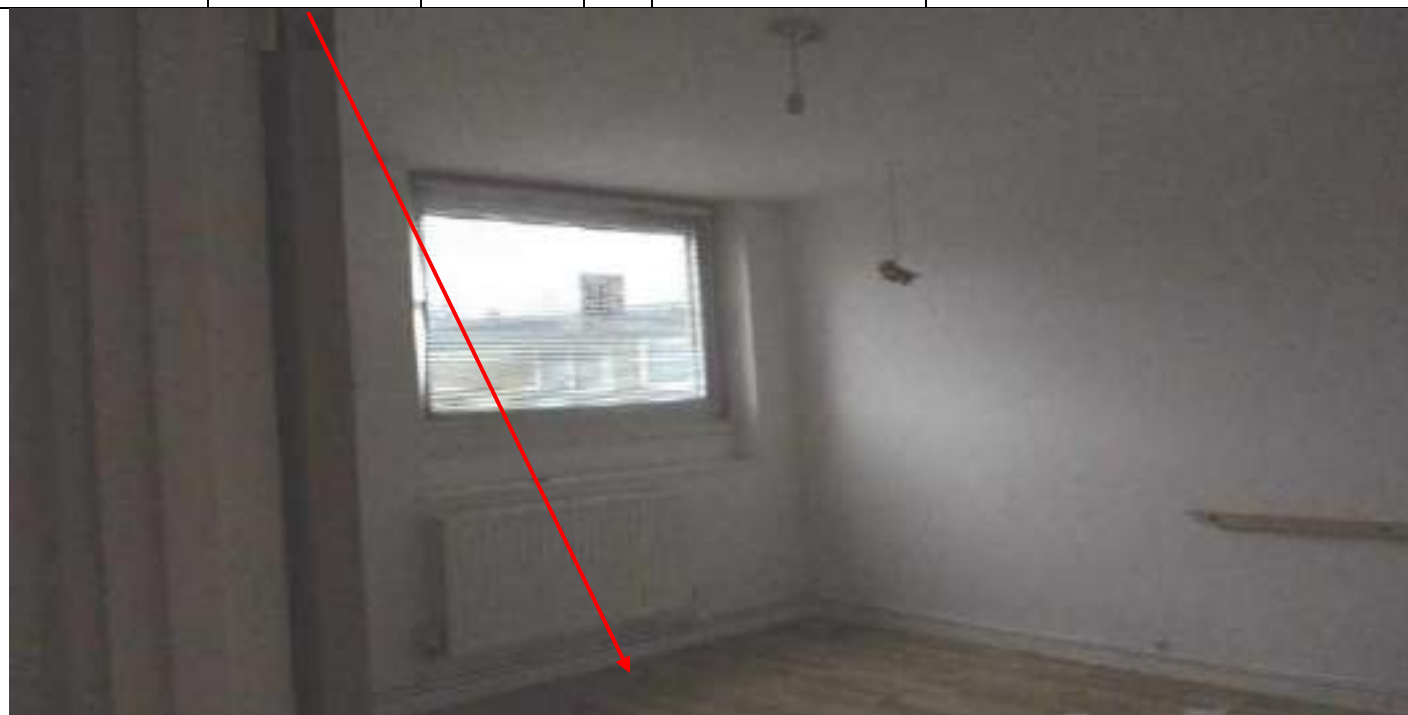
<i>Environmental Inspection Record</i>			FRAMPTON, AGAR GROVE, LONDON, NW1 2SN		
<i>Location</i>		<i>Component</i>		<i>Inspection Ref</i>	
SECOND FLOOR FLAT 10 BEDROOM 1		CONCRETE CEILING PLASTERED BRICK/BREEZE BLOCK WALLS TIMBER FLOORING OVER ASBESTOS VINYL FLOOR TILES & BITUMEN TO CONCRETE		<i>Surveyor:</i>	PB & MC
				PICTURE 35 AS SAMPLE 2	
				<i>Date:</i>	19/01/21
				<i>Survey Type:</i>	REFURBISHMENT/ DEMOLITION SURVEY
<i>Condition:</i>	FAIR	<i>Access:</i>	EASY	<i>Asbestos?</i>	YES
				<i>Re Inspection Date:</i>	N/A
<i>Friability:</i>	LOW	<i>Amount:</i>	APPROX: 10M ²	<i>Type:</i>	CHRYBOTILE TO BOTH
<i>Damage:</i>	LOW	<i>Exposure:</i>	OCCUPANTS	<i>Analysis:</i>	TILES <7% BITUMEN <8%
<i>Position:</i>	VINYL FLOOR TILE & BITUMEN	<i>Risk Factor</i>	4	<i>Priority Assessment:</i>	MINOR RISK
		<i>Risk Band</i>	D

<i>Recommended Action</i>	REMOVE IDENTIFIED ASBESTOS VINYL TILES & ADHESIVE BEFORE DEMOLITION WORKS COMMENCE, USING A COMPETENT CONTRACTOR
----------------------------------	---

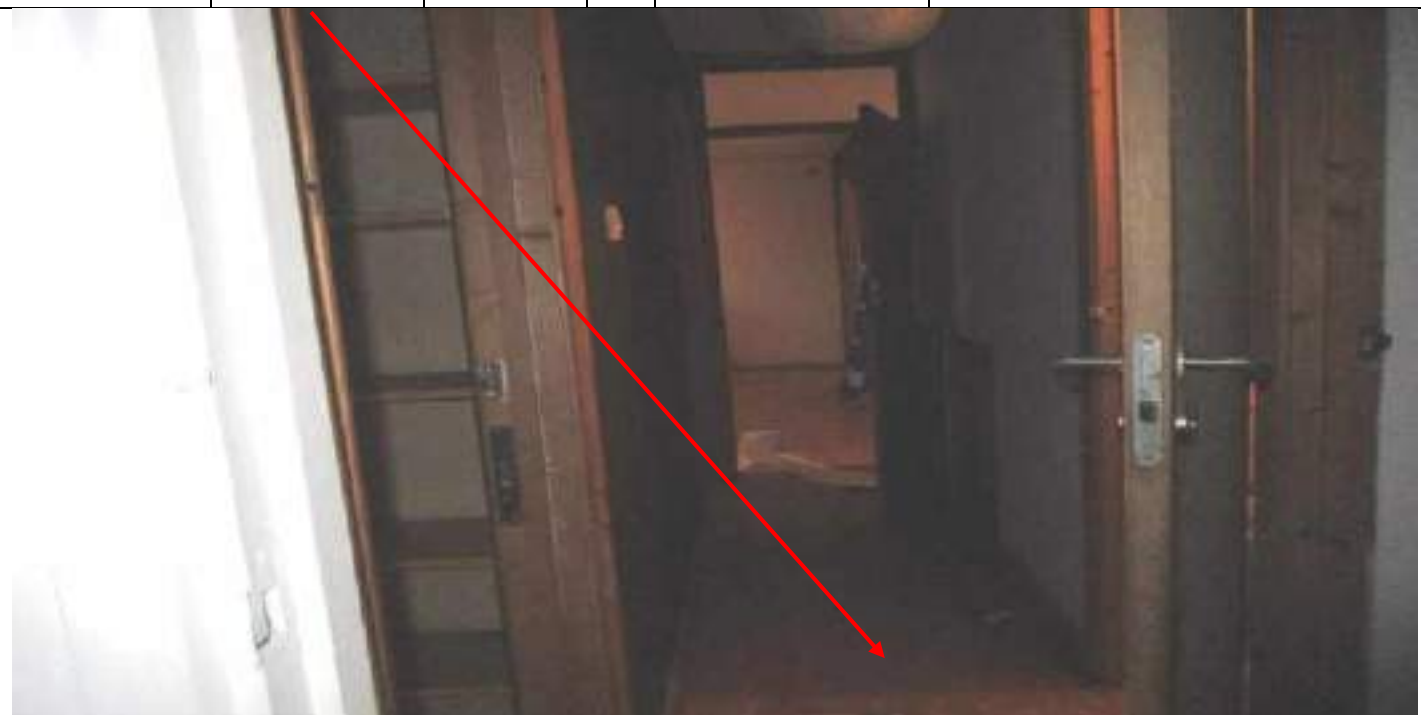
<i>Environmental Inspection Record</i>			FRAMPTON, AGAR GROVE, LONDON, NW1 2SN		
<i>Location</i>		<i>Component</i>		<i>Inspection Ref</i>	
SECOND FLOOR FLAT 10 CORRIDOR		CONCRETE CEILING PLASTERED BRICK/BREEZE BLOCK WALLS CARPET OVER ASBESTOS VINYL FLOOR TILES & BITUMEN TO CONCRETE		<i>Surveyor:</i>	PB & MC
				PICTURE 36 AS SAMPLE 2	
				<i>Date:</i>	19/01/21
				<i>Survey Type:</i>	REFURBISHMENT/ DEMOLITION SURVEY
<i>Condition:</i>	FAIR	<i>Access:</i>	EASY	<i>Asbestos?</i>	YES
				<i>Re Inspection Date:</i>	N/A
<i>Friability:</i>	LOW	<i>Amount:</i>	APPROX: 5M ²	<i>Type:</i>	CHRYSTOLE TO BOTH
<i>Damage:</i>	LOW	<i>Exposure:</i>	OCCUPANTS	<i>Analysis:</i>	TILES <7% BITUMEN <8%
<i>Position:</i>	VINYL FLOOR TILE & BITUMEN	<i>Risk Factor</i>	4	<i>Priority Assessment:</i>	MINOR RISK
		<i>Risk Band</i>	D

<i>Recommended Action</i>	REMOVE IDENTIFIED ASBESTOS VINYL TILES & ADHESIVE BEFORE DEMOLITION WORKS COMMENCE, USING A COMPETENT CONTRACTOR
----------------------------------	---

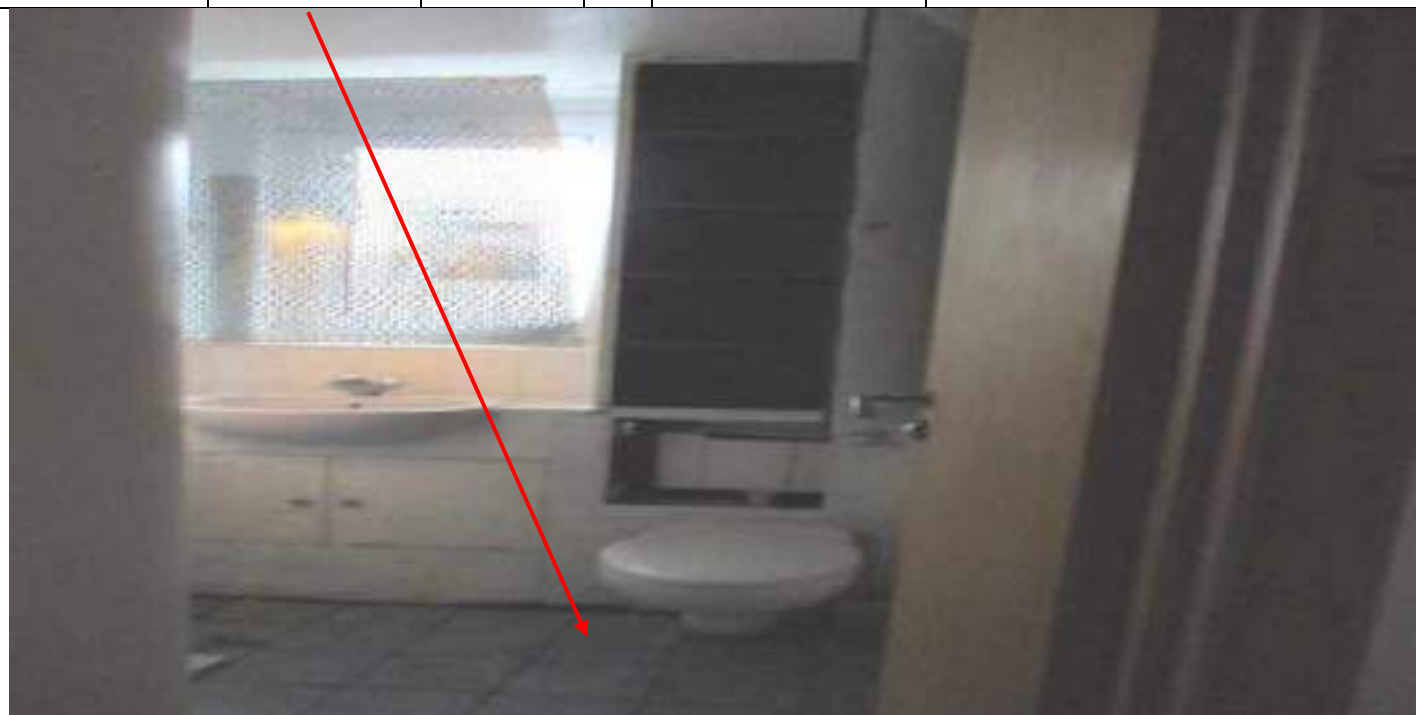
<i>Environmental Inspection Record</i>			FRAMPTON, AGAR GROVE, LONDON, NW1 2SN		
<i>Location</i>		<i>Component</i>		<i>Inspection Ref</i>	
SECOND FLOOR FLAT 10 BATHROOM		CONCRETE CEILING CERAMIC TILES TO PLASTERED BRICK/BREEZE BLOCK WALLS CERAMIC TILES OVER ASBESTOS BITUMEN ADHESIVE TO CONCRETE FLOOR		<i>Surveyor:</i>	PB & MC
				PICTURE 37 AS SAMPLE 2	
				<i>Date:</i>	19/01/21
				<i>Survey Type:</i>	REFURBISHMENT/ DEMOLITION SURVEY
<i>Condition:</i>	FAIR	<i>Access:</i>	MEDIUM	<i>Asbestos?</i>	YES
				<i>Re Inspection Date:</i>	N/A
<i>Friability:</i>	LOW	<i>Amount:</i>	APPROX: 2M ²	<i>Type:</i>	CHRYSOTILE
<i>Damage:</i>	LOW	<i>Exposure:</i>	OCCUPANTS	<i>Analysis:</i>	< 8%
<i>Position:</i>	BITUMEN ADHESIVE	<i>Risk Factor</i>	4	<i>Priority Assessment:</i>	MINOR RISK
		<i>Risk Band</i>	D

<i>Recommended Action</i>	REMOVE IDENTIFIED ASBESTOS BITUMEN ADHESIVE BEFORE DEMOLITION WORKS COMMENCE, USING A COMPETENT CONTRACTOR
----------------------------------	---

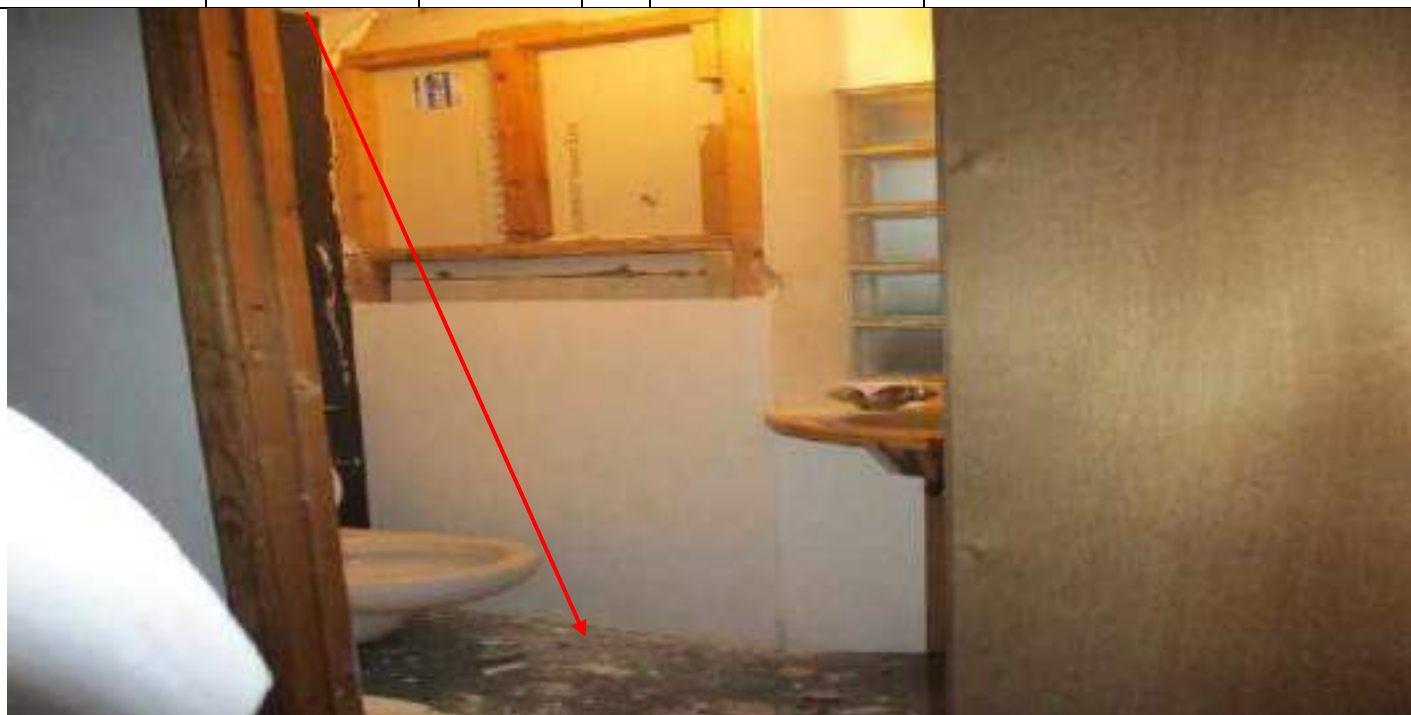
<i>Environmental Inspection Record</i>			FRAMPTON, AGAR GROVE, LONDON, NW1 2SN		
<i>Location</i>		<i>Component</i>		<i>Inspection Ref</i>	
SECOND FLOOR FLAT 10 WC		CONCRETE CEILING CERAMIC TILES TO PLASTERED BRICK/BREEZE BLOCK WALLS ASBESTOS BITUMEN ADHESIVE TO CONCRETE		<i>Surveyor:</i>	PB & MC
				PICTURE 38 AS SAMPLE 2	
				<i>Date:</i>	19/01/21
				<i>Survey Type:</i>	REFURBISHMENT/ DEMOLITION SURVEY
<i>Condition:</i>	FAIR	<i>Access:</i>	MEDIUM	<i>Asbestos?</i>	YES
				<i>Re Inspection Date:</i>	N/A
<i>Friability:</i>	LOW	<i>Amount:</i>	APPROX: 2M ²	<i>Type:</i>	CHRYSOTILE
<i>Damage:</i>	LOW	<i>Exposure:</i>	OCCUPANTS	<i>Analysis:</i>	< 8%
<i>Position:</i>	BITUMEN ADHESIVE	<i>Risk Factor</i>	4	<i>Priority Assessment:</i>	MINOR RISK
		<i>Risk Band</i>	D

<i>Recommended Action</i>	REMOVE IDENTIFIED ASBESTOS BITUMEN ADHESIVE BEFORE DEMOLITION WORKS COMMENCE, USING A COMPETENT CONTRACTOR
----------------------------------	---
