APPENDICES

APPENDIX G

Agar Grove noise policy for Demolition works.

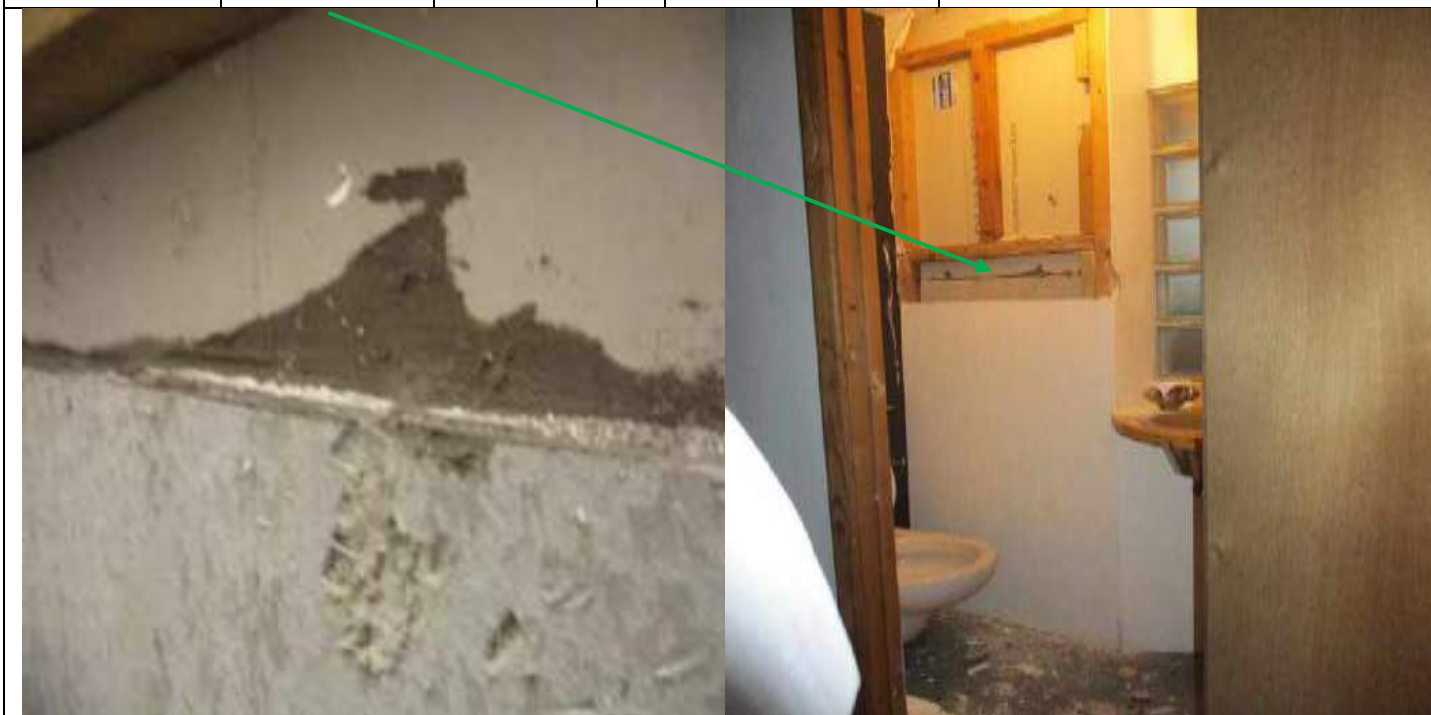
<i>Environmental Inspection Record</i>				FRAMPTON, AGAR GROVE, LONDON, NW1 2SN	
<i>Location</i>		<i>Component</i>		<i>Inspection Ref</i>	
SECOND FLOOR FLAT 10 WC		NON-ASBESTOS INSULATION BOARD PANEL		<i>Surveyor:</i>	PB & MC
				PICTURE 39 SAMPLE 6	
				<i>Date:</i>	19/01/21
				<i>Survey Type:</i>	REFURBISHMENT/ DEMOLITION SURVEY
<i>Condition:</i>	N/A	<i>Access:</i>	N/A	<i>Asbestos?</i>	NO
				<i>Re Inspection Date:</i>	N/A
<i>Friability:</i>	N/A	<i>Amount:</i>	N/A	<i>Type:</i>	NON ASBESTOS
<i>Damage:</i>	N/A	<i>Exposure:</i>	N/A	<i>Analysis:</i>	NADIS
<i>Position:</i>	INSULATION BOARD	<i>Risk Factor</i>	0	<i>Priority Assessment:</i>	NO RISK
		<i>Risk Band</i>	E

<i>Recommended Action</i>	NO ASBESTOS MATERIALS IDENTIFIED.
---------------------------	--

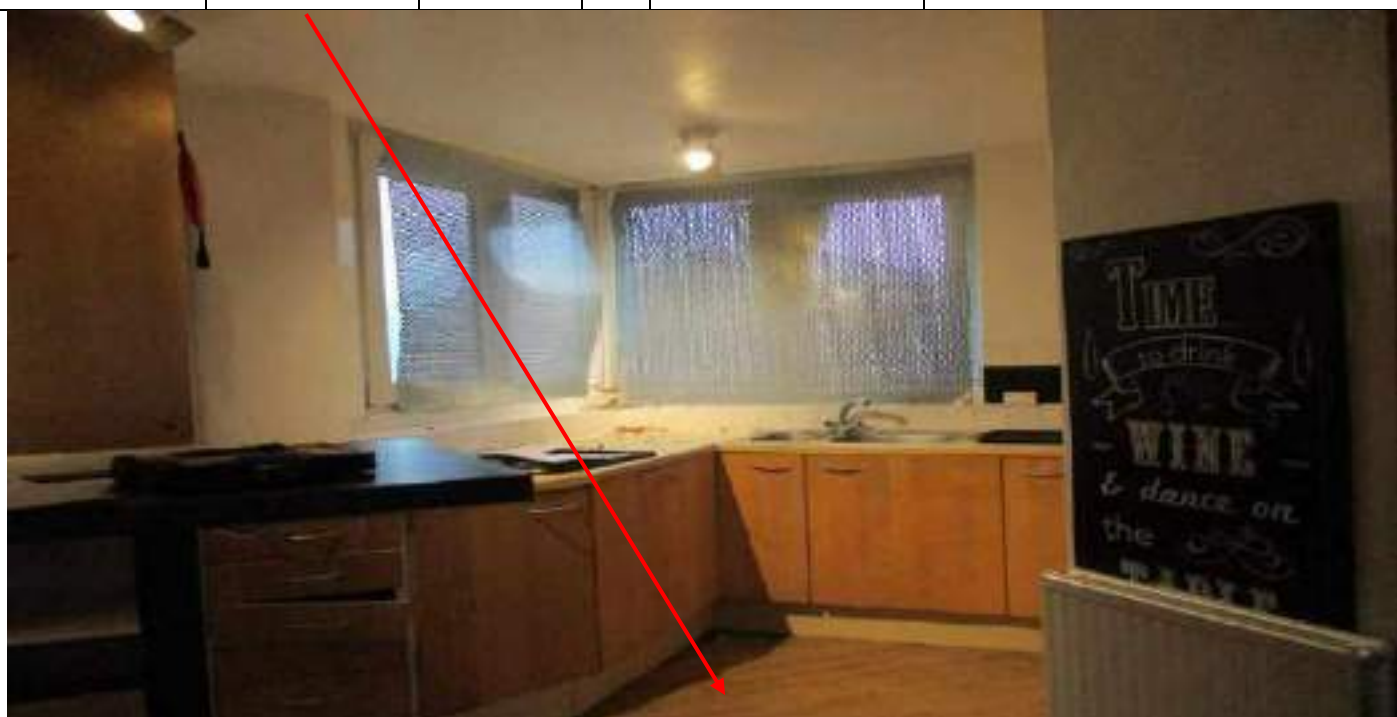
<i>Environmental Inspection Record</i>			FRAMPTON, AGAR GROVE, LONDON, NW1 2SN		
<i>Location</i>		<i>Component</i>		<i>Inspection Ref</i>	
SECOND FLOOR FLAT 10 KITCHEN		CONCRETE CEILING PLASTERED BRICK/BREEZE BLOCK WALLS TIMBER FLOORING OVER ASBESTOS VINYL FLOOR TILES & BITUMEN TO CONCRETE		<i>Surveyor:</i>	PB & MC
				PICTURE 40 AS SAMPLE 2	
				<i>Date:</i>	19/01/21
				<i>Survey Type:</i>	REFURBISHMENT/ DEMOLITION SURVEY
<i>Condition:</i>	FAIR	<i>Access:</i>	EASY	<i>Asbestos?</i>	YES
				<i>Re Inspection Date:</i>	N/A
<i>Friability:</i>	LOW	<i>Amount:</i>	APPROX: 12M ²	<i>Type:</i>	CHRYSOTILE TO BOTH
<i>Damage:</i>	LOW	<i>Exposure:</i>	OCCUPANTS	<i>Analysis:</i>	TILES <7% BITUMEN <8%
<i>Position:</i>	VINYL FLOOR TILE & BITUMEN	<i>Risk Factor</i>	4	<i>Priority Assessment:</i>	MINOR RISK
		<i>Risk Band</i>	D

Recommended Action	REMOVE IDENTIFIED ASBESTOS VINYL TILES & ADHESIVE BEFORE DEMOLITION WORKS COMMENCE, USING A COMPETENT CONTRACTOR
---------------------------	---

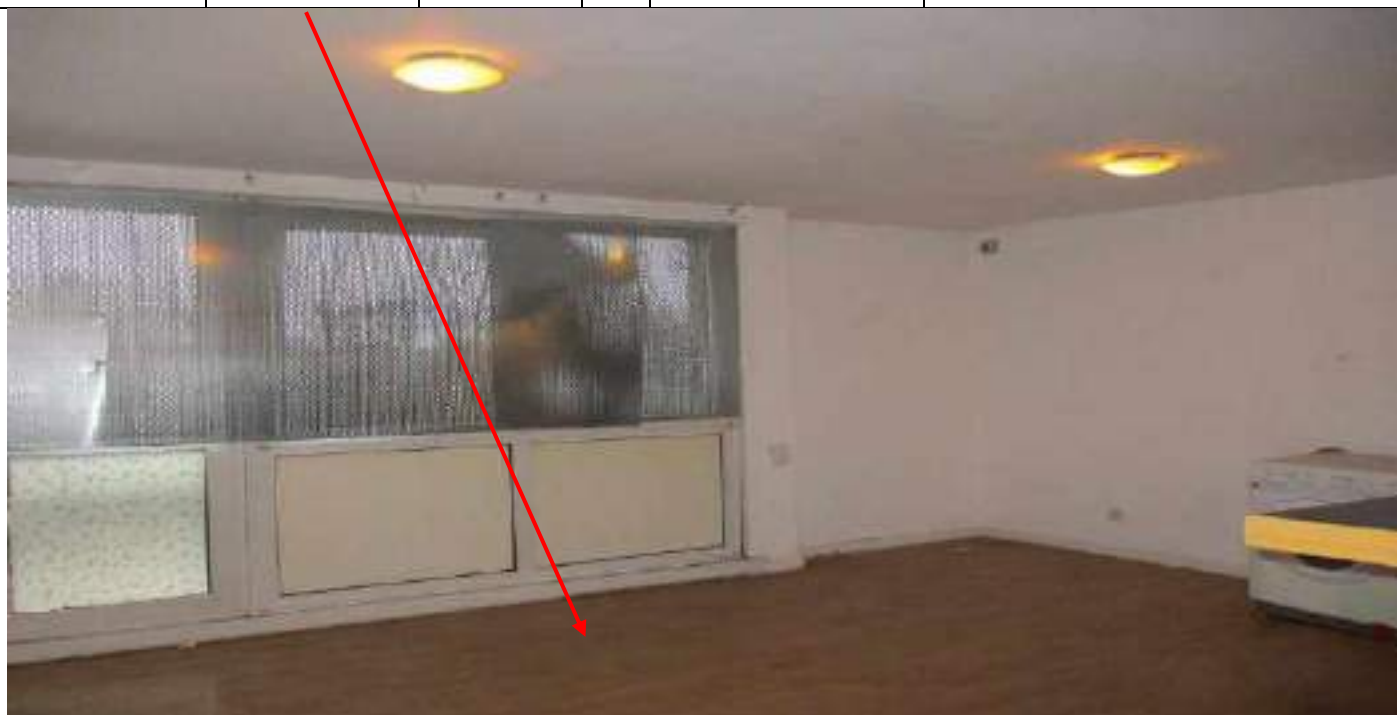
<i>Environmental Inspection Record</i>				FRAMPTON, AGAR GROVE, LONDON, NW1 2SN			
<i>Location</i>		<i>Component</i>			<i>Inspection Ref</i>		
SECOND FLOOR FLAT 10 LOUNGE		CONCRETE CEILING PLASTERED BRICK/BREEZE BLOCK WALLS TIMBER FLOORING OVER ASBESTOS VINYL FLOOR TILES & BITUMEN TO CONCRETE			<i>Surveyor:</i>	PB & MC	
					PICTURE 41 AS SAMPLE 2		
					<i>Date:</i>	19/01/21	
					<i>Survey Type:</i>	REFURBISHMENT/ DEMOLITION SURVEY	
<i>Condition:</i>	FAIR	<i>Access:</i>	EASY		<i>Asbestos?</i>	YES	
					<i>Re Inspection Date:</i>	N/A	
<i>Friability:</i>	LOW	<i>Amount:</i>	APPROX: 25M ²		<i>Type:</i>	CHRYSTOLE TO BOTH	
<i>Damage:</i>	LOW	<i>Exposure:</i>	OCCUPANTS		<i>Analysis:</i>	TILES	<7%
						BITUMEN	<8%
<i>Position:</i>	VINYL FLOOR TILE & BITUMEN	<i>Risk Factor</i>	4	<i>Priority Assessment:</i>	MINOR RISK		
		<i>Risk Band</i>	D

<i>Recommended Action</i>	REMOVE IDENTIFIED ASBESTOS VINYL TILES & ADHESIVE BEFORE DEMOLITION WORKS COMMENCE, USING A COMPETENT CONTRACTOR
----------------------------------	---

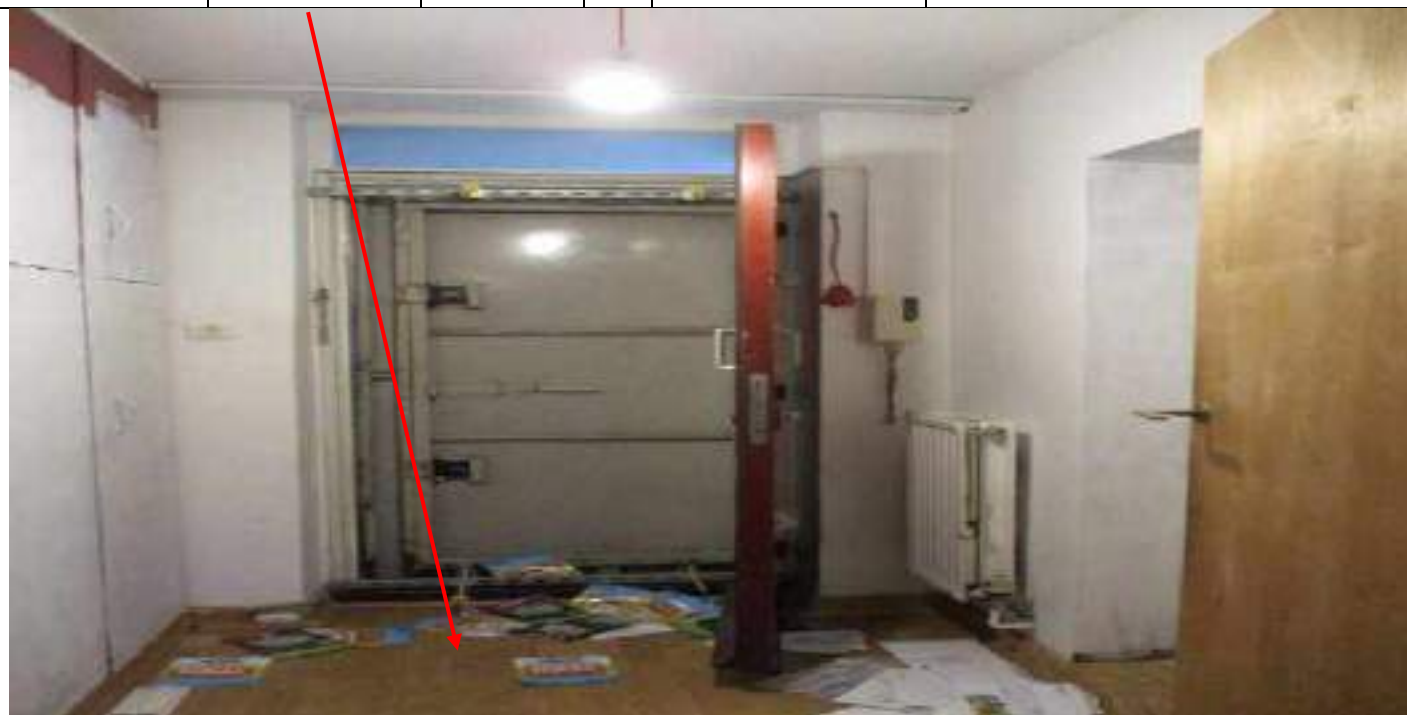
<i>Environmental Inspection Record</i>				FRAMPTON, AGAR GROVE, LONDON, NW1 2SN			
<i>Location</i>		<i>Component</i>			<i>Inspection Ref</i>		
SECOND FLOOR FLAT 10 HALLWAY		CONCRETE CEILING PLASTERED BRICK/BREEZE BLOCK WALLS TIMBER FLOORING OVER ASBESTOS VINYL FLOOR TILES & BITUMEN TO CONCRETE			<i>Surveyor:</i>	PB & MC	
					PICTURE 42 AS SAMPLE 2		
					<i>Date:</i>	19/01/21	
					<i>Survey Type:</i>	REFURBISHMENT/ DEMOLITION SURVEY	
<i>Condition:</i>	FAIR	<i>Access:</i>	EASY		<i>Asbestos?</i>	YES	
					<i>Re Inspection Date:</i>	N/A	
<i>Friability:</i>	LOW	<i>Amount:</i>	APPROX: 5M ²		<i>Type:</i>	CHRYSOTILE TO BOTH	
<i>Damage:</i>	LOW	<i>Exposure:</i>	OCCUPANTS		<i>Analysis:</i>	TILES	<7%
						BITUMEN	<8%
<i>Position:</i>	VINYL FLOOR TILE & BITUMEN	<i>Risk Factor</i>	4	<i>Priority Assessment:</i>	MINOR RISK		
		<i>Risk Band</i>	D

<i>Recommended Action</i>	REMOVE IDENTIFIED ASBESTOS VINYL TILES & ADHESIVE BEFORE DEMOLITION WORKS COMMENCE, USING A COMPETENT CONTRACTOR
----------------------------------	---

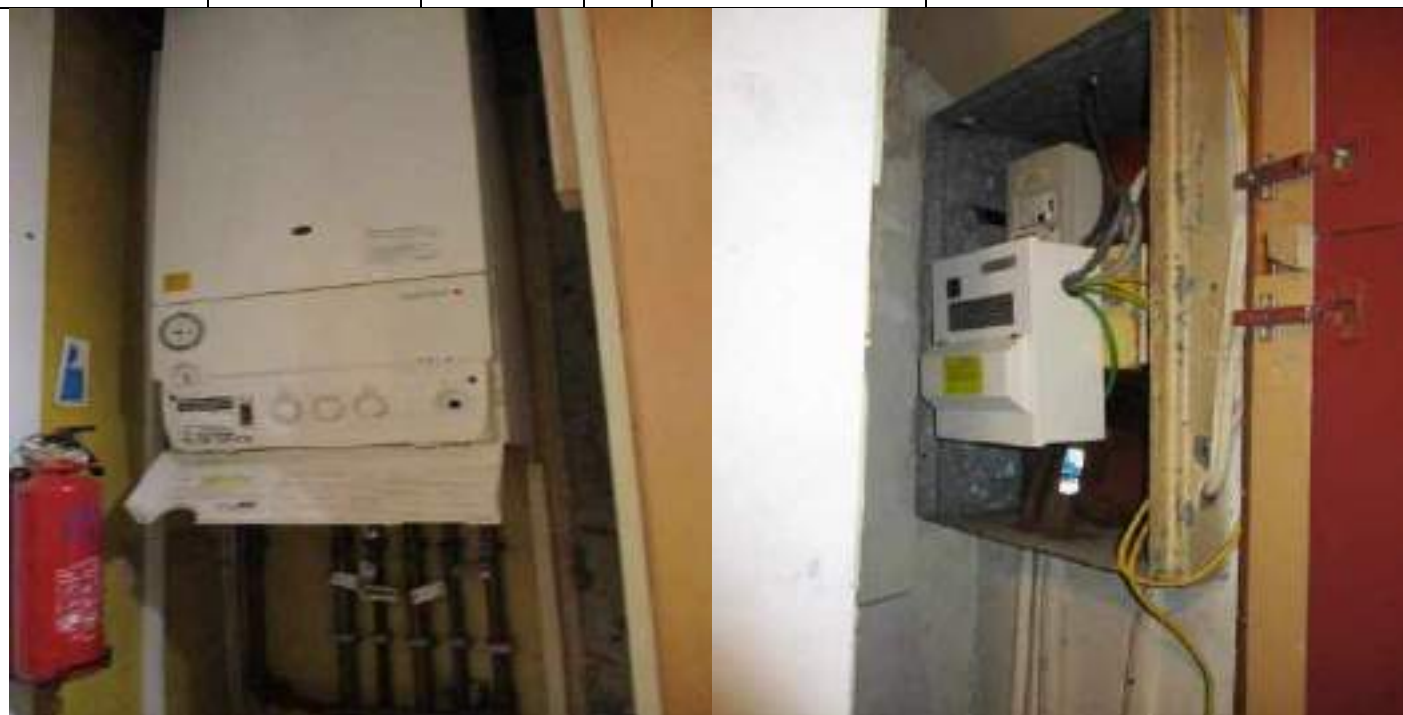
<i>Environmental Inspection Record</i>				FRAMPTON, AGAR GROVE, LONDON, NW1 2SN	
<i>Location</i>		<i>Component</i>		<i>Inspection Ref</i>	
SECOND FLOOR FLAT 10 HALLWAY		BOILER WITH METAL FLUE PIPE ELECTRICAL FUSE BOARD		<i>Surveyor:</i>	PB & MC
				PICTURE 43 & 44	
				<i>Date:</i>	19/01/21
				<i>Survey Type:</i>	REFURBISHMENT/ DEMOLITION SURVEY
<i>Condition:</i>	N/A	<i>Access:</i>	N/A	<i>Asbestos?</i>	NO
				<i>Re Inspection Date:</i>	N/A
<i>Friability:</i>	N/A	<i>Amount:</i>	N/A	<i>Type:</i>	NON ASBESTOS
<i>Damage:</i>	N/A	<i>Exposure:</i>	N/A	<i>Analysis:</i>	N/A
<i>Position:</i>	CUPBOARDS	<i>Risk Factor</i>	0	<i>Priority Assessment:</i>	NO RISK
		<i>Risk Band</i>	E

<i>Recommended Action</i>	NO ASBESTOS MATERIALS IDENTIFIED.
---------------------------	--

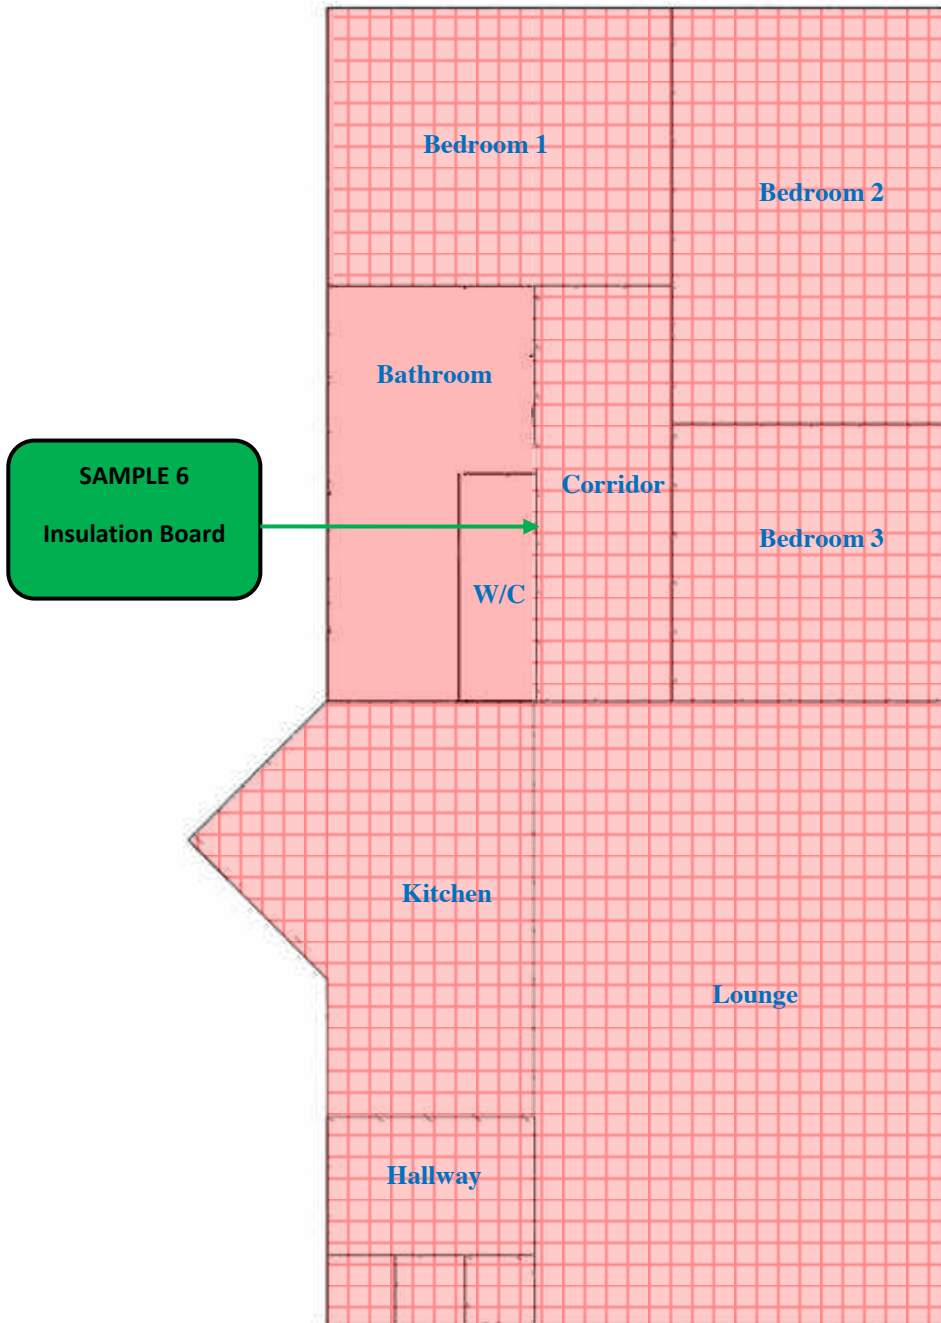
Flat 10

Vinyl Floor Tile

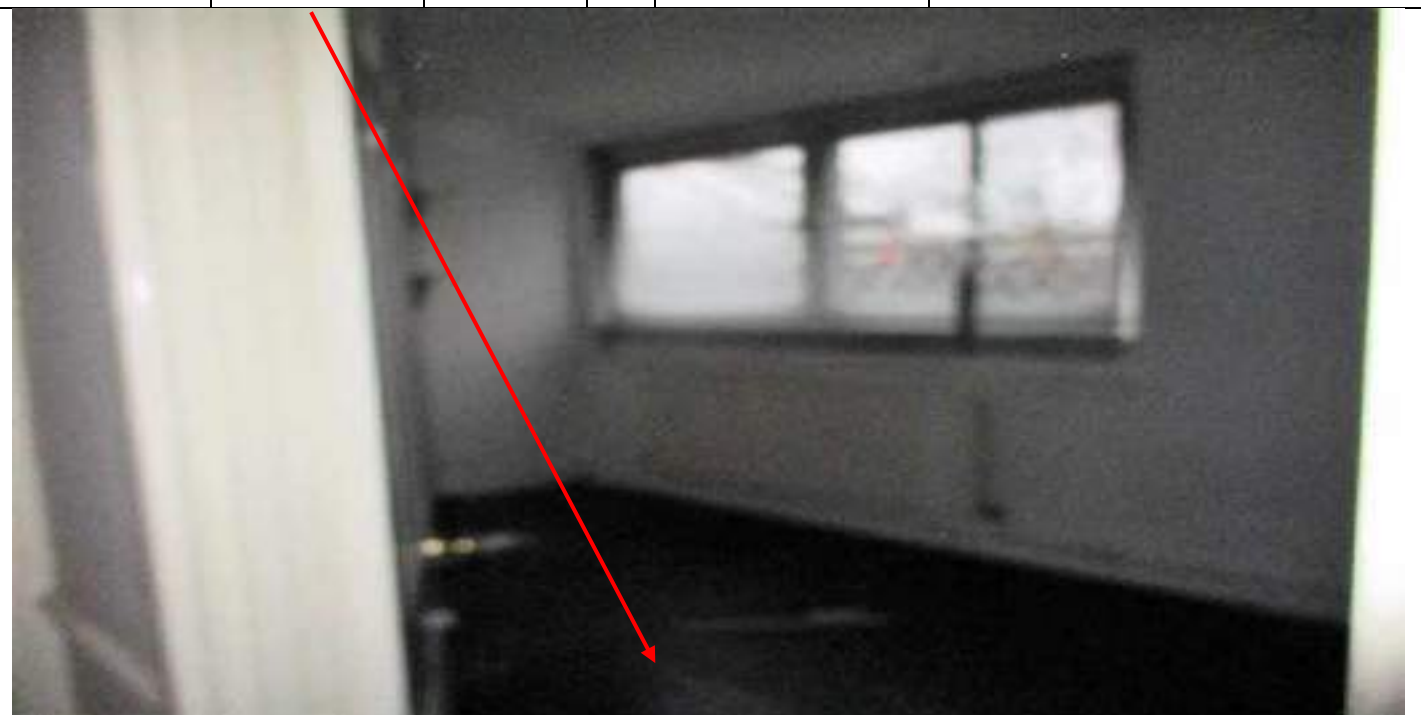
<i>Environmental Inspection Record</i>				FRAMPTON, AGAR GROVE, LONDON, NW1 2SN			
<i>Location</i>		<i>Component</i>			<i>Inspection Ref</i>		
FIRST FLOOR FLAT 8 BEDROOM 3		CONCRETE CEILING PLASTERED BRICK/BREEZE BLOCK WALLS TIMBER FLOORING OVER ASBESTOS VINYL FLOOR TILES & BITUMEN TO CONCRETE			<i>Surveyor:</i>	PB & MC	
					PICTURE 45 AS SAMPLE 2		
					<i>Date:</i>	19/01/21	
					<i>Survey Type:</i>	REFURBISHMENT/ DEMOLITION SURVEY	
<i>Condition:</i>	FAIR	<i>Access:</i>	EASY		<i>Asbestos?</i>	YES	
					<i>Re Inspection Date:</i>	N/A	
<i>Friability:</i>	LOW	<i>Amount:</i>	APPROX: 18M ²		<i>Type:</i>	CHRYBOTILE TO BOTH	
<i>Damage:</i>	LOW	<i>Exposure:</i>	OCCUPANTS		<i>Analysis:</i>	TILES	<7%
						BITUMEN	<8%
<i>Position:</i>	VINYL FLOOR TILE & BITUMEN	<i>Risk Factor</i>	4	<i>Priority Assessment:</i>	MINOR RISK		
		<i>Risk Band</i>	D

<i>Recommended Action</i>	REMOVE IDENTIFIED ASBESTOS VINYL TILES & ADHESIVE BEFORE DEMOLITION WORKS COMMENCE, USING A COMPETENT CONTRACTOR
----------------------------------	---

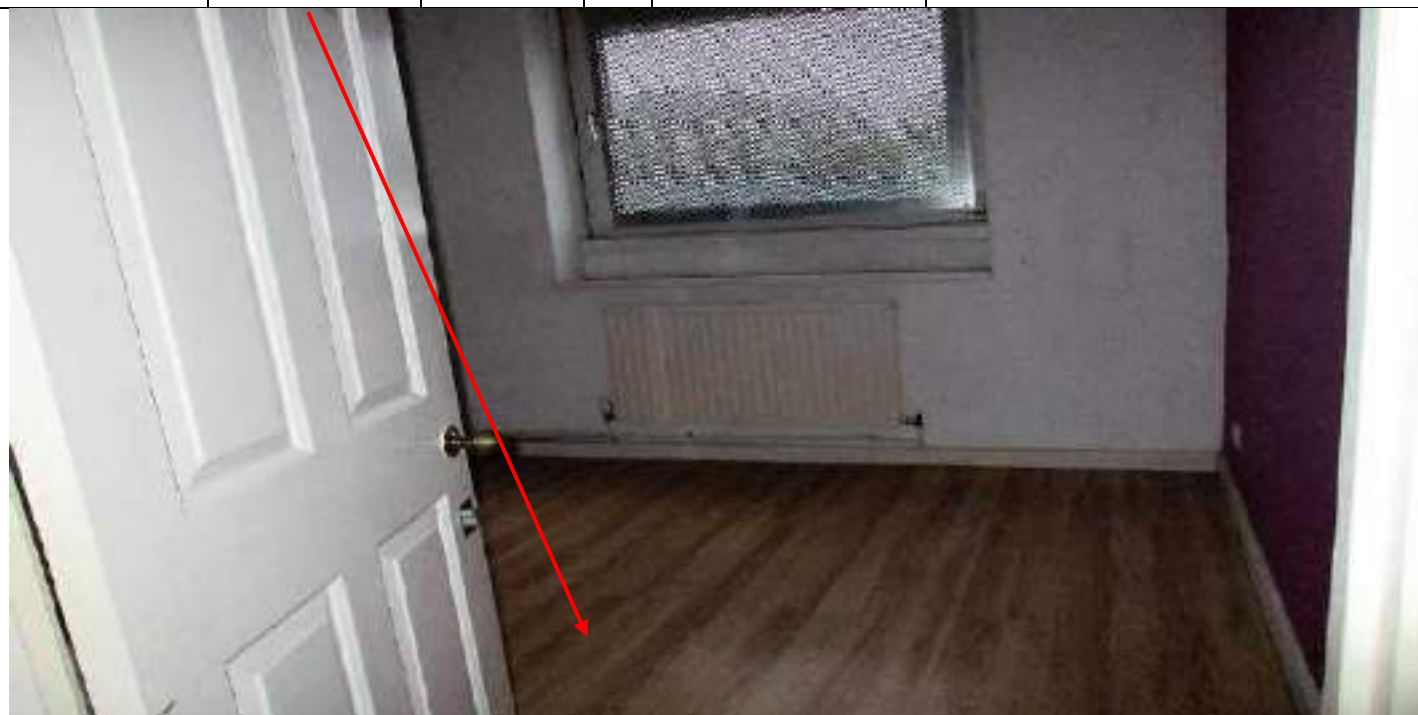
<i>Environmental Inspection Record</i>			FRAMPTON, AGAR GROVE, LONDON, NW1 2SN		
<i>Location</i>		<i>Component</i>		<i>Inspection Ref</i>	
FIRST FLOOR FLAT 8 BEDROOM 2		CONCRETE CEILING PLASTERED BRICK/BREEZE BLOCK WALLS TIMBER FLOORING OVER ASBESTOS VINYL FLOOR TILES & BITUMEN TO CONCRETE		<i>Surveyor:</i>	PB & MC
				PICTURE 46 AS SAMPLE 2	
				<i>Date:</i>	19/01/21
				<i>Survey Type:</i>	REFURBISHMENT/ DEMOLITION SURVEY
<i>Condition:</i>	FAIR	<i>Access:</i>	EASY	<i>Asbestos?</i>	YES
				<i>Re Inspection Date:</i>	N/A
<i>Friability:</i>	LOW	<i>Amount:</i>	APPROX: 10M ²	<i>Type:</i>	CHRYSOTILE TO BOTH
<i>Damage:</i>	LOW	<i>Exposure:</i>	OCCUPANTS	<i>Analysis:</i>	TILES <7% BITUMEN <8%
<i>Position:</i>	VINYL FLOOR TILE & BITUMEN	<i>Risk Factor</i>	4	<i>Priority Assessment:</i>	MINOR RISK
		<i>Risk Band</i>	D

<i>Recommended Action</i>	REMOVE IDENTIFIED ASBESTOS VINYL TILES & ADHESIVE BEFORE DEMOLITION WORKS COMMENCE, USING A COMPETENT CONTRACTOR
----------------------------------	---

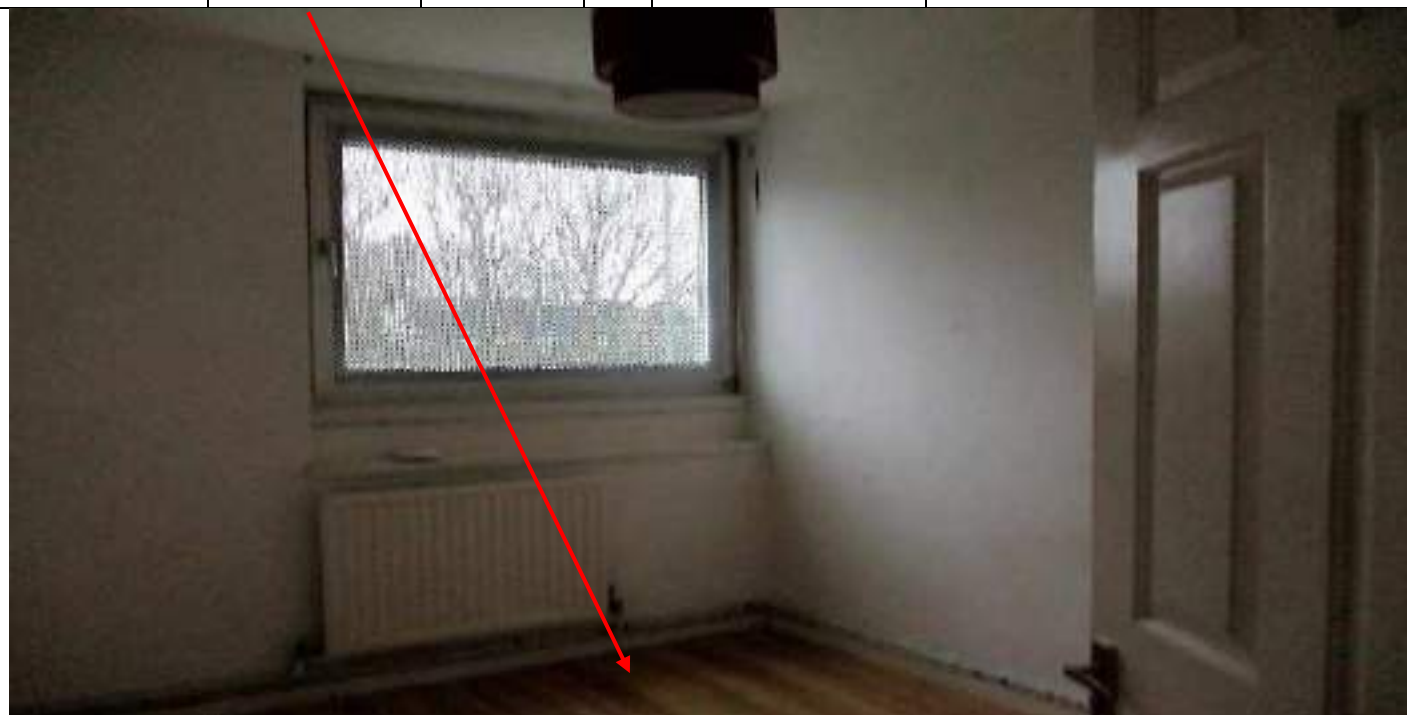
<i>Environmental Inspection Record</i>			FRAMPTON, AGAR GROVE, LONDON, NW1 2SN		
<i>Location</i>		<i>Component</i>		<i>Inspection Ref</i>	
FIRST FLOOR FLAT 8 BEDROOM 1		CONCRETE CEILING PLASTERED BRICK/BREEZE BLOCK WALLS TIMBER FLOORING OVER ASBESTOS VINYL FLOOR TILES & BITUMEN TO CONCRETE		<i>Surveyor:</i>	PB & MC
				PICTURE 47 AS SAMPLE 2	
				<i>Date:</i>	19/01/21
				<i>Survey Type:</i>	REFURBISHMENT/ DEMOLITION SURVEY
<i>Condition:</i>	FAIR	<i>Access:</i>	EASY	<i>Asbestos?</i>	YES
				<i>Re Inspection Date:</i>	N/A
<i>Friability:</i>	LOW	<i>Amount:</i>	APPROX: 6M ²	<i>Type:</i>	CHRYBOTILE TO BOTH
<i>Damage:</i>	LOW	<i>Exposure:</i>	OCCUPANTS	<i>Analysis:</i>	TILES <7% BITUMEN <8%
<i>Position:</i>	VINYL FLOOR TILE & BITUMEN	<i>Risk Factor</i>	4	<i>Priority Assessment:</i>	MINOR RISK
		<i>Risk Band</i>	D

<i>Recommended Action</i>	REMOVE IDENTIFIED ASBESTOS VINYL TILES & ADHESIVE BEFORE DEMOLITION WORKS COMMENCE, USING A COMPETENT CONTRACTOR
----------------------------------	---

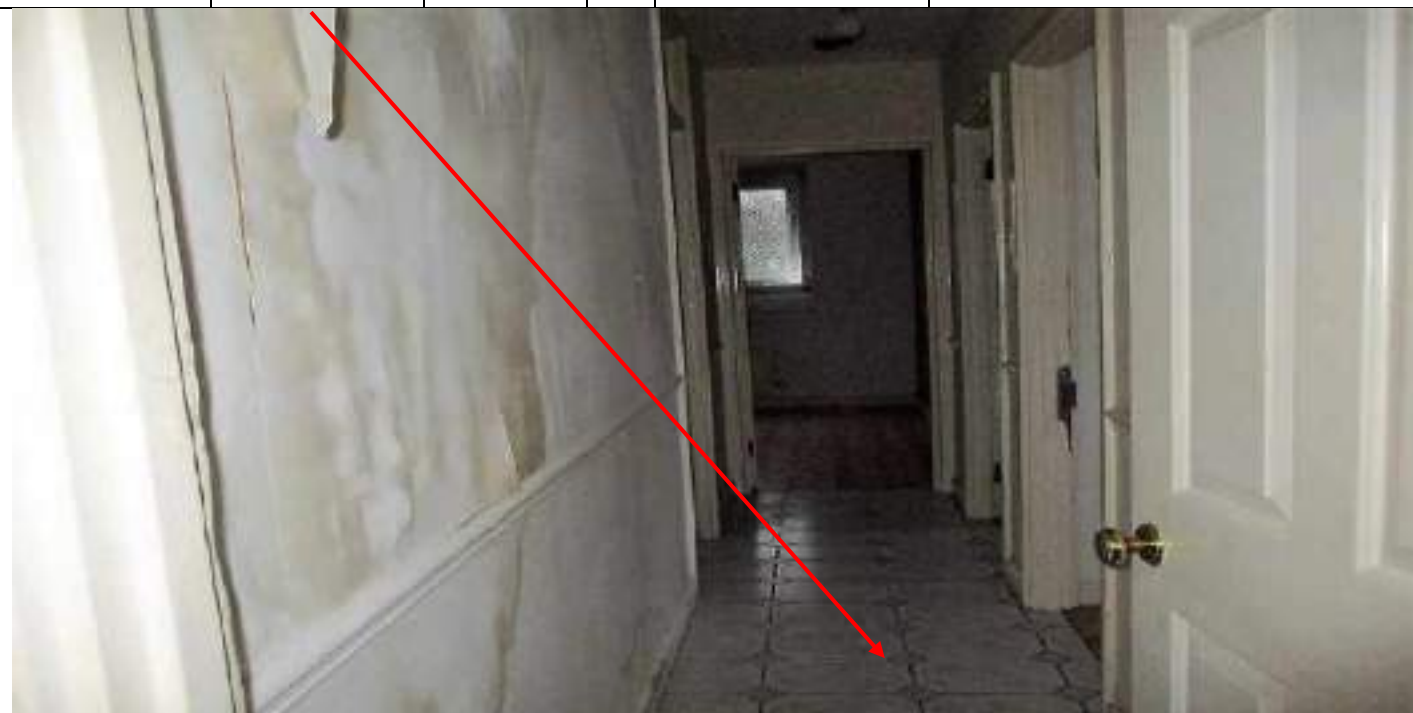
<i>Environmental Inspection Record</i>			FRAMPTON, AGAR GROVE, LONDON, NW1 2SN		
<i>Location</i>		<i>Component</i>		<i>Inspection Ref</i>	
FIRST FLOOR FLAT 8 CORRIDOR		CONCRETE CEILING PLASTERED BRICK/BREEZE BLOCK WALLS CERAMIC TILES OVER ASBESTOS VINYL FLOOR TILES & BITUMEN TO CONCRETE		<i>Surveyor:</i>	PB & MC
				PICTURE 48 AS SAMPLE 2	
				<i>Date:</i>	19/01/21
				<i>Survey Type:</i>	REFURBISHMENT/ DEMOLITION SURVEY
<i>Condition:</i>	FAIR	<i>Access:</i>	EASY	<i>Asbestos?</i>	YES
				<i>Re Inspection Date:</i>	N/A
<i>Friability:</i>	LOW	<i>Amount:</i>	APPROX: 5M ²	<i>Type:</i>	CHRYBOTILE TO BOTH
<i>Damage:</i>	LOW	<i>Exposure:</i>	OCCUPANTS	<i>Analysis:</i>	TILES <7% BITUMEN <8%
<i>Position:</i>	VINYL FLOOR TILE & BITUMEN	<i>Risk Factor</i>	4	<i>Priority Assessment:</i>	MINOR RISK
		<i>Risk Band</i>	D

<i>Recommended Action</i>	REMOVE IDENTIFIED ASBESTOS VINYL TILES & ADHESIVE BEFORE DEMOLITION WORKS COMMENCE, USING A COMPETENT CONTRACTOR
----------------------------------	---

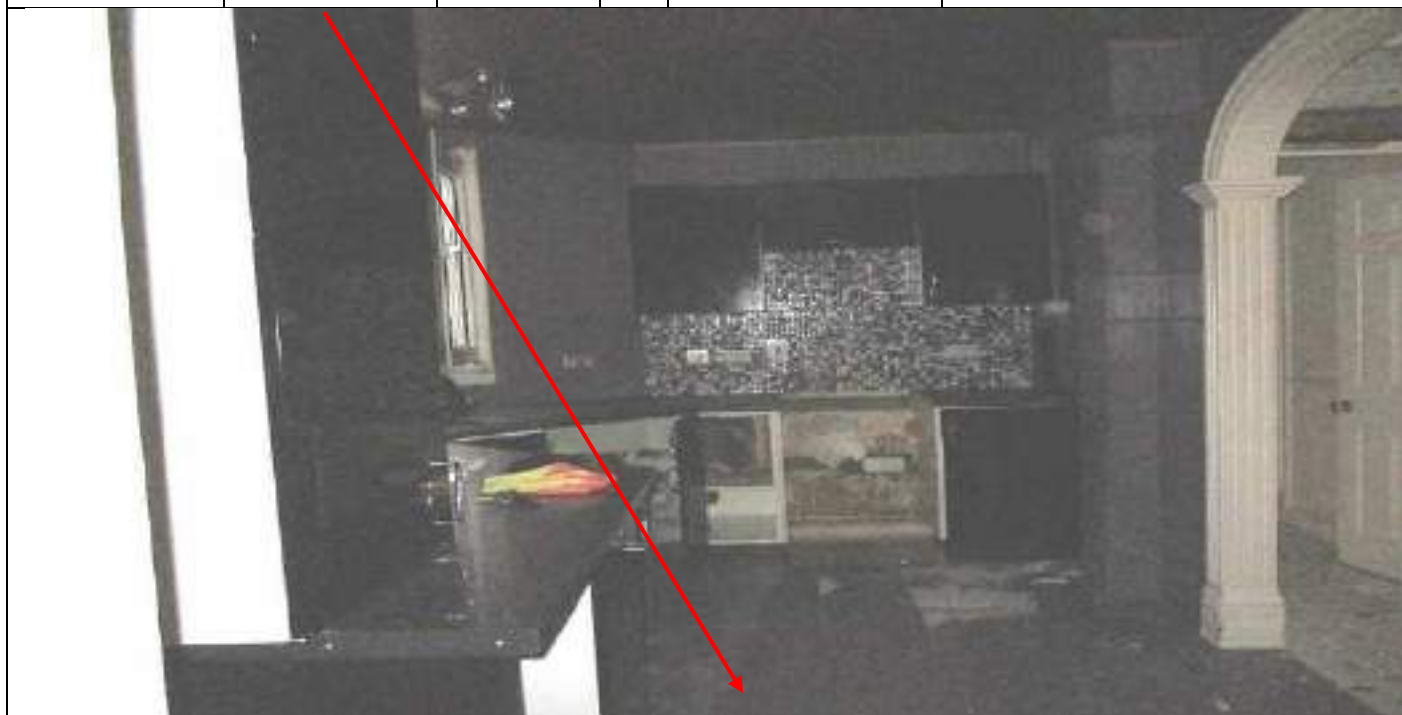
<i>Environmental Inspection Record</i>			FRAMPTON, AGAR GROVE, LONDON, NW1 2SN		
<i>Location</i>		<i>Component</i>		<i>Inspection Ref</i>	
FIRST FLOOR FLAT 8 KITCHEN		CONCRETE CEILING PLASTERED BRICK/BREEZE BLOCK WALLS CERAMIC TILES OVER ASBESTOS VINYL FLOOR TILES & BITUMEN TO CONCRETE		<i>Surveyor:</i>	PB & MC
				PICTURE 51 AS SAMPLE 2	
				<i>Date:</i>	19/01/21
				<i>Survey Type:</i>	REFURBISHMENT/ DEMOLITION SURVEY
<i>Condition:</i>	FAIR	<i>Access:</i>	EASY	<i>Asbestos?</i>	YES
				<i>Re Inspection Date:</i>	N/A
<i>Friability:</i>	LOW	<i>Amount:</i>	APPROX: 12M ²	<i>Type:</i>	CHRYSOTILE TO BOTH
<i>Damage:</i>	LOW	<i>Exposure:</i>	OCCUPANTS	<i>Analysis:</i>	TILES <7% BITUMEN <8%
<i>Position:</i>	VINYL FLOOR TILE & BITUMEN	<i>Risk Factor</i>	4	<i>Priority Assessment:</i>	MINOR RISK
		<i>Risk Band</i>	D

<i>Recommended Action</i>	REMOVE IDENTIFIED ASBESTOS VINYL TILES & ADHESIVE BEFORE DEMOLITION WORKS COMMENCE, USING A COMPETENT CONTRACTOR
---------------------------	---

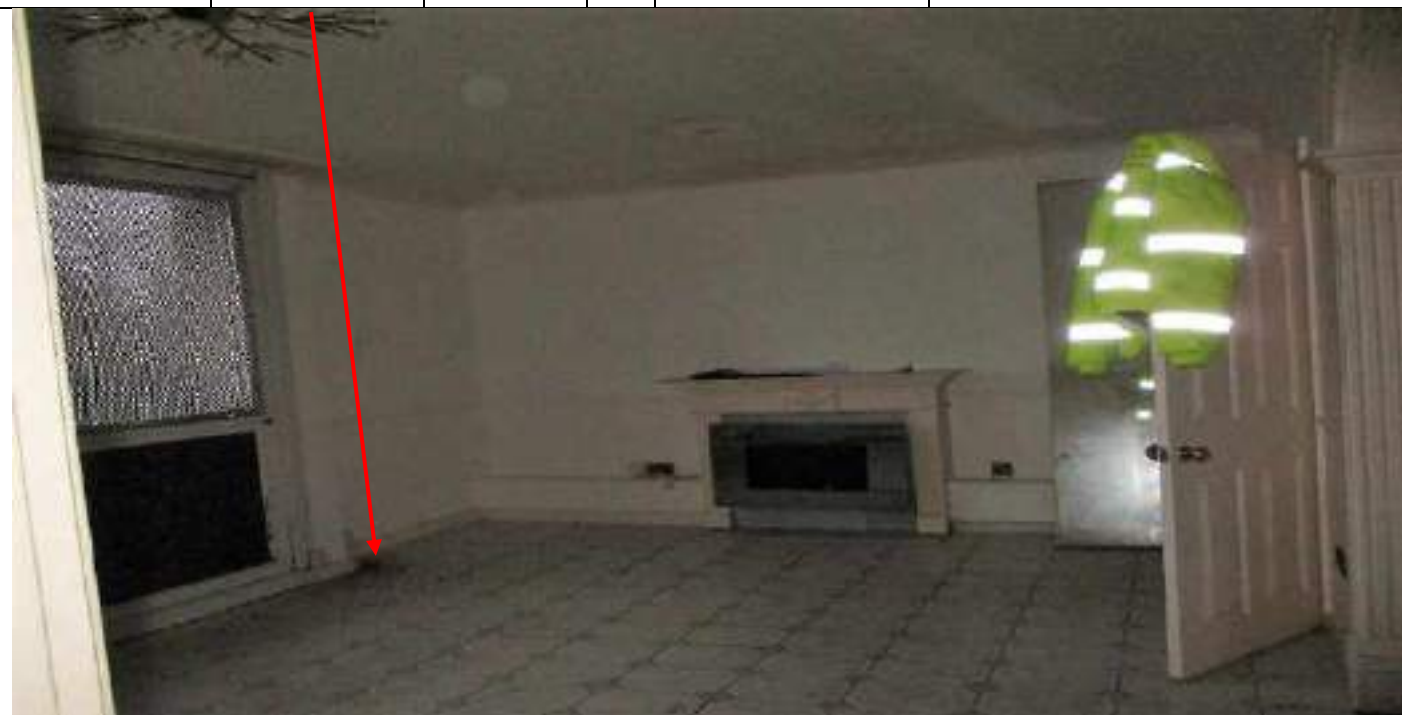
<i>Environmental Inspection Record</i>				FRAMPTON, AGAR GROVE, LONDON, NW1 2SN			
<i>Location</i>		<i>Component</i>			<i>Inspection Ref</i>		
FIRST FLOOR FLAT 8 LOUNGE		CONCRETE CEILING PLASTERED BRICK/BREEZE BLOCK WALLS TIMBER FLOORING OVER ASBESTOS VINYL FLOOR TILES & BITUMEN TO CONCRETE			<i>Surveyor:</i>		PB & MC
					PICTURE 50 AS SAMPLE 2		
					<i>Date:</i>		19/01/21
					<i>Survey Type:</i>		REFURBISHMENT/ DEMOLITION SURVEY
<i>Condition:</i>	FAIR	<i>Access:</i>	EASY	<i>Asbestos?</i>		YES	
				<i>Re Inspection Date:</i>			N/A
<i>Friability:</i>	LOW	<i>Amount:</i>	APPROX: 25M ²	<i>Type:</i>	CHRYBOTILE TO BOTH		
<i>Damage:</i>	LOW	<i>Exposure:</i>	OCCUPANTS	<i>Analysis:</i>	TILES	<7%	
					BITUMEN	<8%	
<i>Position:</i>	VINYL FLOOR TILE & BITUMEN	<i>Risk Factor</i>	4	<i>Priority Assessment:</i>	MINOR RISK		
		<i>Risk Band</i>	D

<i>Recommended Action</i>	REMOVE IDENTIFIED ASBESTOS VINYL TILES & ADHESIVE BEFORE DEMOLITION WORKS COMMENCE, USING A COMPETENT CONTRACTOR
----------------------------------	---

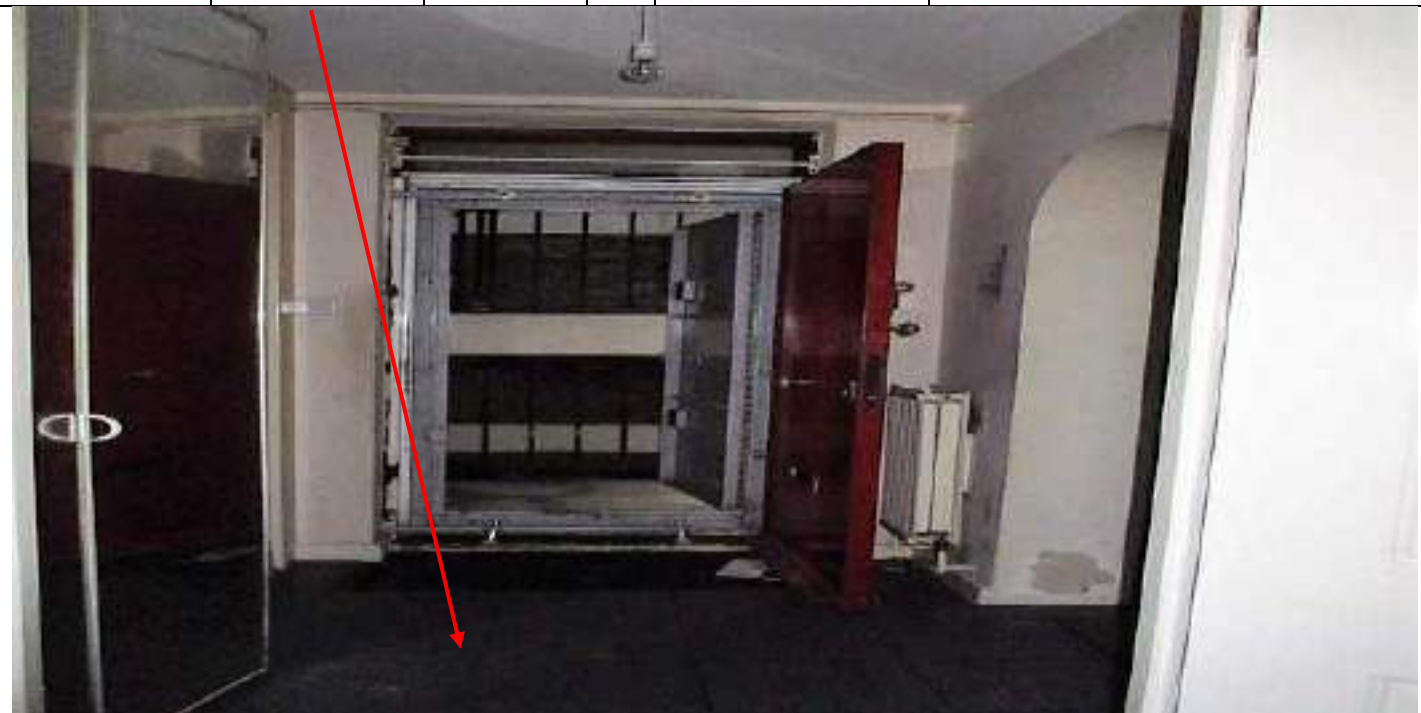
<i>Environmental Inspection Record</i>				FRAMPTON, AGAR GROVE, LONDON, NW1 2SN			
<i>Location</i>		<i>Component</i>			<i>Inspection Ref</i>		
FIRST FLOOR FLAT 8 HALLWAY		CONCRETE CEILING PLASTERED BRICK/BREEZE BLOCK WALLS TIMBER FLOORING OVER ASBESTOS VINYL FLOOR TILES & BITUMEN TO CONCRETE			<i>Surveyor:</i>	PB & MC	
					PICTURE 51 AS SAMPLE 2		
					<i>Date:</i>	19/01/21	
					<i>Survey Type:</i>	REFURBISHMENT/ DEMOLITION SURVEY	
<i>Condition:</i>	FAIR	<i>Access:</i>	EASY		<i>Asbestos?</i>	YES	
					<i>Re Inspection Date:</i>	N/A	
<i>Friability:</i>	LOW	<i>Amount:</i>	APPROX: 5M ²		<i>Type:</i>	CHRYSOTILE TO BOTH	
<i>Damage:</i>	LOW	<i>Exposure:</i>	OCCUPANTS		<i>Analysis:</i>	TILES	<7%
						BITUMEN	<8%
<i>Position:</i>	VINYL FLOOR TILE & BITUMEN	<i>Risk Factor</i>	4	<i>Priority Assessment:</i>	MINOR RISK		
		<i>Risk Band</i>	D

<i>Recommended Action</i>	REMOVE IDENTIFIED ASBESTOS VINYL TILES & ADHESIVE BEFORE DEMOLITION WORKS COMMENCE, USING A COMPETENT CONTRACTOR
----------------------------------	---

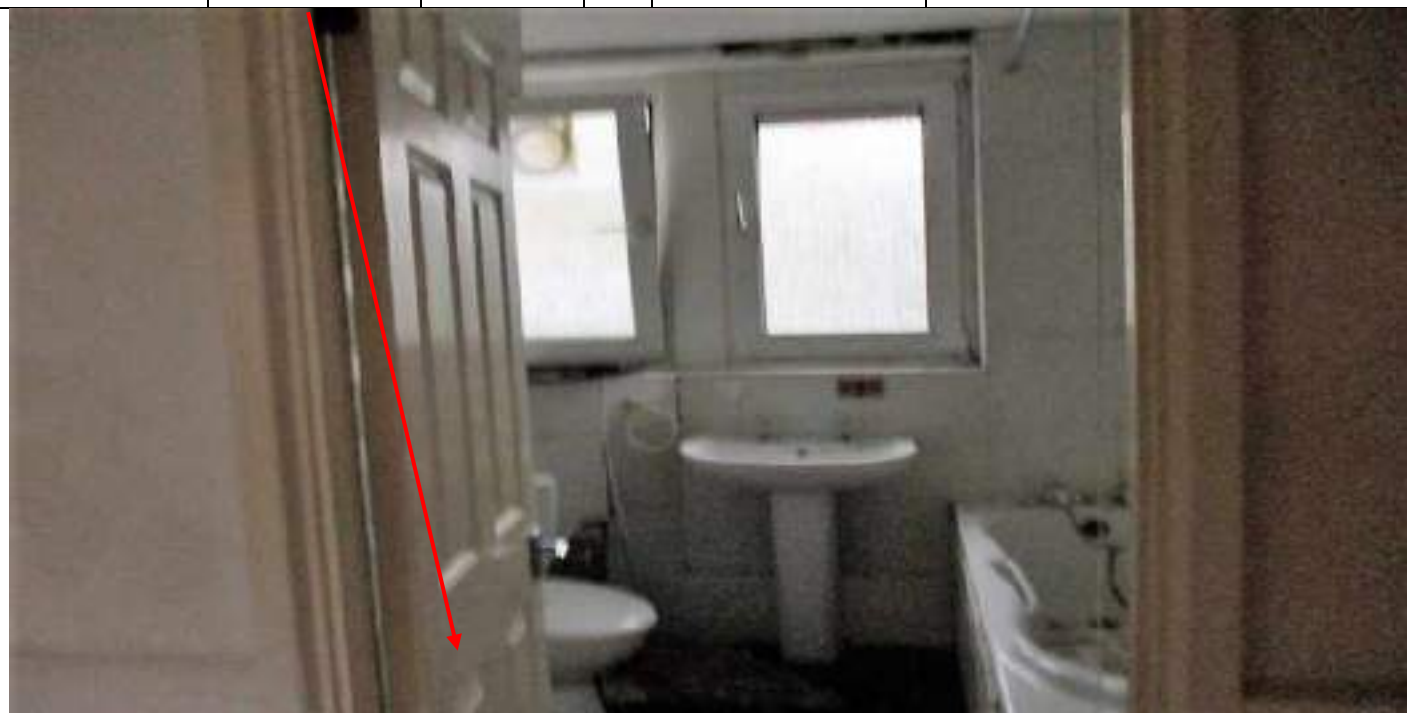
<i>Environmental Inspection Record</i>			FRAMPTON, AGAR GROVE, LONDON, NW1 2SN		
<i>Location</i>		<i>Component</i>		<i>Inspection Ref</i>	
FIRST FLOOR FLAT 8 BATHROOM		CONCRETE CEILING PLASTERED BRICK/BREEZE BLOCK WALLS TIMBER FLOORING OVER ASBESTOS VINYL FLOOR TILES & BITUMEN TO CONCRETE		<i>Surveyor:</i>	PB & MC
				PICTURE 52 AS SAMPLE 2	
				<i>Date:</i>	19/01/21
				<i>Survey Type:</i>	REFURBISHMENT/ DEMOLITION SURVEY
<i>Condition:</i>	FAIR	<i>Access:</i>	EASY	<i>Asbestos?</i>	YES
				<i>Re Inspection Date:</i>	N/A
<i>Friability:</i>	LOW	<i>Amount:</i>	APPROX: 4M ²	<i>Type:</i>	CHRYBOTILE TO BOTH
<i>Damage:</i>	LOW	<i>Exposure:</i>	OCCUPANTS	<i>Analysis:</i>	TILES <7% BITUMEN <8%
<i>Position:</i>	VINYL FLOOR TILE & BITUMEN	<i>Risk Factor</i>	4	<i>Priority Assessment:</i>	MINOR RISK
		<i>Risk Band</i>	D

<i>Recommended Action</i>	REMOVE IDENTIFIED ASBESTOS VINYL TILES & ADHESIVE BEFORE DEMOLITION WORKS COMMENCE, USING A COMPETENT CONTRACTOR
----------------------------------	---

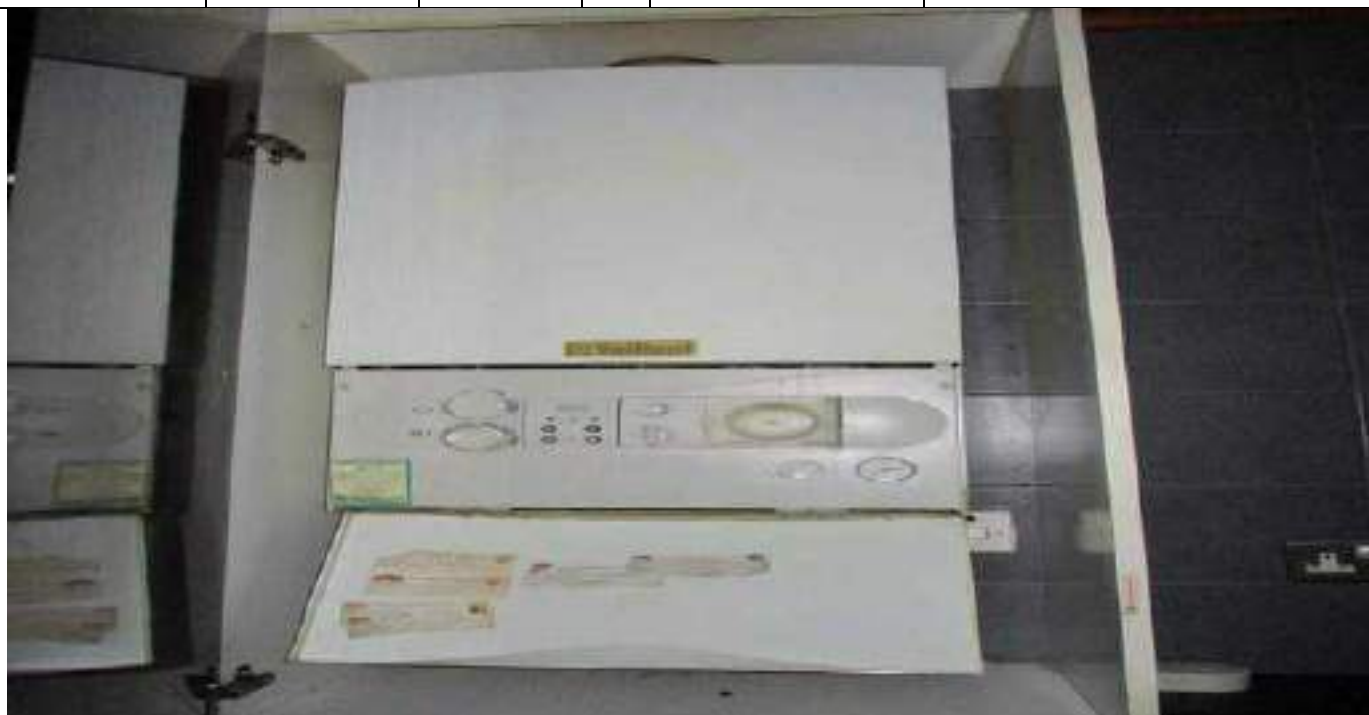
<i>Environmental Inspection Record</i>				FRAMPTON, AGAR GROVE, LONDON, NW1 2SN	
<i>Location</i>		<i>Component</i>		<i>Inspection Ref</i>	
FIRST FLOOR FLAT 8 KITCHEN		BOILER WITH METAL FLUE PIPE		<i>Surveyor:</i>	PB & MC
				PICTURE 53	
				<i>Date:</i>	19/01/21
				<i>Survey Type:</i>	REFURBISHMENT/ DEMOLITION SURVEY
<i>Condition:</i>	N/A	<i>Access:</i>	N/A	<i>Asbestos?</i>	NO
				<i>Re Inspection Date:</i>	N/A
<i>Friability:</i>	N/A	<i>Amount:</i>	N/A	<i>Type:</i>	NON ASBESTOS
<i>Damage:</i>	N/A	<i>Exposure:</i>	N/A	<i>Analysis:</i>	N/A
<i>Position:</i>	CUPBOARD	<i>Risk Factor</i>	0	<i>Priority Assessment:</i>	NO RISK
		<i>Risk Band</i>	E

<i>Recommended Action</i>	NO ASBESTOS MATERIALS IDENTIFIED.
---------------------------	--

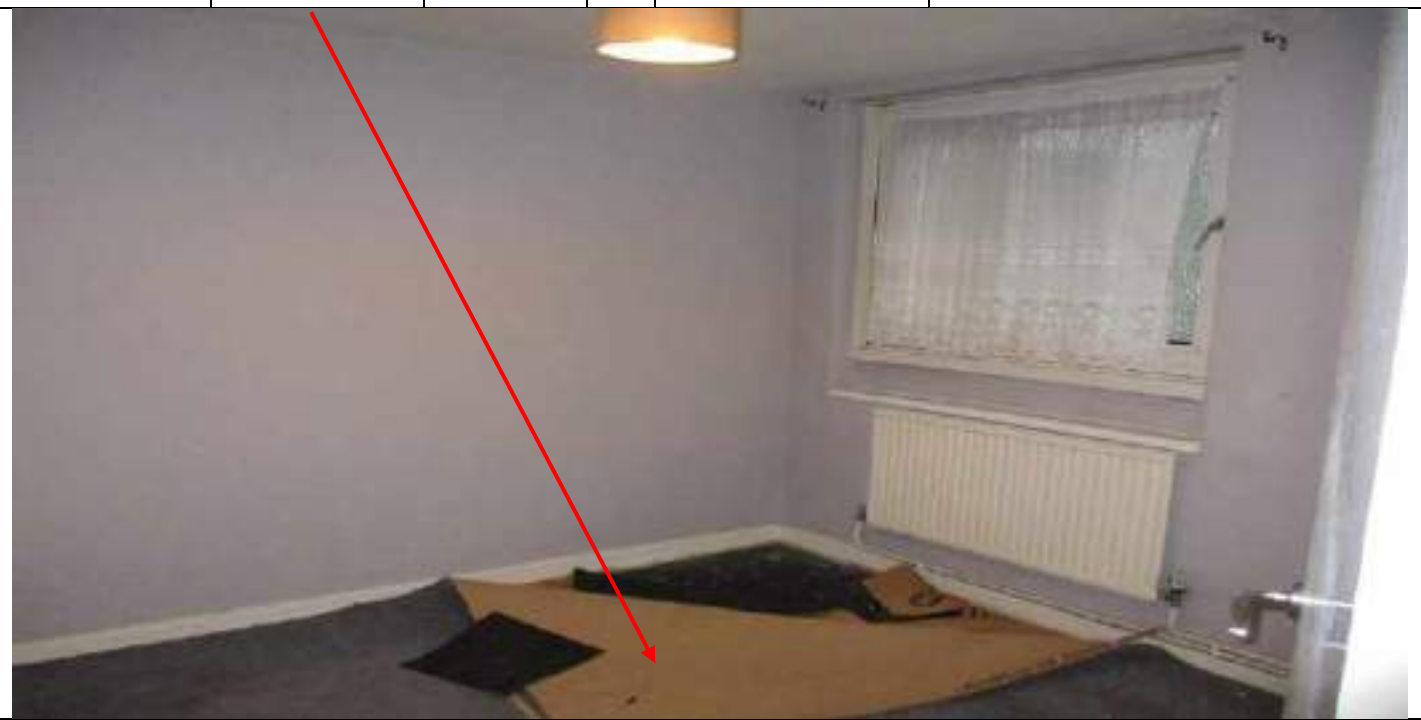
<i>Environmental Inspection Record</i>				FRAMPTON, AGAR GROVE, LONDON, NW1 2SN				
<i>Location</i>		<i>Component</i>			<i>Inspection Ref</i>			
FIRST FLOOR FLAT 7 BEDROOM 3		CONCRETE CEILING PLASTERED BRICK/BREEZE BLOCK WALLS TIMBER FLOORING OVER ASBESTOS VINYL FLOOR TILES & BITUMEN TO CONCRETE			<i>Surveyor:</i>	PB & MC		
					PICTURE 54 AS SAMPLE 2			
					<i>Date:</i>	19/01/21		
					<i>Survey Type:</i>	REFURBISHMENT/ DEMOLITION SURVEY		
<i>Condition:</i>	FAIR	<i>Access:</i>	EASY		<i>Asbestos?</i>	YES		
					<i>Re Inspection Date:</i> N/A			
<i>Friability:</i>	LOW	<i>Amount:</i>	APPROX: 10M ²		<i>Type:</i>	CHRYSOTILE TO BOTH		
<i>Damage:</i>	LOW	<i>Exposure:</i>	OCCUPANTS		<i>Analysis:</i>	TILES	<7%	
					BITUMEN			<8%
<i>Position:</i>	VINYL FLOOR TILE & BITUMEN	<i>Risk Factor</i>	4	<i>Priority Assessment:</i>	MINOR RISK			
		<i>Risk Band</i>	D

<i>Recommended Action</i>	REMOVE IDENTIFIED ASBESTOS VINYL TILES & ADHESIVE BEFORE DEMOLITION WORKS COMMENCE, USING A COMPETENT CONTRACTOR
----------------------------------	---

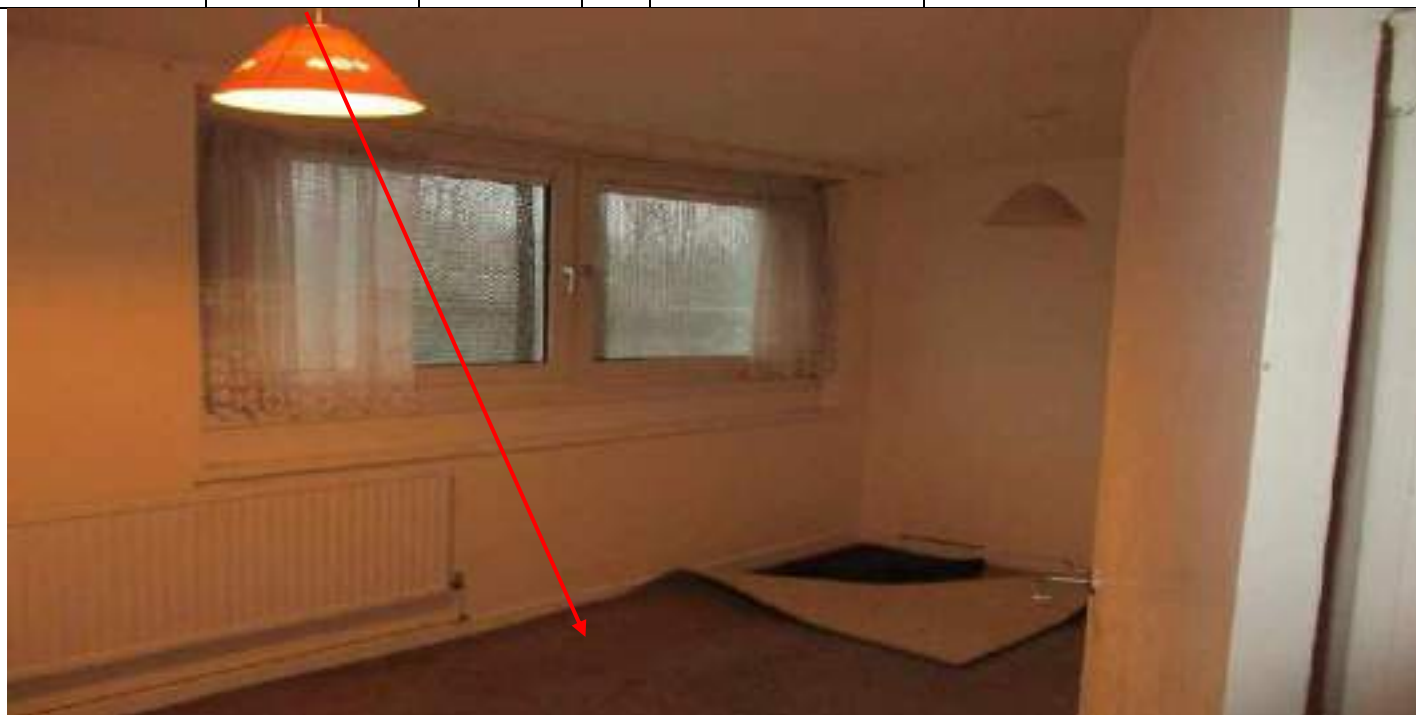
<i>Environmental Inspection Record</i>				FRAMPTON, AGAR GROVE, LONDON, NW1 2SN			
<i>Location</i>		<i>Component</i>			<i>Inspection Ref</i>		
FIRST FLOOR FLAT 7 BEDROOM 2		CONCRETE CEILING PLASTERED BRICK/BREEZE BLOCK WALLS TIMBER FLOORING OVER ASBESTOS VINYL FLOOR TILES & BITUMEN TO CONCRETE			<i>Surveyor:</i>	PB & MC	
					PICTURE 55 AS SAMPLE 2		
					<i>Date:</i>	19/01/21	
					<i>Survey Type:</i>	REFURBISHMENT/ DEMOLITION SURVEY	
<i>Condition:</i>	FAIR	<i>Access:</i>	EASY		<i>Asbestos?</i>	YES	
					<i>Re Inspection Date:</i>	N/A	
<i>Friability:</i>	LOW	<i>Amount:</i>	APPROX: 18M ²		<i>Type:</i>	CHRYBOTILE TO BOTH	
<i>Damage:</i>	LOW	<i>Exposure:</i>	OCCUPANTS		<i>Analysis:</i>	TILES	<7%
						BITUMEN	<8%
<i>Position:</i>	VINYL FLOOR TILE & BITUMEN	<i>Risk Factor</i>	4	<i>Priority Assessment:</i>	MINOR RISK		
		<i>Risk Band</i>	D

<i>Recommended Action</i>	REMOVE IDENTIFIED ASBESTOS VINYL TILES & ADHESIVE BEFORE DEMOLITION WORKS COMMENCE, USING A COMPETENT CONTRACTOR
----------------------------------	---
