APPENDICES

APPENDIX G

Agar Grove noise policy for Demolition works.

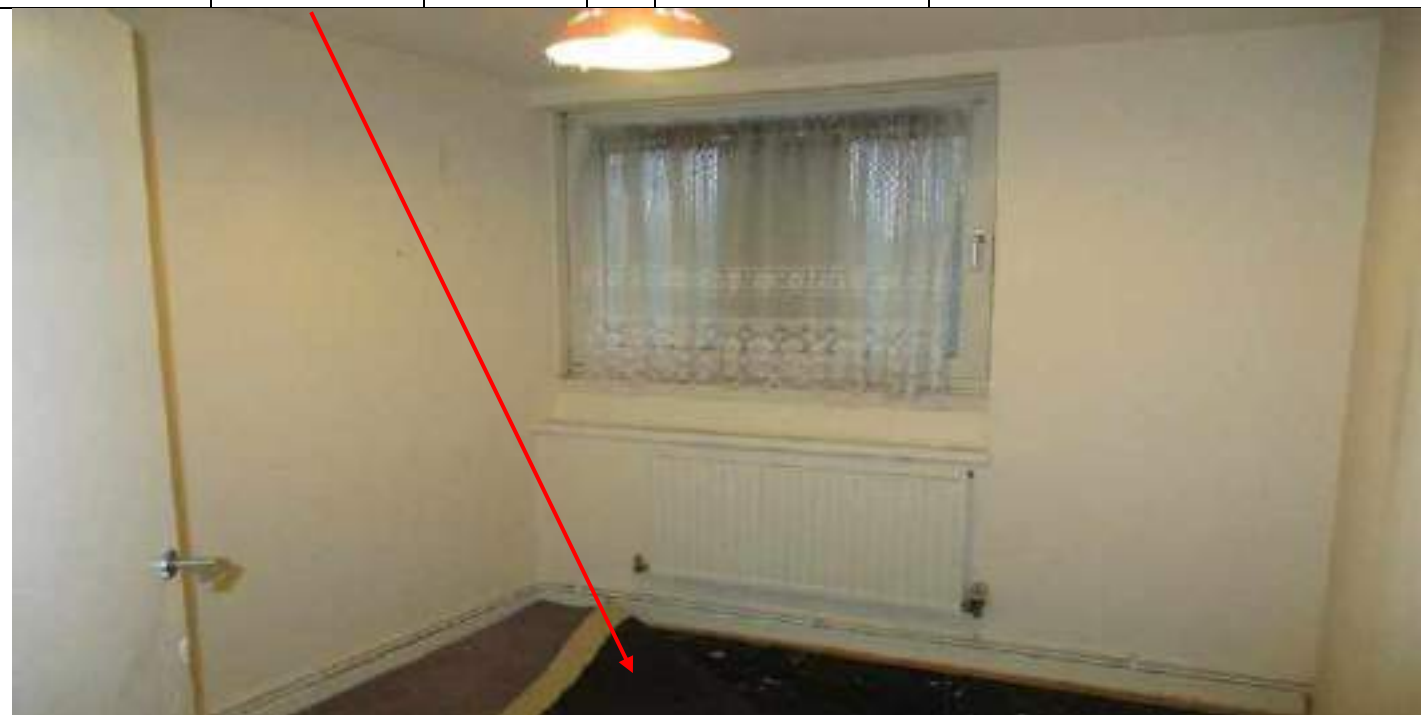
<i>Environmental Inspection Record</i>			FRAMPTON, AGAR GROVE, LONDON, NW1 2SN		
<i>Location</i>		<i>Component</i>		<i>Inspection Ref</i>	
FIRST FLOOR FLAT 7 BEDROOM 1		CONCRETE CEILING PLASTERED BRICK/BREEZE BLOCK WALLS TIMBER FLOORING OVER ASBESTOS VINYL FLOOR TILES & BITUMEN TO CONCRETE		<i>Surveyor:</i>	PB & MC
				PICTURE 56 AS SAMPLE 2	
				<i>Date:</i>	19/01/21
				<i>Survey Type:</i>	REFURBISHMENT/ DEMOLITION SURVEY
<i>Condition:</i>	FAIR	<i>Access:</i>	EASY	<i>Asbestos?</i>	YES
				<i>Re Inspection Date:</i>	N/A
<i>Friability:</i>	LOW	<i>Amount:</i>	APPROX: 6M ²	<i>Type:</i>	CHRYSO TILE TO BOTH
<i>Damage:</i>	LOW	<i>Exposure:</i>	OCCUPANTS	<i>Analysis:</i>	TILES <7% BITUMEN <8%
<i>Position:</i>	VINYL FLOOR TILE & BITUMEN	<i>Risk Factor</i>	4	<i>Priority Assessment:</i>	MINOR RISK
		<i>Risk Band</i>	D

<i>Recommended Action</i>	REMOVE IDENTIFIED ASBESTOS VINYL TILES & ADHESIVE BEFORE DEMOLITION WORKS COMMENCE, USING A COMPETENT CONTRACTOR
----------------------------------	---

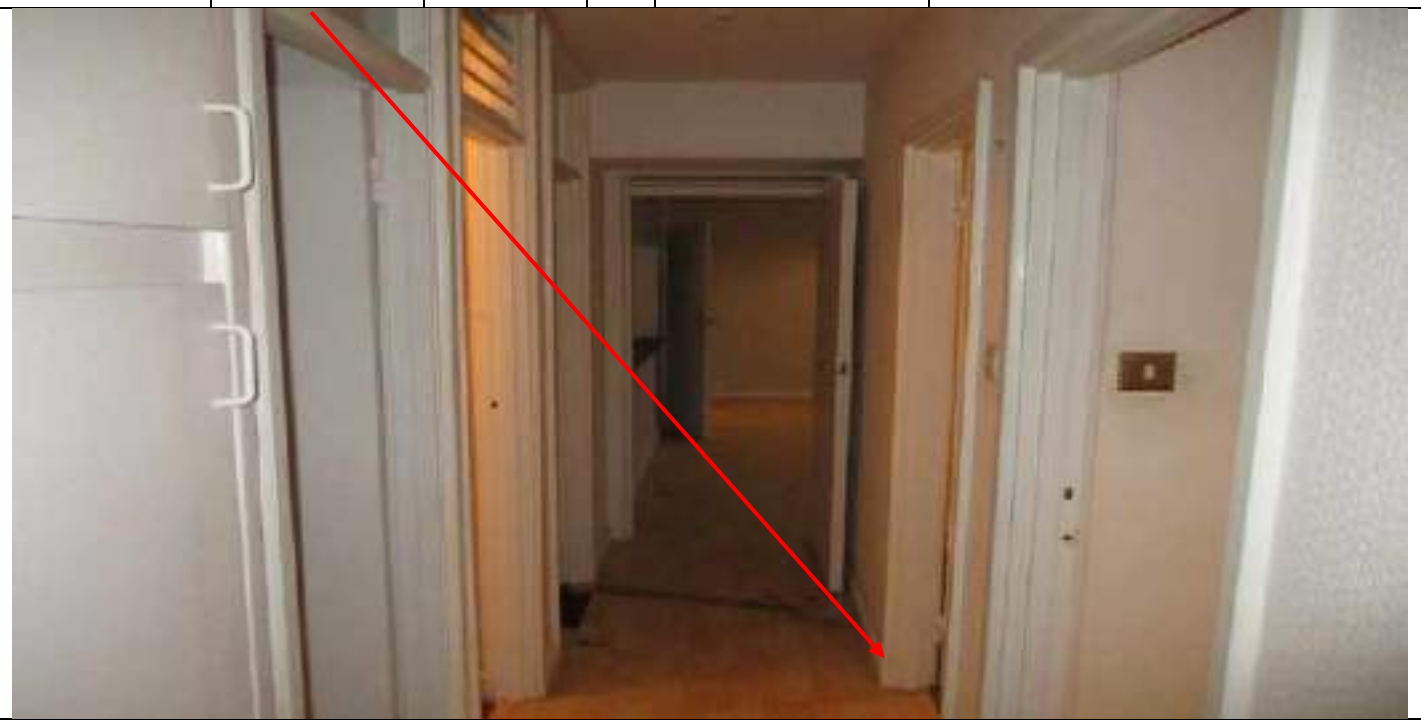
<i>Environmental Inspection Record</i>				FRAMPTON, AGAR GROVE, LONDON, NW1 2SN			
<i>Location</i>		<i>Component</i>			<i>Inspection Ref</i>		
FIRST FLOOR FLAT 7 CORRIDOR		CONCRETE CEILING PLASTERED BRICK/BREEZE BLOCK WALLS TIMBER FLOORING OVER ASBESTOS VINYL FLOOR TILES & BITUMEN TO CONCRETE			<i>Surveyor:</i>	PB & MC	
					PICTURE 57 AS SAMPLE 2		
					<i>Date:</i>	19/01/21	
					<i>Survey Type:</i>	REFURBISHMENT/ DEMOLITION SURVEY	
<i>Condition:</i>	FAIR	<i>Access:</i>	EASY		<i>Asbestos?</i>	YES	
					<i>Re Inspection Date:</i>	N/A	
<i>Friability:</i>	LOW	<i>Amount:</i>	APPROX: 5M ²		<i>Type:</i>	CHRYSO TILE TO BOTH	
<i>Damage:</i>	LOW	<i>Exposure:</i>	OCCUPANTS		<i>Analysis:</i>	TILES	<7%
						BITUMEN	<8%
<i>Position:</i>	VINYL FLOOR TILE & BITUMEN	<i>Risk Factor</i>	4	<i>Priority Assessment:</i>	MINOR RISK		
		<i>Risk Band</i>	D

<i>Recommended Action</i>	REMOVE IDENTIFIED ASBESTOS VINYL TILES & ADHESIVE BEFORE DEMOLITION WORKS COMMENCE, USING A COMPETENT CONTRACTOR
----------------------------------	---

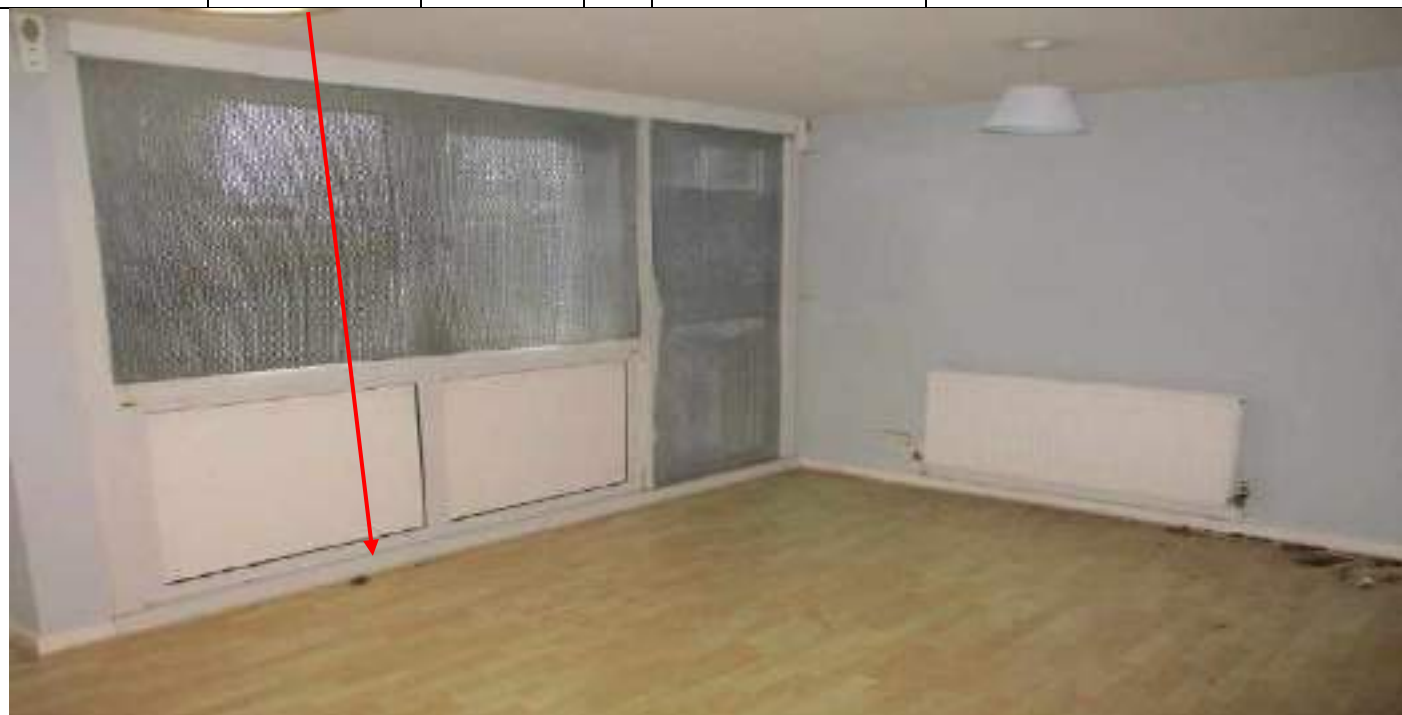
<i>Environmental Inspection Record</i>			FRAMPTON, AGAR GROVE, LONDON, NW1 2SN		
<i>Location</i>		<i>Component</i>		<i>Inspection Ref</i>	
FIRST FLOOR FLAT 7 LOUNGE		CONCRETE CEILING PLASTERED BRICK/BREEZE BLOCK WALLS TIMBER FLOORING OVER ASBESTOS VINYL FLOOR TILES & BITUMEN TO CONCRETE		<i>Surveyor:</i>	PB & MC
				PICTURE 58 AS SAMPLE 2	
				<i>Date:</i>	19/01/21
				<i>Survey Type:</i>	REFURBISHMENT/ DEMOLITION SURVEY
<i>Condition:</i>	FAIR	<i>Access:</i>	EASY	<i>Asbestos?</i>	YES
				<i>Re Inspection Date:</i>	N/A
<i>Friability:</i>	LOW	<i>Amount:</i>	APPROX: 25M ²	<i>Type:</i>	CHRYSO TILE TO BOTH
<i>Damage:</i>	LOW	<i>Exposure:</i>	OCCUPANTS	<i>Analysis:</i>	TILES <7% BITUMEN <8%
<i>Position:</i>	VINYL FLOOR TILE & BITUMEN	<i>Risk Factor</i>	4	<i>Priority Assessment:</i>	MINOR RISK
		<i>Risk Band</i>	D

<i>Recommended Action</i>	REMOVE IDENTIFIED ASBESTOS VINYL TILES & ADHESIVE BEFORE DEMOLITION WORKS COMMENCE, USING A COMPETENT CONTRACTOR
----------------------------------	---

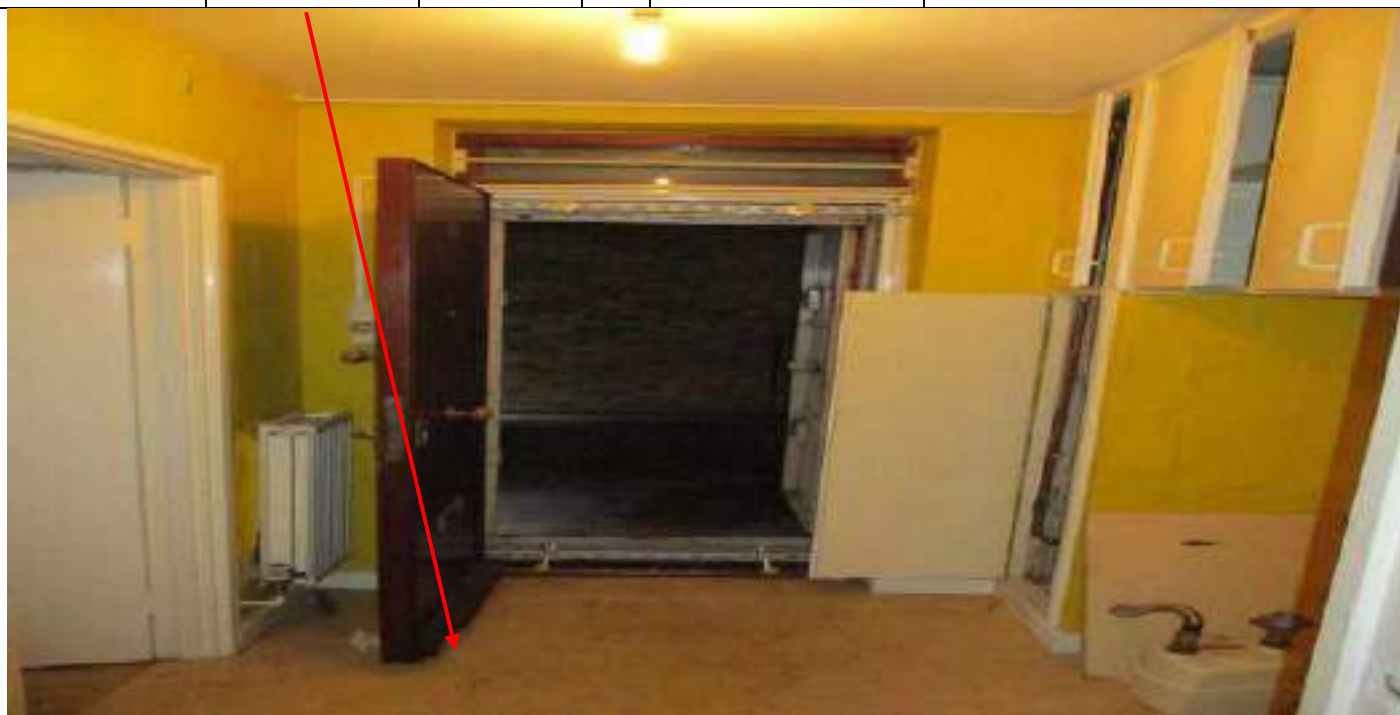
<i>Environmental Inspection Record</i>				FRAMPTON, AGAR GROVE, LONDON, NW1 2SN			
<i>Location</i>		<i>Component</i>			<i>Inspection Ref</i>		
FIRST FLOOR FLAT 7 HALLWAY		CONCRETE CEILING PLASTERED BRICK/BREEZE BLOCK WALLS TIMBER FLOORING OVER ASBESTOS VINYL FLOOR TILES & BITUMEN TO CONCRETE			<i>Surveyor:</i>	PB & MC	
					PICTURE 59 AS SAMPLE 2		
					<i>Date:</i>	19/01/21	
					<i>Survey Type:</i>	REFURBISHMENT/ DEMOLITION SURVEY	
<i>Condition:</i>	FAIR	<i>Access:</i>	EASY		<i>Asbestos?</i>	YES	
					<i>Re Inspection Date:</i>	N/A	
<i>Friability:</i>	LOW	<i>Amount:</i>	APPROX: 5M ²		<i>Type:</i>	CHRYSOTILE TO BOTH	
<i>Damage:</i>	LOW	<i>Exposure:</i>	OCCUPANTS		<i>Analysis:</i>	TILES	<7%
						BITUMEN	<8%
<i>Position:</i>	VINYL FLOOR TILE & BITUMEN	<i>Risk Factor</i>	4	<i>Priority Assessment:</i>	MINOR RISK		
		<i>Risk Band</i>	D

<i>Recommended Action</i>	REMOVE IDENTIFIED ASBESTOS VINYL TILES & ADHESIVE BEFORE DEMOLITION WORKS COMMENCE, USING A COMPETENT CONTRACTOR
----------------------------------	---

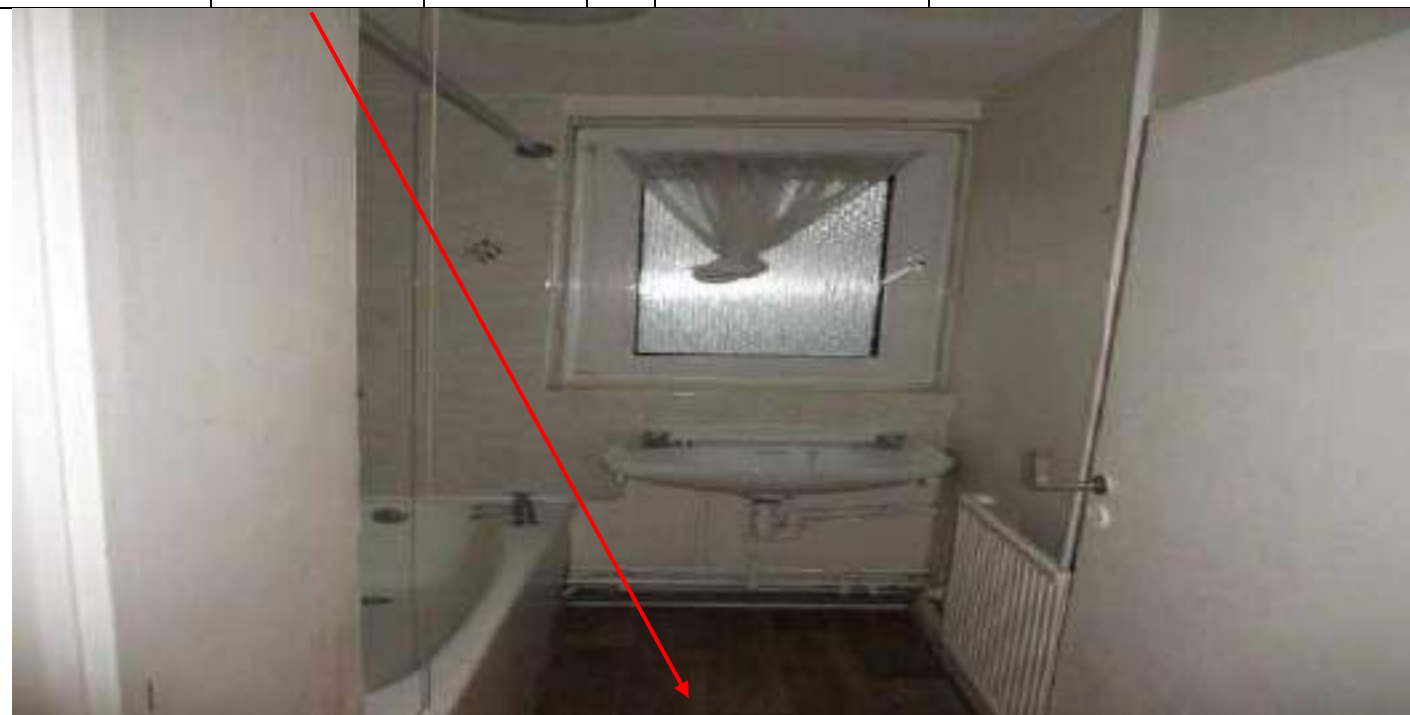
<i>Environmental Inspection Record</i>			FRAMPTON, AGAR GROVE, LONDON, NW1 2SN		
<i>Location</i>		<i>Component</i>		<i>Inspection Ref</i>	
FIRST FLOOR FLAT 7 BATHROOM		CONCRETE CEILING CERAMIC TILES TO PLASTERED BRICK/BREEZE BLOCK WALLS TIMBER FLOORING OVER ASBESTOS VINYL FLOOR TILES & BITUMEN TO CONCRETE		<i>Surveyor:</i>	PB & MC
				PICTURE 60 AS SAMPLE 2	
				<i>Date:</i>	19/01/21
				<i>Survey Type:</i>	REFURBISHMENT/ DEMOLITION SURVEY
<i>Condition:</i>	FAIR	<i>Access:</i>	EASY	<i>Asbestos?</i>	YES
				<i>Re Inspection Date:</i>	N/A
<i>Friability:</i>	LOW	<i>Amount:</i>	APPROX: 2M ²	<i>Type:</i>	CHRYBOTILE TO BOTH
<i>Damage:</i>	LOW	<i>Exposure:</i>	OCCUPANTS	<i>Analysis:</i>	TILES <7% BITUMEN <8%
<i>Position:</i>	VINYL FLOOR TILE & BITUMEN	<i>Risk Factor</i>	4	<i>Priority Assessment:</i>	MINOR RISK
		<i>Risk Band</i>	D

<i>Recommended Action</i>	REMOVE IDENTIFIED ASBESTOS VINYL TILES & ADHESIVE BEFORE DEMOLITION WORKS COMMENCE, USING A COMPETENT CONTRACTOR
----------------------------------	---

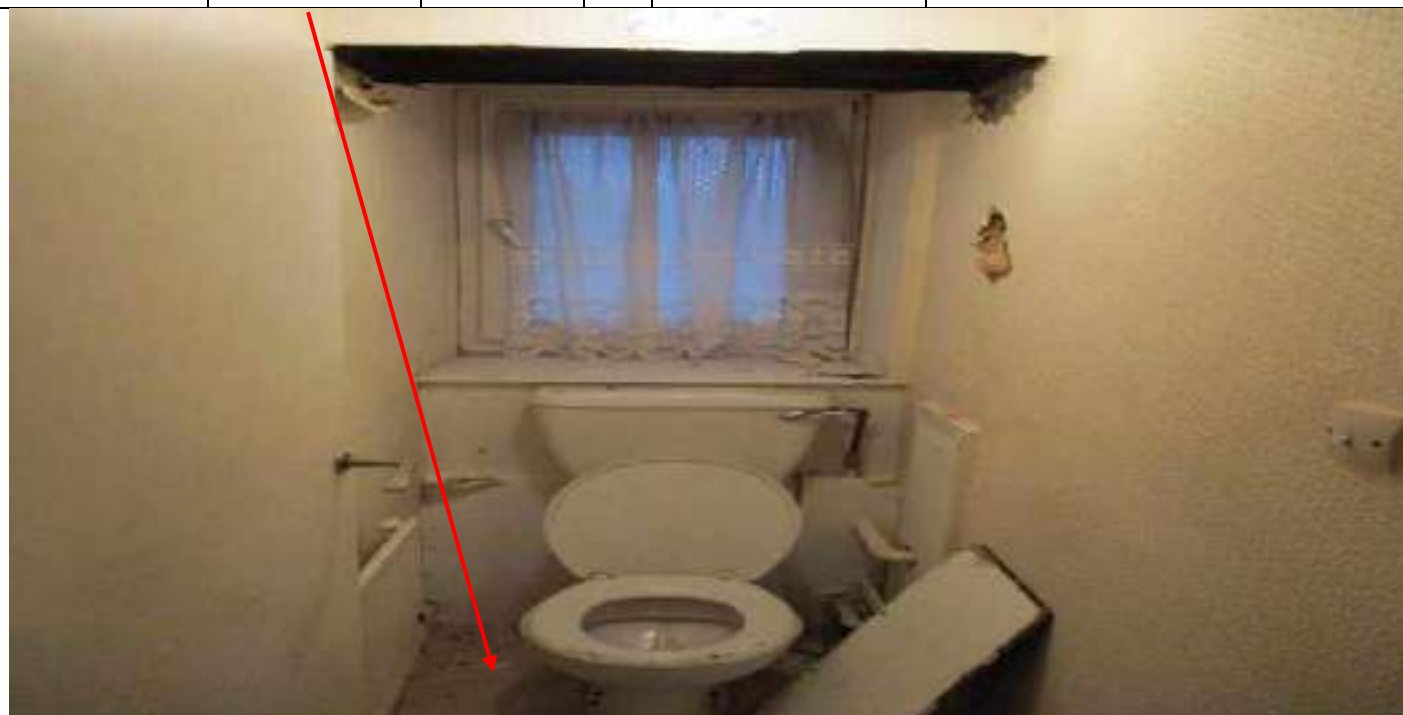
<i>Environmental Inspection Record</i>				FRAMPTON, AGAR GROVE, LONDON, NW1 2SN						
<i>Location</i>		<i>Component</i>			<i>Inspection Ref</i>					
FIRST FLOOR FLAT 7 WC		CONCRETE CEILING CERAMIC TILES TO PLASTERED BRICK/BREEZE BLOCK WALLS TIMBER FLOORING OVER ASBESTOS VINYL FLOOR TILES & BITUMEN TO CONCRETE			<i>Surveyor:</i>		PB & MC			
					PICTURE 61 AS SAMPLE 2					
					<i>Date:</i>		19/01/21			
					<i>Survey Type:</i>		REFURBISHMENT/ DEMOLITION SURVEY			
<i>Condition:</i>	FAIR	<i>Access:</i>	EASY			<i>Asbestos?</i>	YES			
						<i>Re Inspection Date:</i>	N/A			
<i>Friability:</i>	LOW	<i>Amount:</i>	APPROX: 2M ²			<i>Type:</i>	CHRYBOTILE TO BOTH			
<i>Damage:</i>	LOW	<i>Exposure:</i>	OCCUPANTS			<i>Analysis:</i>	TILES <7% BITUMEN <8%			
<i>Position:</i>	VINYL FLOOR TILE & BITUMEN	<i>Risk Factor</i>	4	<i>Priority Assessment:</i>		MINOR RISK				
		<i>Risk Band</i>	D

<i>Recommended Action</i>	REMOVE IDENTIFIED ASBESTOS VINYL TILES & ADHESIVE BEFORE DEMOLITION WORKS COMMENCE, USING A COMPETENT CONTRACTOR
----------------------------------	---

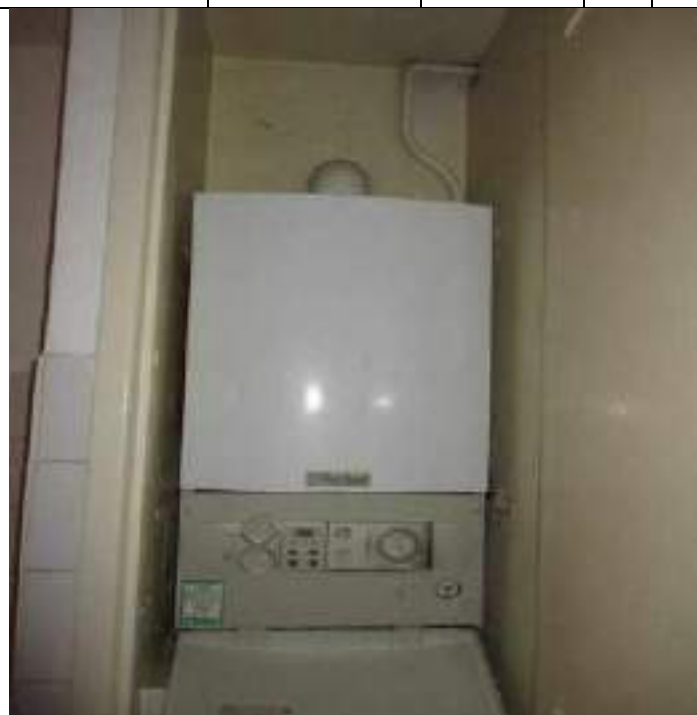
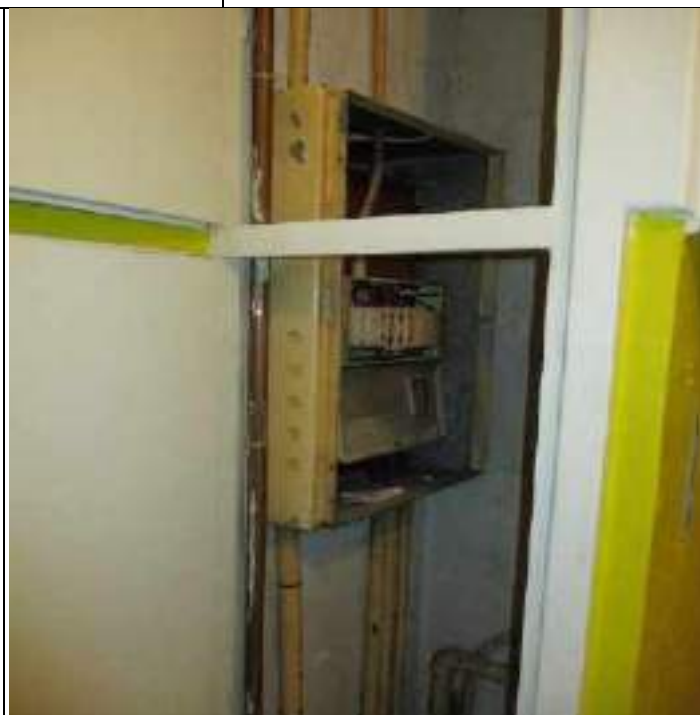
<i>Environmental Inspection Record</i>				FRAMPTON, AGAR GROVE, LONDON, NW1 2SN	
<i>Location</i>		<i>Component</i>		<i>Inspection Ref</i>	
FIRST FLOOR FLAT 7 KITCHEN		BOILER WITH METAL FLUE PIPE ELECTRICAL FUSE BOARD		<i>Surveyor:</i>	PB & MC
				PICTURE 62 & 63	
				<i>Date:</i>	19/01/21
				<i>Survey Type:</i>	REFURBISHMENT/ DEMOLITION SURVEY
<i>Condition:</i>	N/A	<i>Access:</i>	N/A	<i>Asbestos?</i>	NO
				<i>Re Inspection Date:</i>	N/A
<i>Friability:</i>	N/A	<i>Amount:</i>	N/A	<i>Type:</i>	NON ASBESTOS
<i>Damage:</i>	N/A	<i>Exposure:</i>	N/A	<i>Analysis:</i>	N/A
<i>Position:</i>	CUPBOARD	<i>Risk Factor</i>	0	<i>Priority Assessment:</i>	NO RISK
		<i>Risk Band</i>	E

<i>Recommended Action</i>	NO ASBESTOS MATERIALS IDENTIFIED.
---------------------------	--

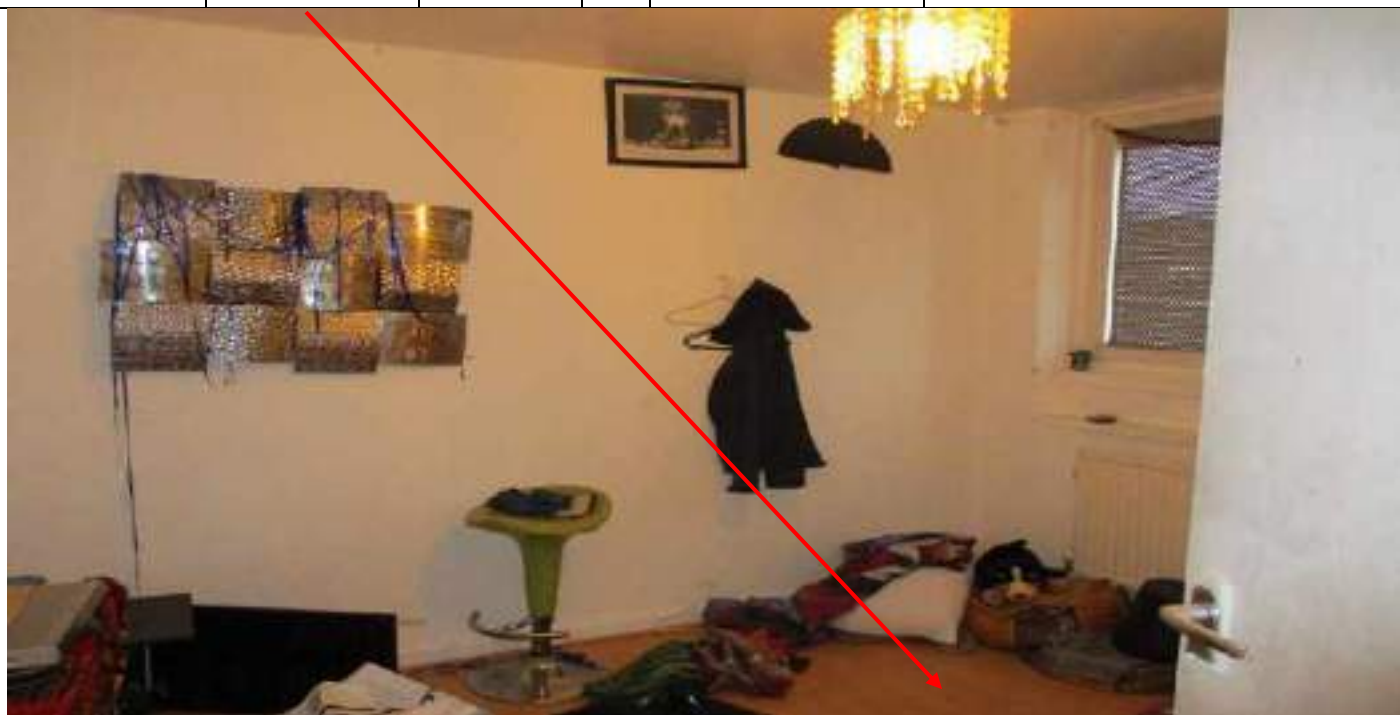
<i>Environmental Inspection Record</i>				FRAMPTON, AGAR GROVE, LONDON, NW1 2SN					
<i>Location</i>		<i>Component</i>			<i>Inspection Ref</i>				
SECOND FLOOR FLAT 11 BEDROOM 3		NON-ASBESTOS TEXTURED COATING TO PLASTERBOARD CEILING TO TIMBER JOISTS PLASTERED BRICK/BREEZE BLOCK WALLS TIMBER FLOORING OVER ASBESTOS VINYL FLOOR TILES & BITUMEN TO CONCRETE			Surveyor:		PB & MC		
					PICTURE 64 AS SAMPLE 2				
					Date:		19/01/21		
					Survey Type:		REFURBISHMENT/ DEMOLITION SURVEY		
Condition:	FAIR	Access:	EASY		Asbestos?		YES		
					Re Inspection Date:		N/A		
Friability:	LOW	Amount:	APPROX: 10M ²		Type:	CHRYSOTILE TO BOTH			
Damage:	LOW	Exposure:	OCCUPANTS		Analysis:	TILES	<7%		
						BITUMEN	<8%		
Position:	VINYL FLOOR TILE & BITUMEN	Risk Factor	4	Priority Assessment:	MINOR RISK				
		Risk Band	D

Recommended Action	REMOVE IDENTIFIED ASBESTOS VINYL TILES & ADHESIVE BEFORE DEMOLITION WORKS COMMENCE, USING A COMPETENT CONTRACTOR
---------------------------	---

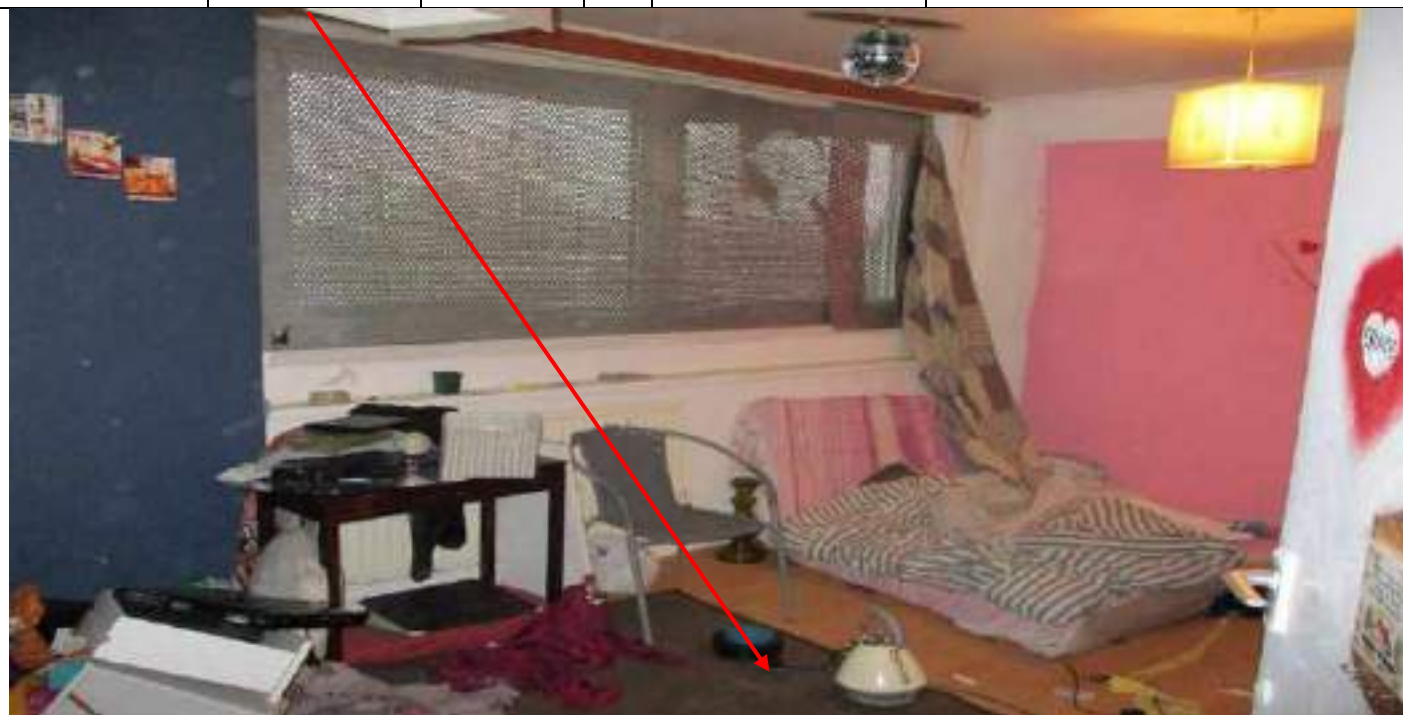
<i>Environmental Inspection Record</i>				FRAMPTON, AGAR GROVE, LONDON, NW1 2SN						
<i>Location</i>		<i>Component</i>			<i>Inspection Ref</i>					
SECOND FLOOR FLAT 11 BEDROOM 2		NON-ASBESTOS TEXTURED COATING TO PLASTERBOARD CEILING TO TIMBER JOISTS PLASTERED BRICK/BREEZE BLOCK WALLS CARPET & TIMBER FLOORING OVER ASBESTOS VINYL FLOOR TILES & BITUMEN TO CONCRETE			Surveyor:		PB & MC			
					PICTURE 65 AS SAMPLE 2					
					Date:		19/01/21			
					Survey Type:		REFURBISHMENT/ DEMOLITION SURVEY			
Condition:	FAIR	Access:	EASY		Asbestos?		YES			
						Re Inspection Date: N/A				
Friability:	LOW	Amount:	APPROX: 18M ²		Type:	CHRYBOTILE TO BOTH				
Damage:	LOW	Exposure:	OCCUPANTS		Analysis:	TILES	<7%			
						BITUMEN	<8%			
Position:	VINYL FLOOR TILE & BITUMEN	Risk Factor	4	Priority Assessment:	MINOR RISK					
		Risk Band	D

Recommended Action	REMOVE IDENTIFIED ASBESTOS VINYL TILES & ADHESIVE BEFORE DEMOLITION WORKS COMMENCE, USING A COMPETENT CONTRACTOR
---------------------------	---

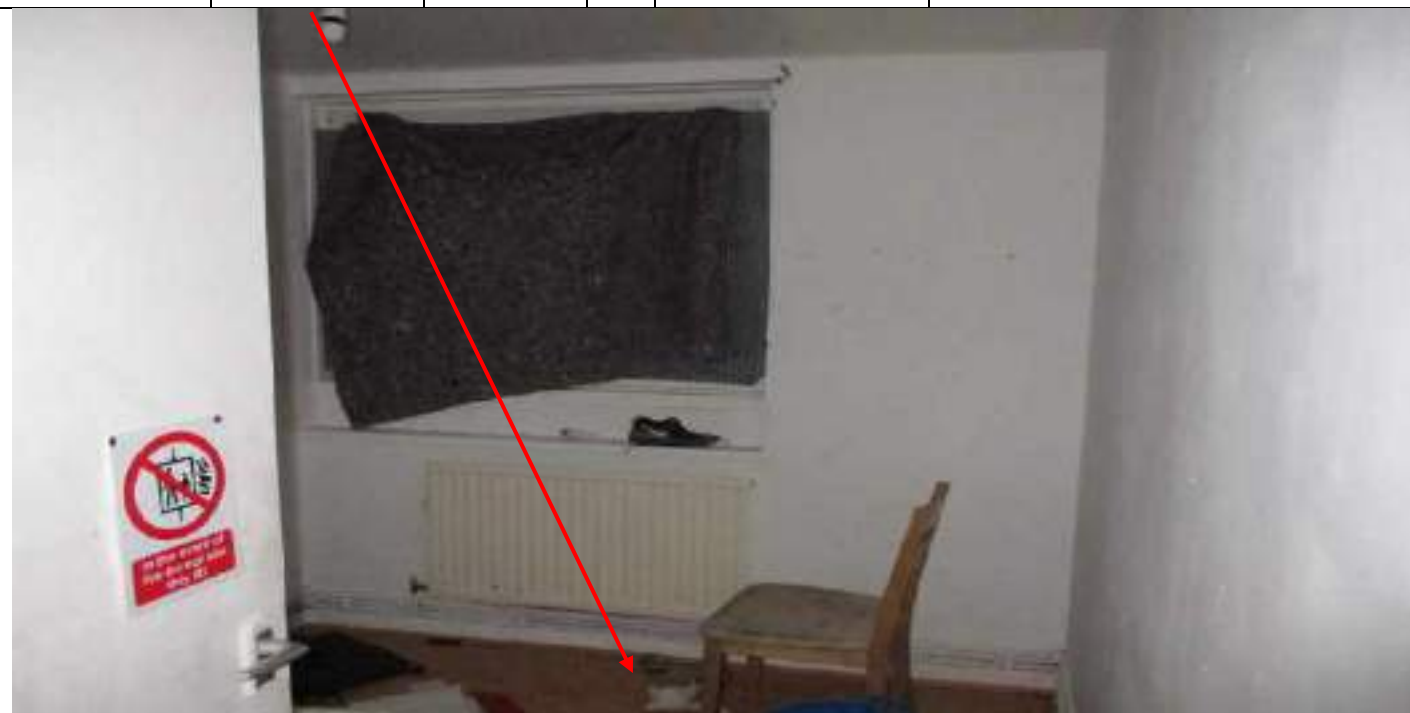
<i>Environmental Inspection Record</i>			FRAMPTON, AGAR GROVE, LONDON, NW1 2SN						
<i>Location</i>		<i>Component</i>		<i>Inspection Ref</i>					
SECOND FLOOR FLAT 11 BEDROOM 1		NON-ASBESTOS TEXTURED COATING TO PLASTERBOARD CEILING TO TIMBER JOISTS PLASTERED BRICK/BREEZE BLOCK WALLS TIMBER FLOORING OVER ASBESTOS VINYL FLOOR TILES & BITUMEN TO CONCRETE		<i>Surveyor:</i>	PB & MC				
				PICTURE 66 AS SAMPLE 2					
				<i>Date:</i>	19/01/21				
				<i>Survey Type:</i>	REFURBISHMENT/ DEMOLITION SURVEY				
<i>Condition:</i>	FAIR	<i>Access:</i>	EASY	<i>Asbestos?</i>	YES				
				<i>Re Inspection Date:</i>	N/A				
<i>Friability:</i>	LOW	<i>Amount:</i>	APPROX: 6M ²	<i>Type:</i>	CHRYBOTILE TO BOTH				
<i>Damage:</i>	LOW	<i>Exposure:</i>	OCCUPANTS	<i>Analysis:</i>	<table border="1"> <tr> <td>TILES</td> <td><7%</td> </tr> <tr> <td>BITUMEN</td> <td><8%</td> </tr> </table>	TILES	<7%	BITUMEN	<8%
TILES	<7%								
BITUMEN	<8%								
<i>Position:</i>	VINYL FLOOR TILE & BITUMEN	<i>Risk Factor</i>	4	<i>Priority Assessment:</i>	MINOR RISK				
		<i>Risk Band</i>	D

<i>Recommended Action</i>	REMOVE IDENTIFIED ASBESTOS VINYL TILES & ADHESIVE BEFORE DEMOLITION WORKS COMMENCE, USING A COMPETENT CONTRACTOR
----------------------------------	---

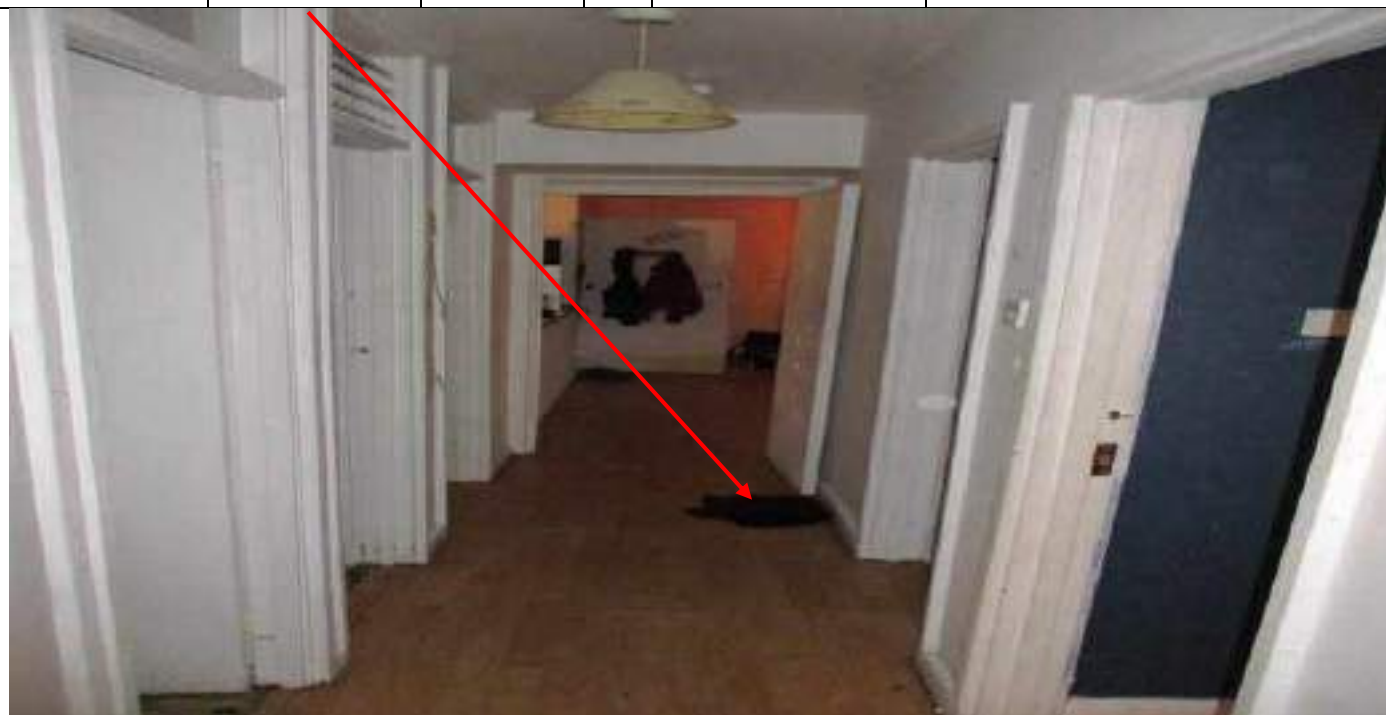
<i>Environmental Inspection Record</i>			FRAMPTON, AGAR GROVE, LONDON, NW1 2SN		
<i>Location</i>		<i>Component</i>		<i>Inspection Ref</i>	
SECOND FLOOR FLAT 11 CORRIDOR		PLASTERBOARD CEILING TO TIMBER JOISTS PLASTERED BRICK/BREEZE BLOCK WALLS TIMBER FLOORING OVER ASBESTOS VINYL FLOOR TILES & BITUMEN TO CONCRETE		<i>Surveyor:</i>	PB & MC
				PICTURE 67 AS SAMPLE 2	
				<i>Date:</i>	19/01/21
				<i>Survey Type:</i>	REFURBISHMENT/ DEMOLITION SURVEY
<i>Condition:</i>	FAIR	<i>Access:</i>	EASY	<i>Asbestos?</i>	YES
				<i>Re Inspection Date:</i>	N/A
<i>Friability:</i>	LOW	<i>Amount:</i>	APPROX: 5M ²	<i>Type:</i>	CHRYBOTILE TO BOTH
<i>Damage:</i>	LOW	<i>Exposure:</i>	OCCUPANTS	<i>Analysis:</i>	TILES <7% BITUMEN <8%
<i>Position:</i>	VINYL FLOOR TILE & BITUMEN	<i>Risk Factor</i>	4	<i>Priority Assessment:</i>	MINOR RISK
		<i>Risk Band</i>	D

<i>Recommended Action</i>	REMOVE IDENTIFIED ASBESTOS VINYL TILES & ADHESIVE BEFORE DEMOLITION WORKS COMMENCE, USING A COMPETENT CONTRACTOR
----------------------------------	---

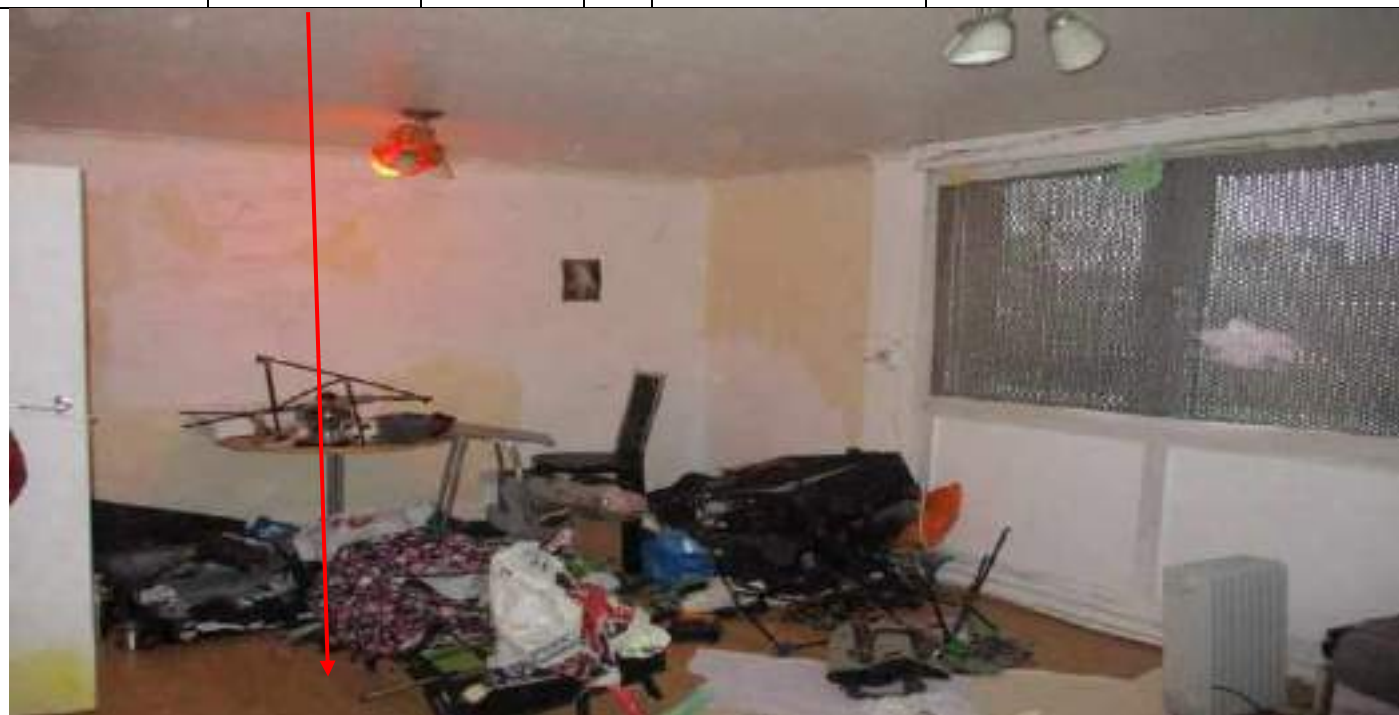
<i>Environmental Inspection Record</i>				FRAMPTON, AGAR GROVE, LONDON, NW1 2SN						
<i>Location</i>		<i>Component</i>			<i>Inspection Ref</i>					
SECOND FLOOR FLAT 11 LOUNGE		PLASTERBOARD CEILING TO TIMBER JOISTS PLASTERED BRICK/BREEZE BLOCK WALLS TIMBER FLOORING OVER ASBESTOS VINYL FLOOR TILES & BITUMEN TO CONCRETE			<i>Surveyor:</i>		PB & MC			
					PICTURE 68 AS SAMPLE 2					
					<i>Date:</i>		19/01/21			
					<i>Survey Type:</i>		REFURBISHMENT/ DEMOLITION SURVEY			
<i>Condition:</i>	FAIR	<i>Access:</i>	EASY		<i>Asbestos?</i>		YES			
						<i>Re Inspection Date:</i>		N/A		
<i>Friability:</i>	LOW	<i>Amount:</i>	APPROX: 25M ²		<i>Type:</i>	CHRYSOTILE TO BOTH				
<i>Damage:</i>	LOW	<i>Exposure:</i>	OCCUPANTS		<i>Analysis:</i>	TILES	<7%			
						BITUMEN	<8%			
<i>Position:</i>	VINYL FLOOR TILE & BITUMEN	<i>Risk Factor</i>	4	<i>Priority Assessment:</i>	MINOR RISK					
		<i>Risk Band</i>	D

<i>Recommended Action</i>	REMOVE IDENTIFIED ASBESTOS VINYL TILES & ADHESIVE BEFORE DEMOLITION WORKS COMMENCE, USING A COMPETENT CONTRACTOR
----------------------------------	---

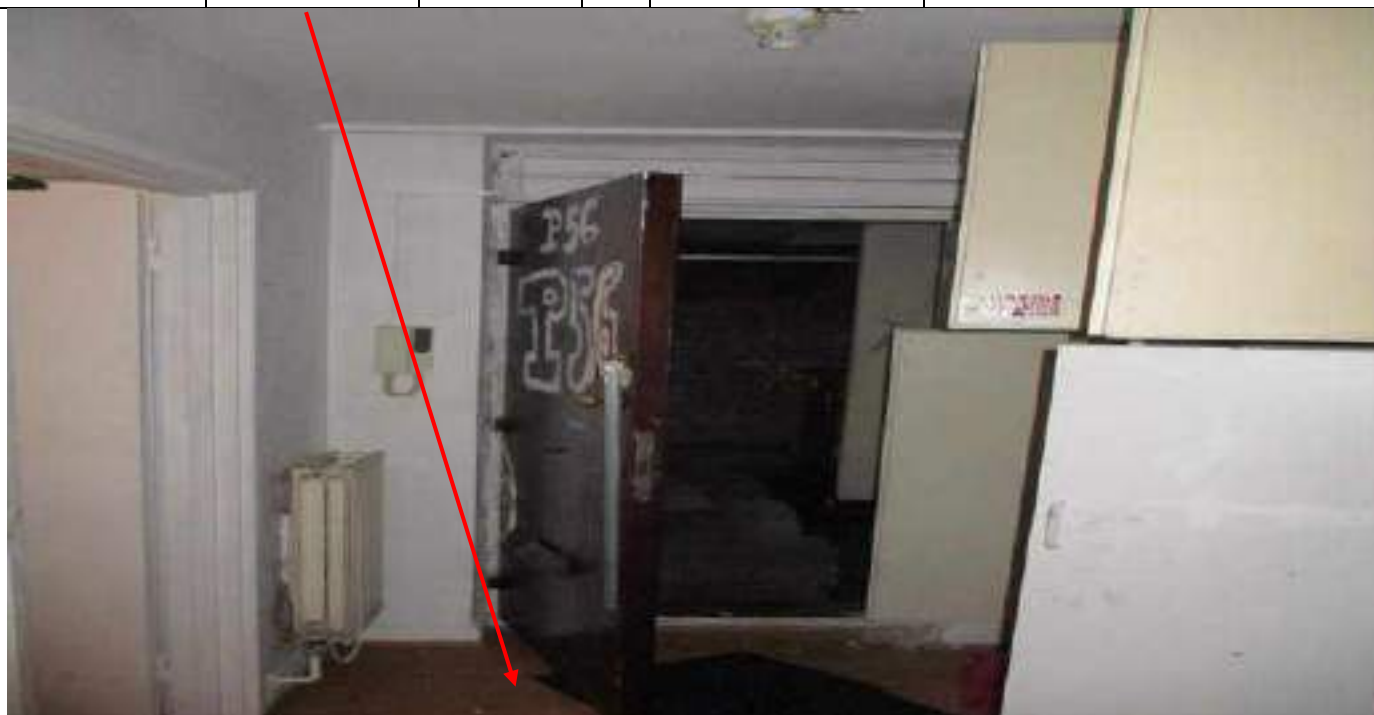
<i>Environmental Inspection Record</i>			FRAMPTON, AGAR GROVE, LONDON, NW1 2SN		
<i>Location</i>		<i>Component</i>		<i>Inspection Ref</i>	
SECOND FLOOR FLAT 11 HALLWAY		PLASTERBOARD CEILING TO TIMBER JOISTS PLASTERED BRICK/BREEZE BLOCK WALLS TIMBER FLOORING OVER ASBESTOS VINYL FLOOR TILES & BITUMEN TO CONCRETE		<i>Surveyor:</i>	PB & MC
				PICTURE 69 AS SAMPLE 2	
				<i>Date:</i>	19/01/21
				<i>Survey Type:</i>	REFURBISHMENT/ DEMOLITION SURVEY
<i>Condition:</i>	FAIR	<i>Access:</i>	EASY	<i>Asbestos?</i>	YES
				<i>Re Inspection Date:</i>	N/A
<i>Friability:</i>	LOW	<i>Amount:</i>	APPROX: 5M ²	<i>Type:</i>	CHRYSO TILE TO BOTH
<i>Damage:</i>	LOW	<i>Exposure:</i>	OCCUPANTS	<i>Analysis:</i>	TILES <7% BITUMEN <8%
<i>Position:</i>	VINYL FLOOR TILE & BITUMEN	<i>Risk Factor</i>	4	<i>Priority Assessment:</i>	MINOR RISK
		<i>Risk Band</i>	D

<i>Recommended Action</i>	REMOVE IDENTIFIED ASBESTOS VINYL TILES & ADHESIVE BEFORE DEMOLITION WORKS COMMENCE, USING A COMPETENT CONTRACTOR
----------------------------------	---

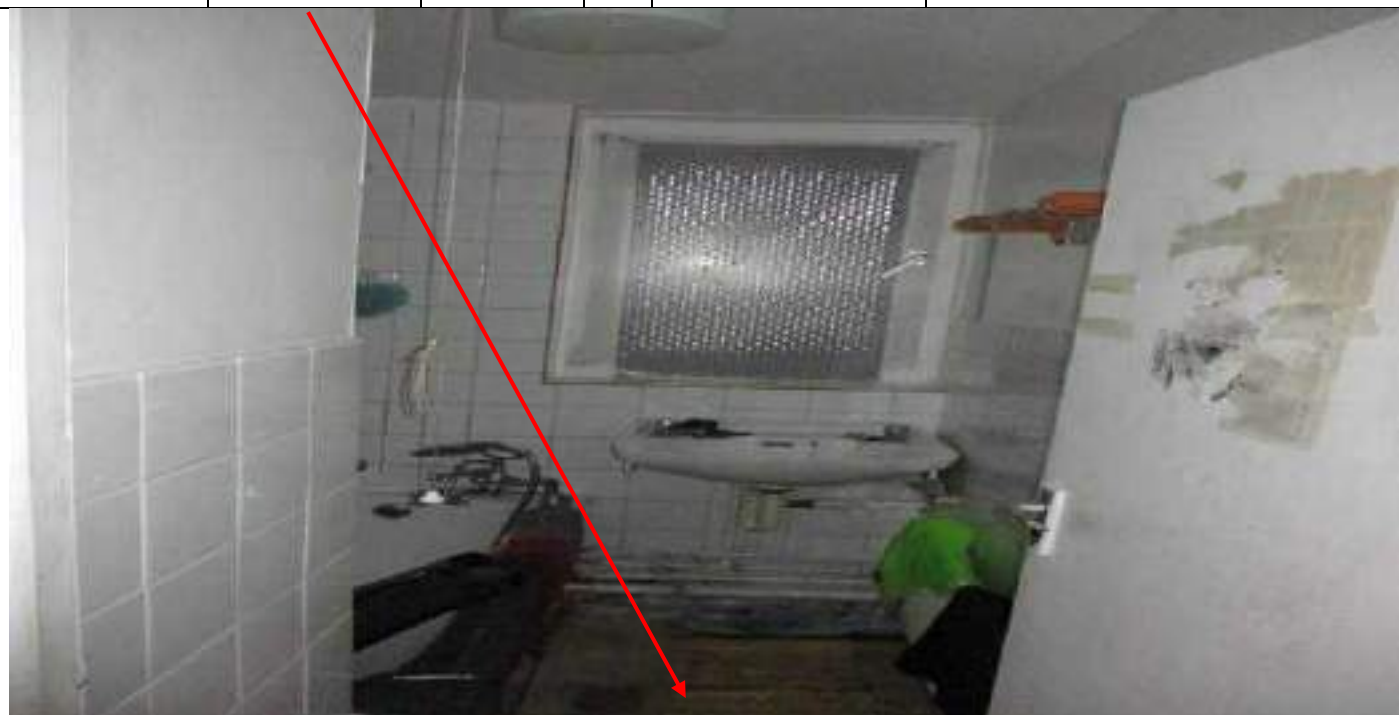
<i>Environmental Inspection Record</i>				FRAMPTON, AGAR GROVE, LONDON, NW1 2SN						
<i>Location</i>		<i>Component</i>			<i>Inspection Ref</i>					
SECOND FLOOR FLAT 11 BATHROOM		PLASTERBOARD CEILING TO TIMBER JOISTS CERAMIC TILES TO PLASTERED BRICK/BREEZE BLOCK WALLS MODERN VINYL FLOOR COVERING OVER ASBESTOS VINYL FLOOR TILES & BITUMEN TO CONCRETE			Surveyor:		PB & MC			
					PICTURE 70 AS SAMPLE 2					
					Date:		19/01/21			
					Survey Type:		REFURBISHMENT/ DEMOLITION SURVEY			
Condition:	FAIR	Access:	EASY		Asbestos?		YES			
						Re Inspection Date:		N/A		
Friability:	LOW	Amount:	APPROX: 2M ²		Type:	CHRYSOTILE TO BOTH				
Damage:	LOW	Exposure:	OCCUPANTS		Analysis:	TILES	<7%			
						BITUMEN	<8%			
Position:	VINYL FLOOR TILE & BITUMEN	Risk Factor	4	Priority Assessment:	MINOR RISK					
		Risk Band	D

Recommended Action	REMOVE IDENTIFIED ASBESTOS VINYL TILES & ADHESIVE BEFORE DEMOLITION WORKS COMMENCE, USING A COMPETENT CONTRACTOR
---------------------------	---

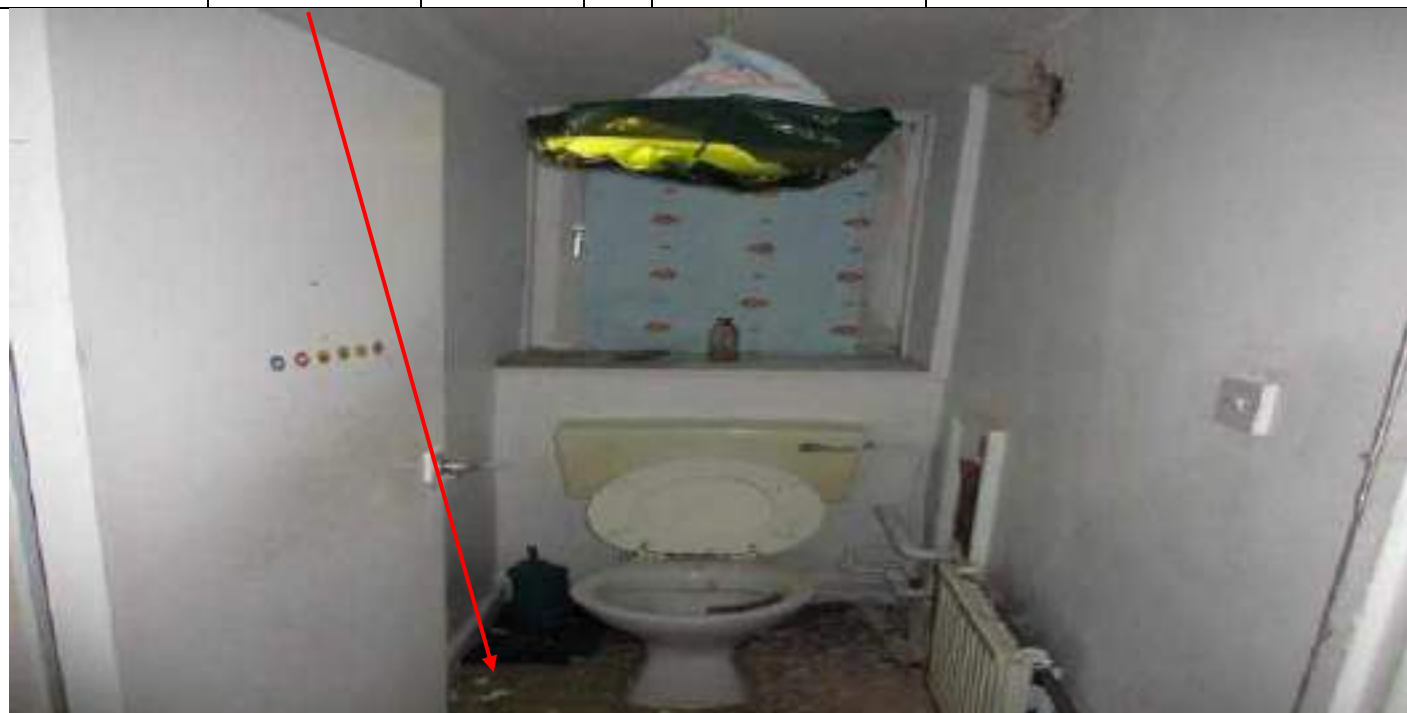
<i>Environmental Inspection Record</i>				FRAMPTON, AGAR GROVE, LONDON, NW1 2SN						
<i>Location</i>		<i>Component</i>			<i>Inspection Ref</i>					
SECOND FLOOR FLAT 11 WC		PLASTERBOARD CEILING TO TIMBER JOISTS CERAMIC TILES TO PLASTERED BRICK/BREEZE BLOCK WALLS MODERN VINYL FLOOR COVERING OVER ASBESTOS VINYL FLOOR TILES & BITUMEN TO CONCRETE			<i>Surveyor:</i>		PB & MC			
					PICTURE 71 AS SAMPLE 2					
					<i>Date:</i>		19/01/21			
					<i>Survey Type:</i>		REFURBISHMENT/ DEMOLITION SURVEY			
<i>Condition:</i>	FAIR	<i>Access:</i>	EASY			<i>Asbestos?</i> YES				
						<i>Re Inspection Date:</i> N/A				
<i>Friability:</i>	LOW	<i>Amount:</i>	APPROX: 2M ²			<i>Type:</i>	CHRYSO TILE TO BOTH			
<i>Damage:</i>	LOW	<i>Exposure:</i>	OCCUPANTS			<i>Analysis:</i>	TILES <7% BITUMEN <8%			
<i>Position:</i>	VINYL FLOOR TILE & BITUMEN	<i>Risk Factor</i>	4	<i>Priority Assessment:</i>		MINOR RISK				
		<i>Risk Band</i>	D

<i>Recommended Action</i>	REMOVE IDENTIFIED ASBESTOS VINYL TILES & ADHESIVE BEFORE DEMOLITION WORKS COMMENCE, USING A COMPETENT CONTRACTOR
----------------------------------	---

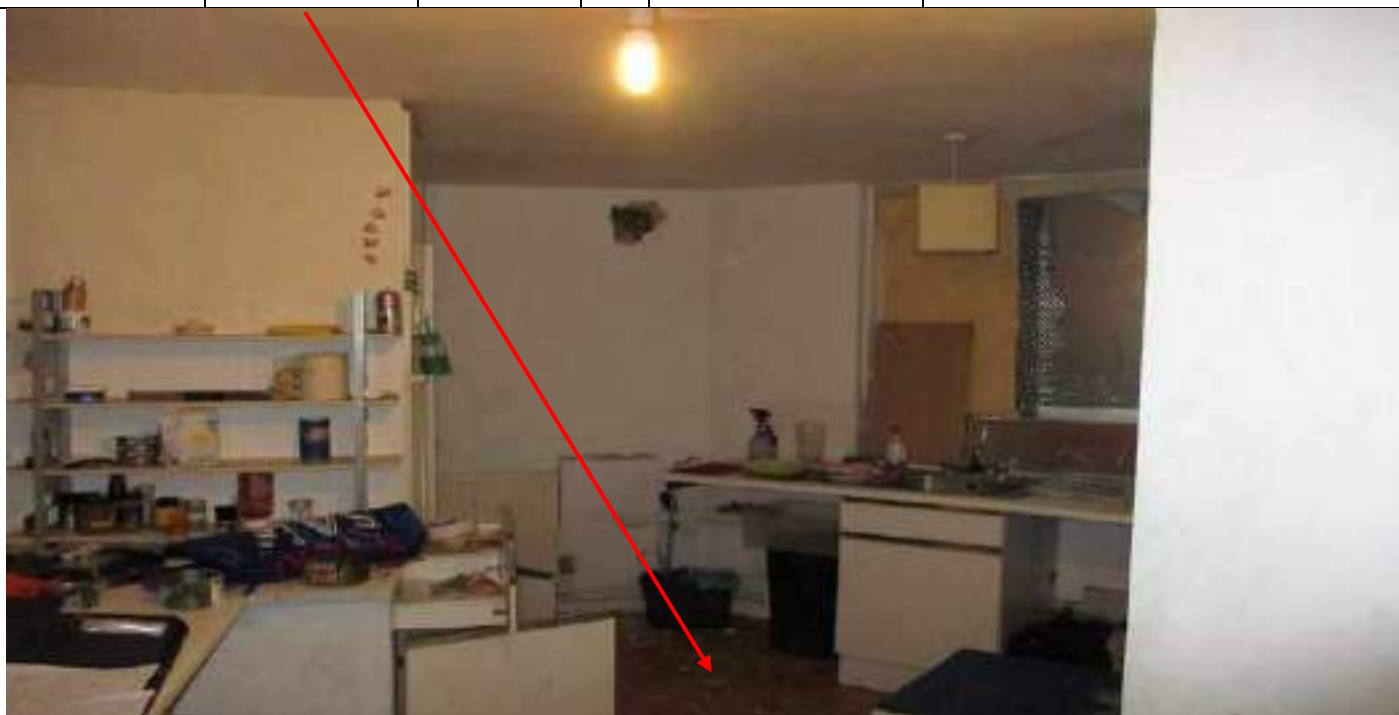
<i>Environmental Inspection Record</i>			FRAMPTON, AGAR GROVE, LONDON, NW1 2SN		
<i>Location</i>		<i>Component</i>		<i>Inspection Ref</i>	
SECOND FLOOR FLAT 11 KITCHEN		PLASTERBOARD CEILING TO TIMBER JOISTS CERAMIC TILES TO PLASTERED BRICK/BREEZE BLOCK WALLS TIMBER FLOORING OVER ASBESTOS VINYL FLOOR TILES & BITUMEN TO CONCRETE		<i>Surveyor:</i>	PB & MC
				PICTURE 72 AS SAMPLE 2	
				<i>Date:</i>	19/01/21
				<i>Survey Type:</i>	REFURBISHMENT/ DEMOLITION SURVEY
<i>Condition:</i>	FAIR	<i>Access:</i>	EASY	<i>Asbestos?</i>	YES
				<i>Re Inspection Date:</i>	N/A
<i>Friability:</i>	LOW	<i>Amount:</i>	APPROX: 12M ²	<i>Type:</i>	CHRYBOTILE TO BOTH
<i>Damage:</i>	LOW	<i>Exposure:</i>	OCCUPANTS	<i>Analysis:</i>	TILES <7% BITUMEN <8%
<i>Position:</i>	VINYL FLOOR TILE & BITUMEN	<i>Risk Factor</i>	4	<i>Priority Assessment:</i>	MINOR RISK
		<i>Risk Band</i>	D

<i>Recommended Action</i>	REMOVE IDENTIFIED ASBESTOS VINYL TILES & ADHESIVE BEFORE DEMOLITION WORKS COMMENCE, USING A COMPETENT CONTRACTOR
---------------------------	---

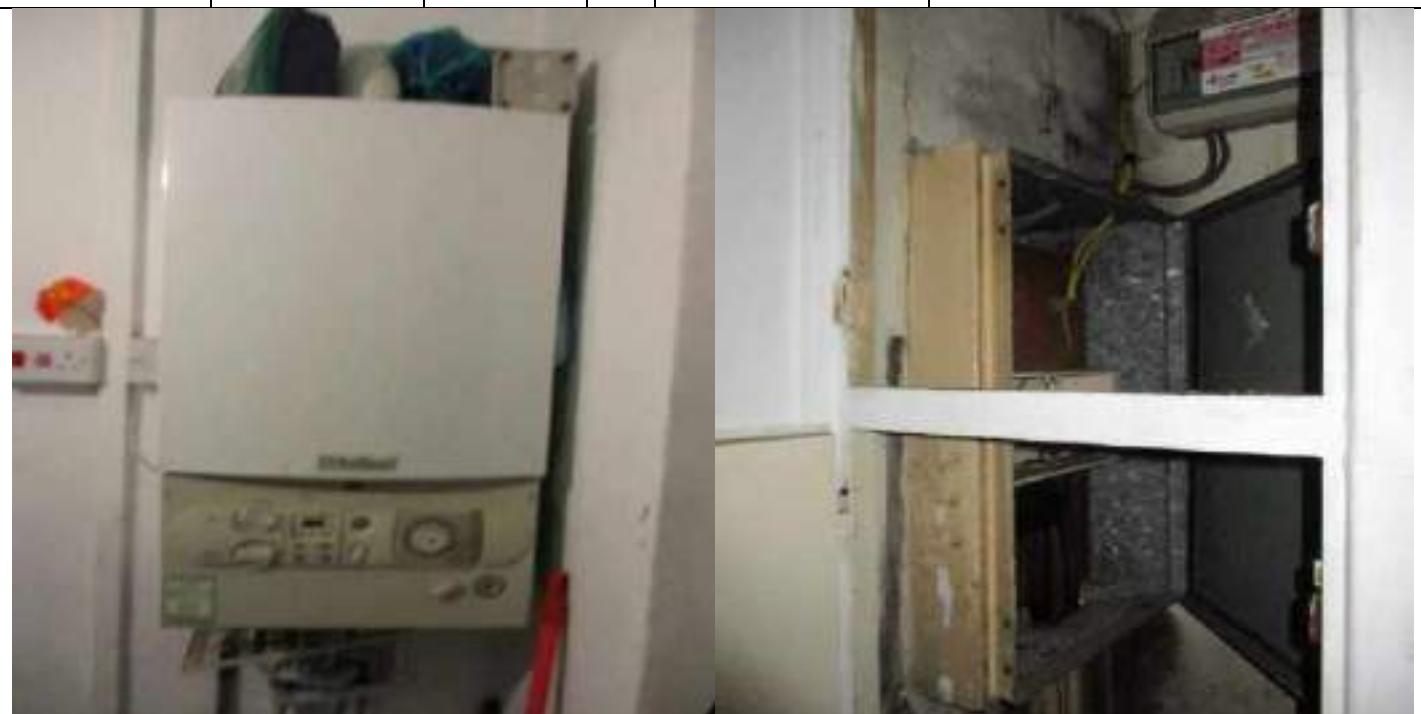
<i>Environmental Inspection Record</i>				FRAMPTON, AGAR GROVE, LONDON, NW1 2SN	
<i>Location</i>		<i>Component</i>		<i>Inspection Ref</i>	
SECOND FLOOR FLAT 11 KITCHEN		BOILER WITH METAL FLUE PIPE ELECTRICAL FUSE BOARD		<i>Surveyor:</i>	PB & MC
				PICTURE 73 & 74	
				<i>Date:</i>	19/01/21
				<i>Survey Type:</i>	REFURBISHMENT/ DEMOLITION SURVEY
<i>Condition:</i>	N/A	<i>Access:</i>	N/A	<i>Asbestos?</i>	NO
				<i>Re Inspection Date:</i>	N/A
<i>Friability:</i>	N/A	<i>Amount:</i>	N/A	<i>Type:</i>	NON ASBESTOS
<i>Damage:</i>	N/A	<i>Exposure:</i>	N/A	<i>Analysis:</i>	N/A
<i>Position:</i>	CUPBOARD	<i>Risk Factor</i>	0	<i>Priority Assessment:</i>	NO RISK
		<i>Risk Band</i>	E		
<i>Recommended Action</i>		NO ASBESTOS MATERIALS IDENTIFIED.

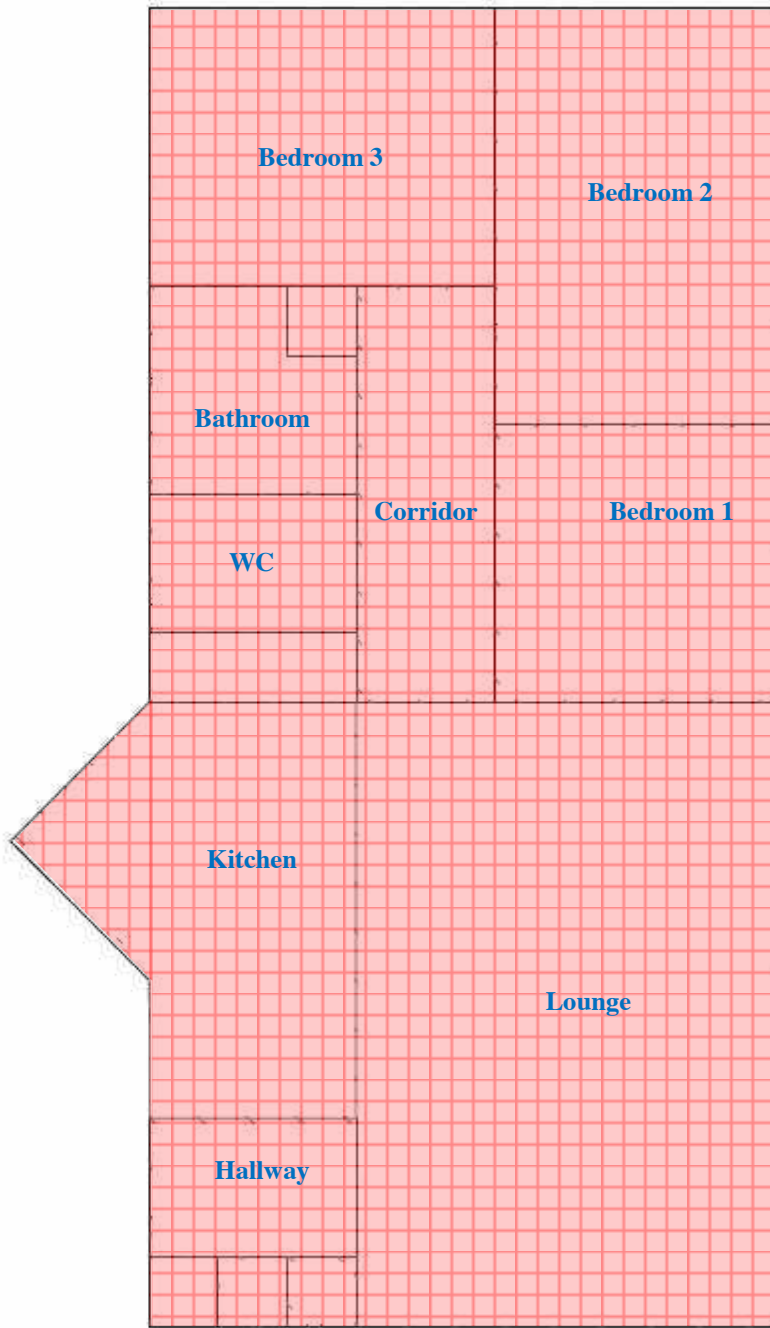
Flat 11

Vinyl Floor Tile
