APPENDICES

APPENDIX G

Agar Grove noise policy for Demolition works.

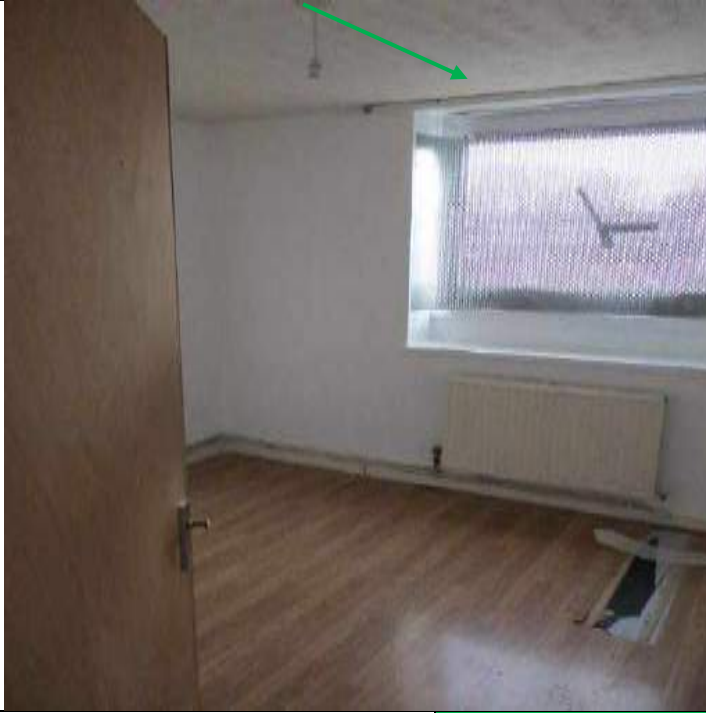
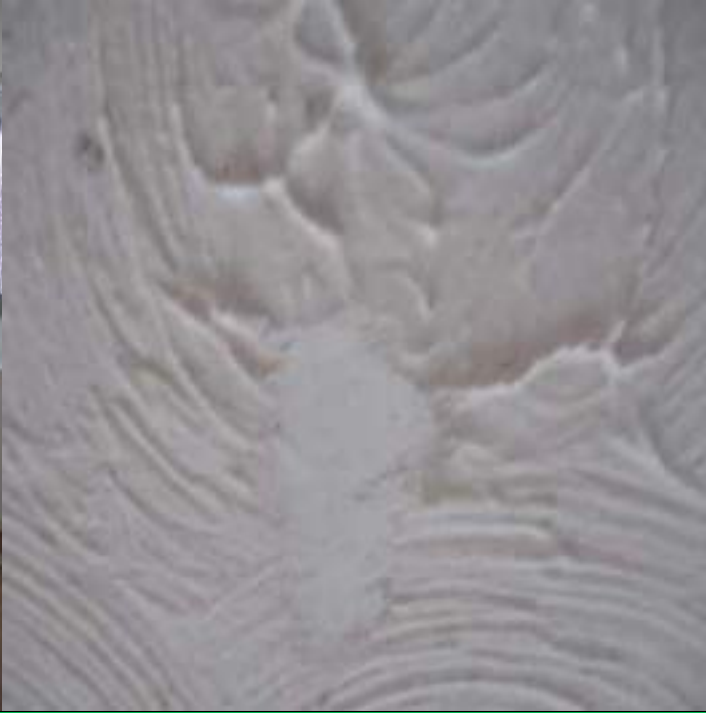
<i>Environmental Inspection Record</i>			FRAMPTON, AGAR GROVE, LONDON, NW1 2SN		
<i>Location</i>		<i>Component</i>		<i>Inspection Ref</i>	
SECOND FLOOR FLAT 12 BEDROOM 3		NON-ASBESTOS TEXTURED COATING TO PLASTERBOARD CEILING TO TIMBER JOISTS PLASTERED BRICK/BREEZE BLOCK WALLS TIMBER FLOORING OVER ASBESTOS VINYL FLOOR TILES & BITUMEN TO CONCRETE		<i>Surveyor:</i>	PB & MC
				PICTURE 75 & 76 SAMPLE 7	
				<i>Date:</i>	19/01/21
				<i>Survey Type:</i>	REFURBISHMENT/ DEMOLITION SURVEY
<i>Condition:</i>	N/A	<i>Access:</i>	N/A	<i>Asbestos?</i>	NO
				<i>Re Inspection Date:</i>	N/A
<i>Friability:</i>	N/A	<i>Amount:</i>	N/A	<i>Type:</i>	NON ASBESTOS
<i>Damage:</i>	N/A	<i>Exposure:</i>	OCCUPANTS	<i>Analysis:</i>	NADIS
<i>Position:</i>	TEXTURED COATING	<i>Risk Factor</i>	0	<i>Priority Assessment:</i>	NO RISK
		<i>Risk Band</i>	E

<i>Recommended Action</i>		NO ACTION REQUIRED

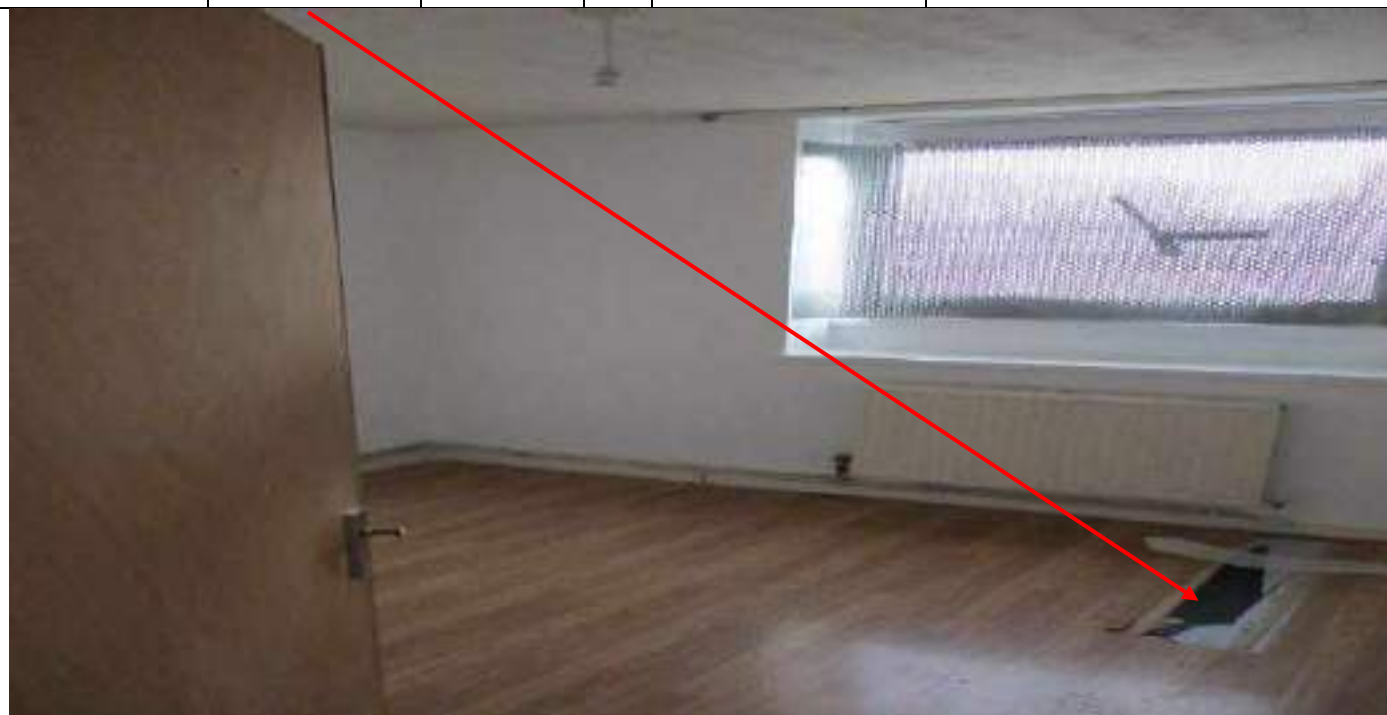
<i>Environmental Inspection Record</i>				FRAMPTON, AGAR GROVE, LONDON, NW1 2SN			
<i>Location</i>		<i>Component</i>			<i>Inspection Ref</i>		
SECOND FLOOR FLAT 12 BEDROOM 3		ASBESTOS VINYL FLOOR TILES & BITUMEN TO CONCRETE			<i>Surveyor:</i>		PB & MC
					PICTURE 77 AS SAMPLE 2		
					<i>Date:</i>		19/01/21
					<i>Survey Type:</i>		REFURBISHMENT/ DEMOLITION SURVEY
<i>Condition:</i>	FAIR	<i>Access:</i>	EASY	<i>Asbestos?</i>		YES	
				<i>Re Inspection Date:</i>			N/A
<i>Friability:</i>	LOW	<i>Amount:</i>	APPROX: 10M ²	<i>Type:</i>	CHRYSOTILE TO BOTH		
<i>Damage:</i>	LOW	<i>Exposure:</i>	OCCUPANTS	<i>Analysis:</i>	TILES	<7%	
					BITUMEN	<8%	
<i>Position:</i>	VINYL FLOOR TILE & BITUMEN	<i>Risk Factor</i>	4	<i>Priority Assessment:</i>	MINOR RISK		
		<i>Risk Band</i>	D

<i>Recommended Action</i>	REMOVE IDENTIFIED ASBESTOS VINYL TILES & ADHESIVE BEFORE DEMOLITION WORKS COMMENCE, USING A COMPETENT CONTRACTOR
----------------------------------	---

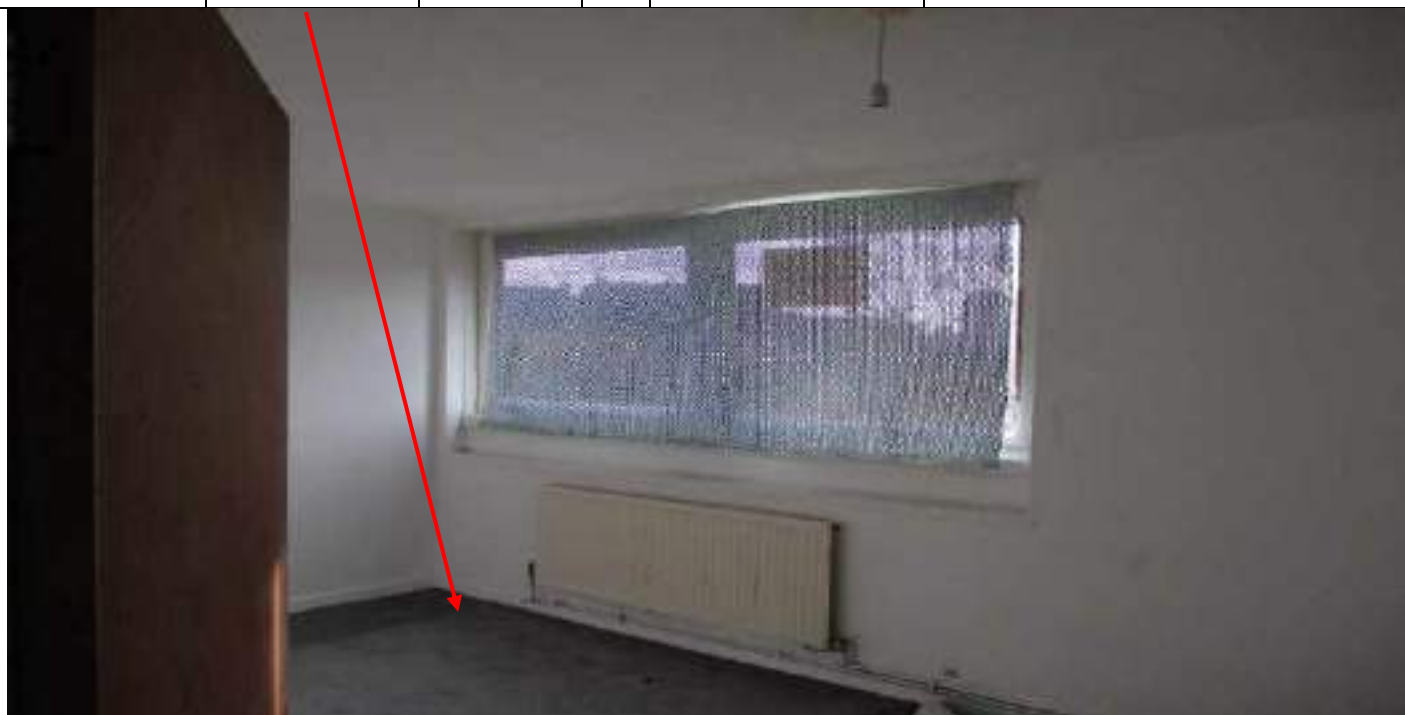
<i>Environmental Inspection Record</i>			FRAMPTON, AGAR GROVE, LONDON, NW1 2SN			
<i>Location</i>		<i>Component</i>		<i>Inspection Ref</i>		
SECOND FLOOR FLAT 12 BEDROOM 2		PLASTERBOARD CEILING TO TIMBER JOISTS PLASTERED BRICK/BREEZE BLOCK WALLS CARPET & TIMBER FLOORING OVER ASBESTOS VINYL FLOOR TILES & BITUMEN TO CONCRETE		<i>Surveyor:</i>	PB & MC	
				PICTURE 78 AS SAMPLE 2		
				<i>Date:</i>	19/01/21	
				<i>Survey Type:</i>	REFURBISHMENT/ DEMOLITION SURVEY	
<i>Condition:</i>	FAIR	<i>Access:</i>	EASY	<i>Asbestos?</i>	YES	
				<i>Re Inspection Date:</i>	N/A	
<i>Friability:</i>	LOW	<i>Amount:</i>	APPROX: 18M ²	<i>Type:</i>	CHRYBOTILE TO BOTH	
<i>Damage:</i>	LOW	<i>Exposure:</i>	OCCUPANTS	<i>Analysis:</i>	TILES	<7%
					BITUMEN	<8%
<i>Position:</i>	VINYL FLOOR TILE & BITUMEN	<i>Risk Factor</i>	4	<i>Priority Assessment:</i>	MINOR RISK	
		<i>Risk Band</i>	D

<i>Recommended Action</i>	REMOVE IDENTIFIED ASBESTOS VINYL TILES & ADHESIVE BEFORE DEMOLITION WORKS COMMENCE, USING A COMPETENT CONTRACTOR
----------------------------------	---

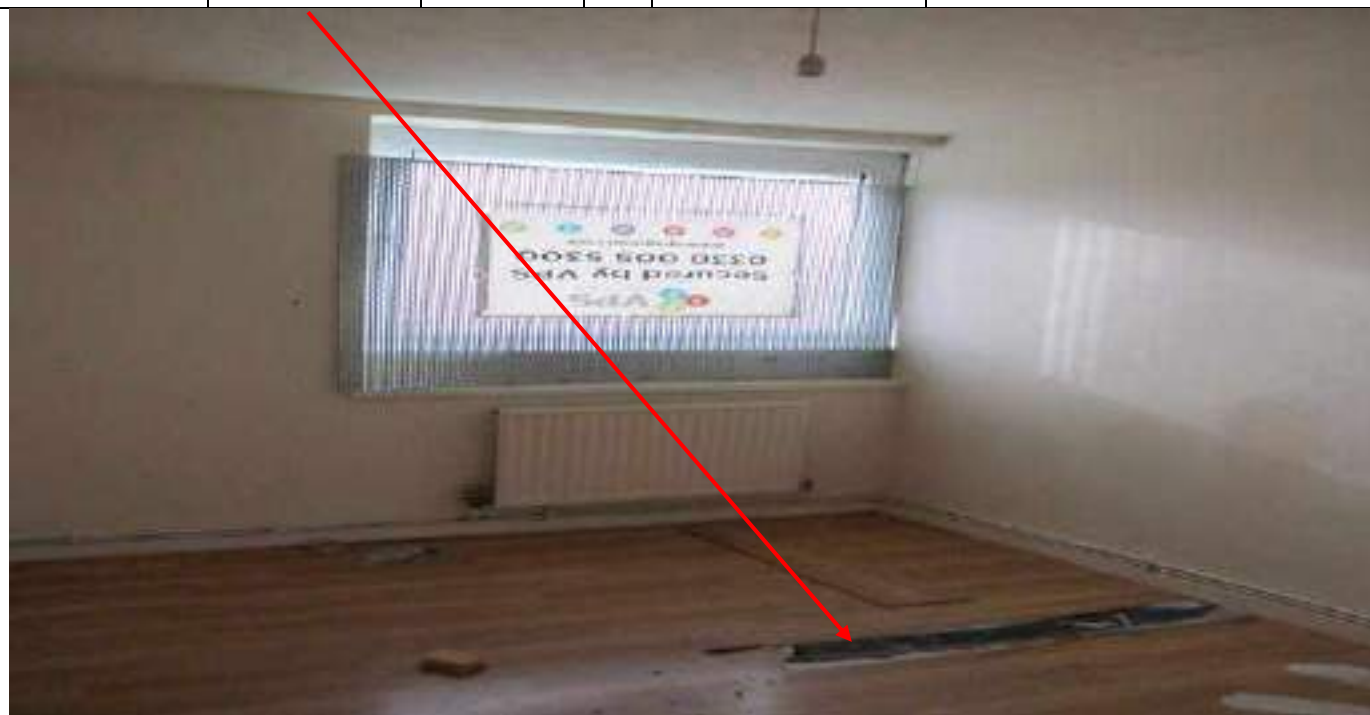
<i>Environmental Inspection Record</i>			FRAMPTON, AGAR GROVE, LONDON, NW1 2SN		
<i>Location</i>		<i>Component</i>		<i>Inspection Ref</i>	
SECOND FLOOR FLAT 12 BEDROOM 1		NON-ASBESTOS TEXTURED COATING TO PLASTERBOARD CEILING TO TIMBER JOISTS PLASTERED BRICK/BREEZE BLOCK WALLS TIMBER FLOORING OVER ASBESTOS VINYL FLOOR TILES & BITUMEN TO CONCRETE		<i>Surveyor:</i>	PB & MC
				PICTURE 79 AS SAMPLE 2	
				<i>Date:</i>	19/01/21
				<i>Survey Type:</i>	REFURBISHMENT/ DEMOLITION SURVEY
<i>Condition:</i>	FAIR	<i>Access:</i>	EASY	<i>Asbestos?</i>	YES
				<i>Re Inspection Date:</i>	N/A
<i>Friability:</i>	LOW	<i>Amount:</i>	APPROX: 6M ²	<i>Type:</i>	CHRYBOTILE TO BOTH
<i>Damage:</i>	LOW	<i>Exposure:</i>	OCCUPANTS	<i>Analysis:</i>	TILES <7% BITUMEN <8%
<i>Position:</i>	VINYL FLOOR TILE & BITUMEN	<i>Risk Factor</i>	4	<i>Priority Assessment:</i>	MINOR RISK
		<i>Risk Band</i>	D

<i>Recommended Action</i>	REMOVE IDENTIFIED ASBESTOS VINYL TILES & ADHESIVE BEFORE DEMOLITION WORKS COMMENCE, USING A COMPETENT CONTRACTOR
----------------------------------	---

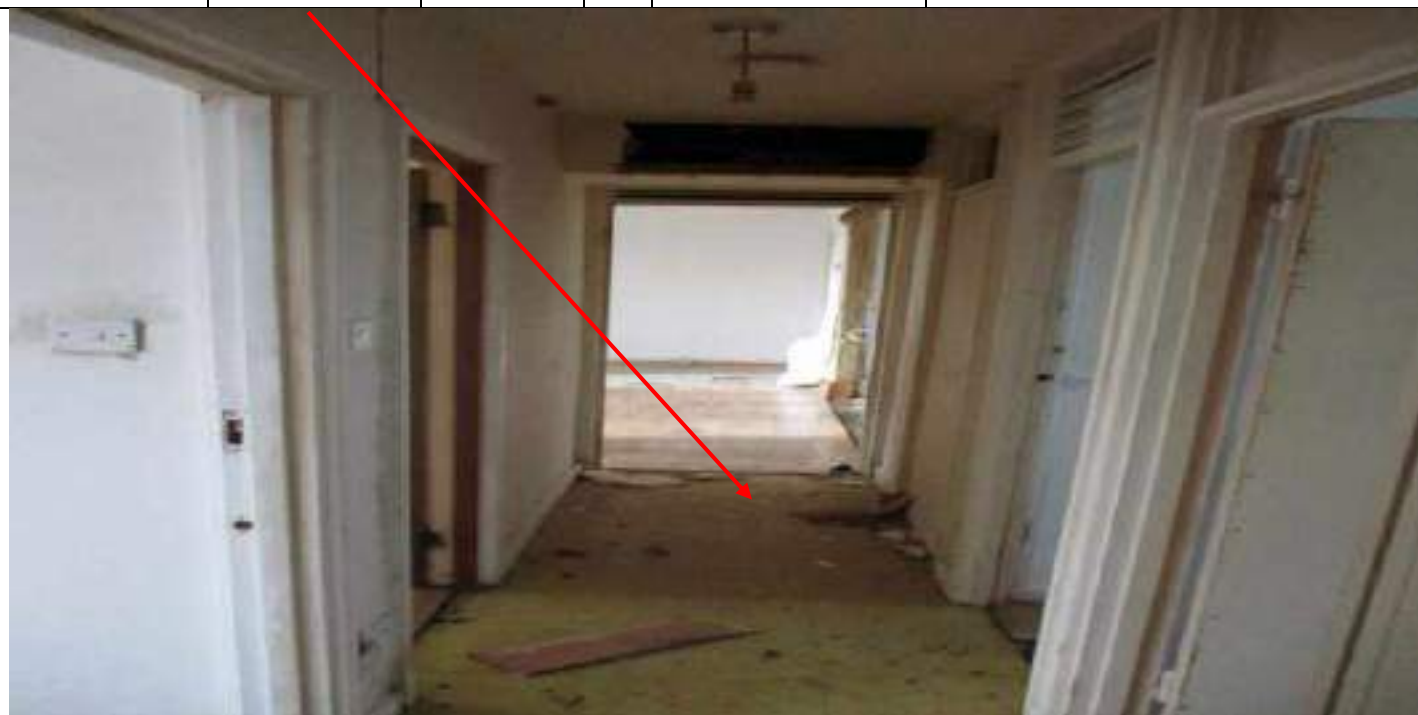
<i>Environmental Inspection Record</i>			FRAMPTON, AGAR GROVE, LONDON, NW1 2SN		
<i>Location</i>		<i>Component</i>		<i>Inspection Ref</i>	
SECOND FLOOR FLAT 12 CORRIDOR		PLASTERBOARD CEILING TO TIMBER JOISTS PLASTERED BRICK/BREEZE BLOCK WALLS TIMBER FLOORING OVER ASBESTOS VINYL FLOOR TILES & BITUMEN TO CONCRETE		<i>Surveyor:</i>	PB & MC
				PICTURE 80 AS SAMPLE 2	
				<i>Date:</i>	19/01/21
				<i>Survey Type:</i>	REFURBISHMENT/ DEMOLITION SURVEY
<i>Condition:</i>	FAIR	<i>Access:</i>	EASY	<i>Asbestos?</i>	YES
				<i>Re Inspection Date:</i>	N/A
<i>Friability:</i>	LOW	<i>Amount:</i>	APPROX: 5M ²	<i>Type:</i>	CHRYSOTILE TO BOTH
<i>Damage:</i>	LOW	<i>Exposure:</i>	OCCUPANTS	<i>Analysis:</i>	TILES <7% BITUMEN <8%
<i>Position:</i>	VINYL FLOOR TILE & BITUMEN	<i>Risk Factor</i>	4	<i>Priority Assessment:</i>	MINOR RISK
		<i>Risk Band</i>	D

<i>Recommended Action</i>	REMOVE IDENTIFIED ASBESTOS VINYL TILES & ADHESIVE BEFORE DEMOLITION WORKS COMMENCE, USING A COMPETENT CONTRACTOR
----------------------------------	---

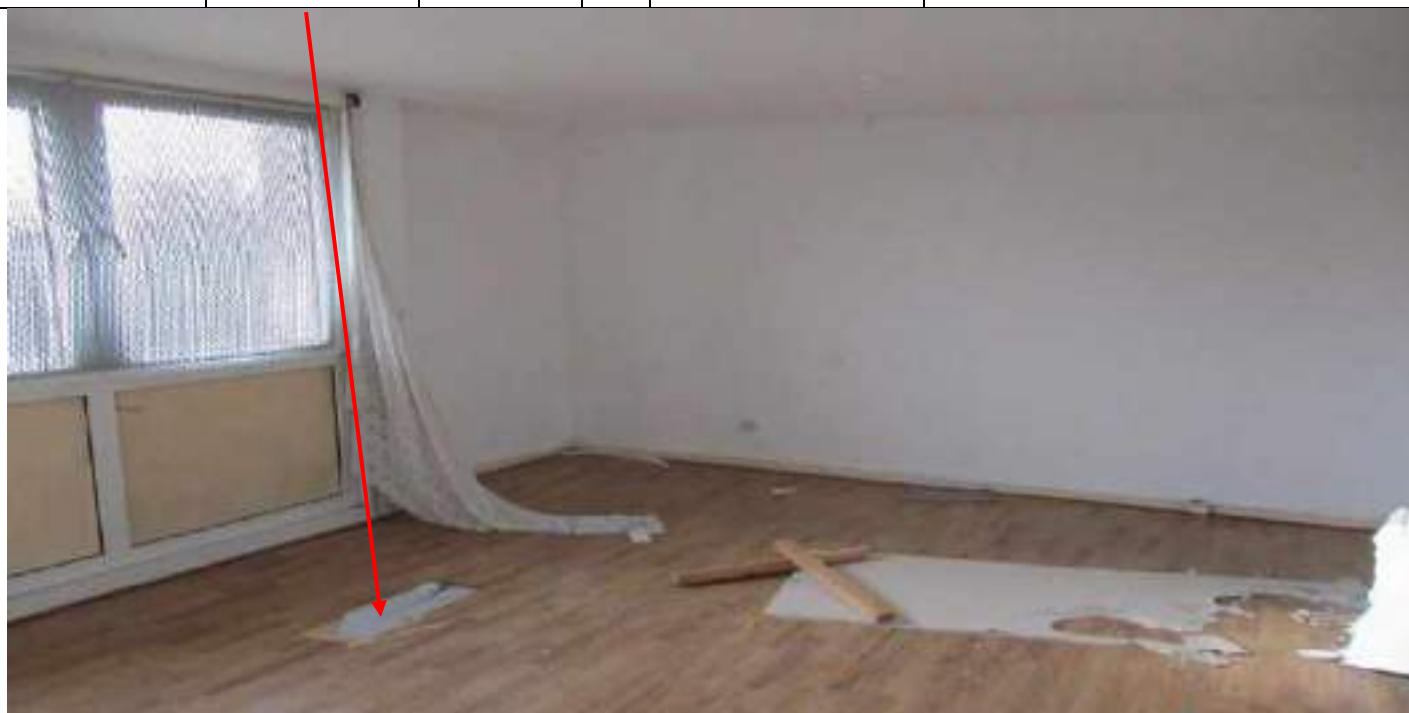
<i>Environmental Inspection Record</i>			FRAMPTON, AGAR GROVE, LONDON, NW1 2SN		
<i>Location</i>		<i>Component</i>		<i>Inspection Ref</i>	
SECOND FLOOR FLAT 12 LOUNGE		PLASTERBOARD CEILING TO TIMBER JOISTS PLASTERED BRICK/BREEZE BLOCK WALLS TIMBER FLOORING OVER ASBESTOS VINYL FLOOR TILES & BITUMEN TO CONCRETE		<i>Surveyor:</i>	PB & MC
				PICTURE 81 AS SAMPLE 2	
				<i>Date:</i>	19/01/21
				<i>Survey Type:</i>	REFURBISHMENT/ DEMOLITION SURVEY
<i>Condition:</i>	FAIR	<i>Access:</i>	EASY	<i>Asbestos?</i>	YES
				<i>Re Inspection Date:</i>	N/A
<i>Friability:</i>	LOW	<i>Amount:</i>	APPROX: 25M ²	<i>Type:</i>	CHRYSO TILE TO BOTH
<i>Damage:</i>	LOW	<i>Exposure:</i>	OCCUPANTS	<i>Analysis:</i>	TILES <7% BITUMEN <8%
<i>Position:</i>	VINYL FLOOR TILE & BITUMEN	<i>Risk Factor</i>	4	<i>Priority Assessment:</i>	MINOR RISK
		<i>Risk Band</i>	D

<i>Recommended Action</i>	REMOVE IDENTIFIED ASBESTOS VINYL TILES & ADHESIVE BEFORE DEMOLITION WORKS COMMENCE, USING A COMPETENT CONTRACTOR
----------------------------------	---

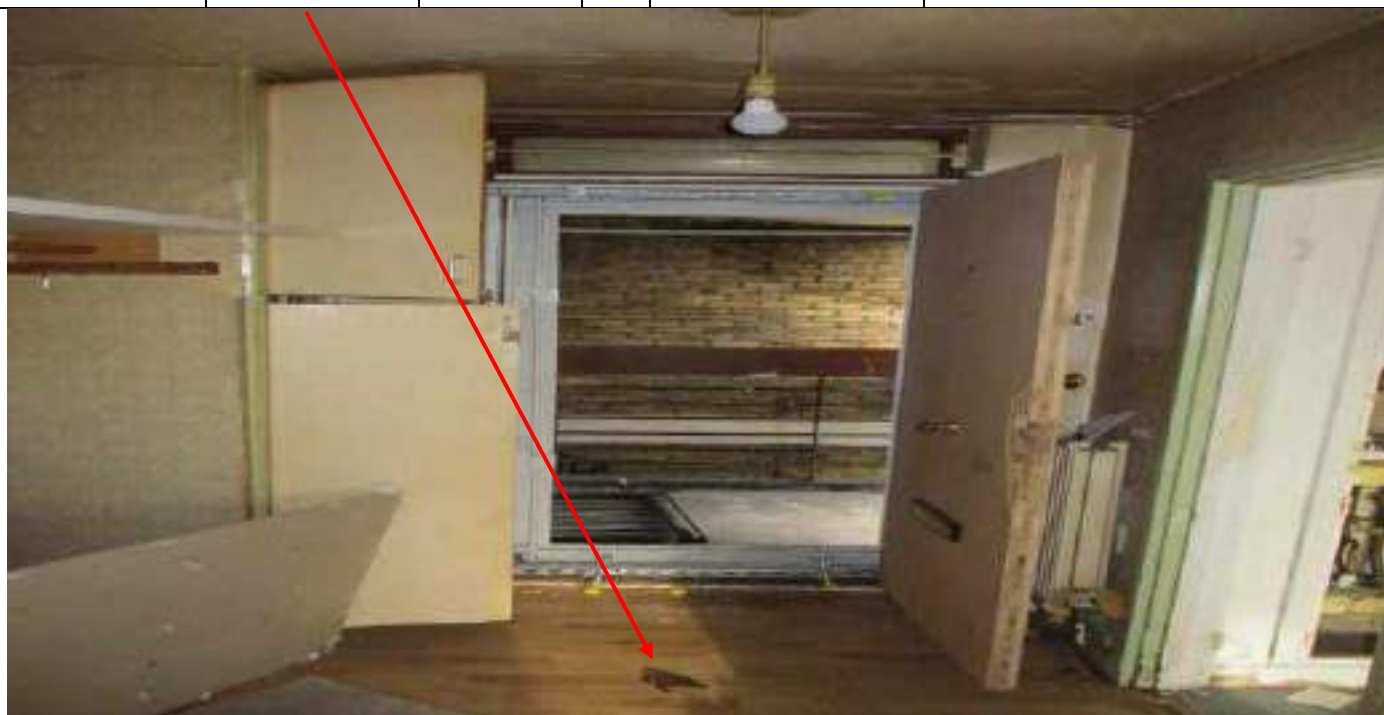
<i>Environmental Inspection Record</i>			FRAMPTON, AGAR GROVE, LONDON, NW1 2SN		
<i>Location</i>		<i>Component</i>		<i>Inspection Ref</i>	
SECOND FLOOR FLAT 12 HALLWAY		PLASTERBOARD CEILING TO TIMBER JOISTS PLASTERED BRICK/BREEZE BLOCK WALLS TIMBER FLOORING OVER ASBESTOS VINYL FLOOR TILES & BITUMEN TO CONCRETE		<i>Surveyor:</i>	PB & MC
				PICTURE 83 AS SAMPLE 2	
				<i>Date:</i>	19/01/21
				<i>Survey Type:</i>	REFURBISHMENT/ DEMOLITION SURVEY
<i>Condition:</i>	FAIR	<i>Access:</i>	EASY	<i>Asbestos?</i>	YES
				<i>Re Inspection Date:</i>	N/A
<i>Friability:</i>	LOW	<i>Amount:</i>	APPROX: 5M ²	<i>Type:</i>	CHRYBOTILE TO BOTH
<i>Damage:</i>	LOW	<i>Exposure:</i>	OCCUPANTS	<i>Analysis:</i>	TILES <7% BITUMEN <8%
<i>Position:</i>	VINYL FLOOR TILE & BITUMEN	<i>Risk Factor</i>	4	<i>Priority Assessment:</i>	MINOR RISK
		<i>Risk Band</i>	D

<i>Recommended Action</i>	REMOVE IDENTIFIED ASBESTOS VINYL TILES & ADHESIVE BEFORE DEMOLITION WORKS COMMENCE, USING A COMPETENT CONTRACTOR
----------------------------------	---

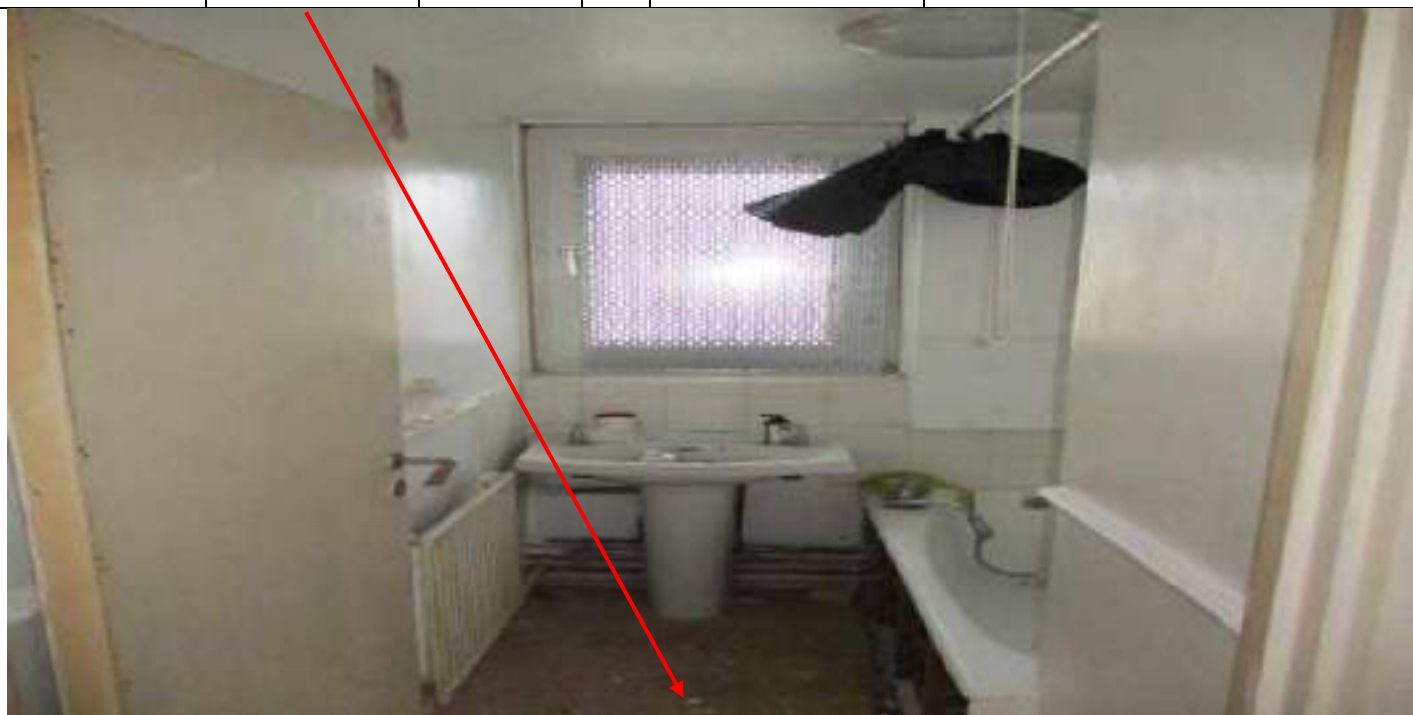
<i>Environmental Inspection Record</i>				FRAMPTON, AGAR GROVE, LONDON, NW1 2SN						
<i>Location</i>		<i>Component</i>			<i>Inspection Ref</i>					
SECOND FLOOR FLAT 12 BATHROOM		PLASTERBOARD CEILING TO TIMBER JOISTS CERAMIC TILES TO PLASTERED BRICK/BREEZE BLOCK WALLS MODERN VINYL FLOOR COVERING OVER ASBESTOS VINYL FLOOR TILES & BITUMEN TO CONCRETE			<i>Surveyor:</i>		PB & MC			
					PICTURE 84 AS SAMPLE 2					
					<i>Date:</i>		19/01/21			
					<i>Survey Type:</i>		REFURBISHMENT/ DEMOLITION SURVEY			
<i>Condition:</i>	FAIR	<i>Access:</i>	EASY		<i>Asbestos?</i>		YES			
						<i>Re Inspection Date:</i>		N/A		
<i>Friability:</i>	LOW	<i>Amount:</i>	APPROX: 2M ²		<i>Type:</i>	CHRYBOTILE TO BOTH				
<i>Damage:</i>	LOW	<i>Exposure:</i>	OCCUPANTS		<i>Analysis:</i>	TILES	<7%			
						BITUMEN		<8%		
<i>Position:</i>	VINYL FLOOR TILE & BITUMEN	<i>Risk Factor</i>	4	<i>Priority Assessment:</i>	MINOR RISK

<i>Risk Band</i>	D

<i>Recommended Action</i>	REMOVE IDENTIFIED ASBESTOS VINYL TILES & ADHESIVE BEFORE DEMOLITION WORKS COMMENCE, USING A COMPETENT CONTRACTOR
----------------------------------	---

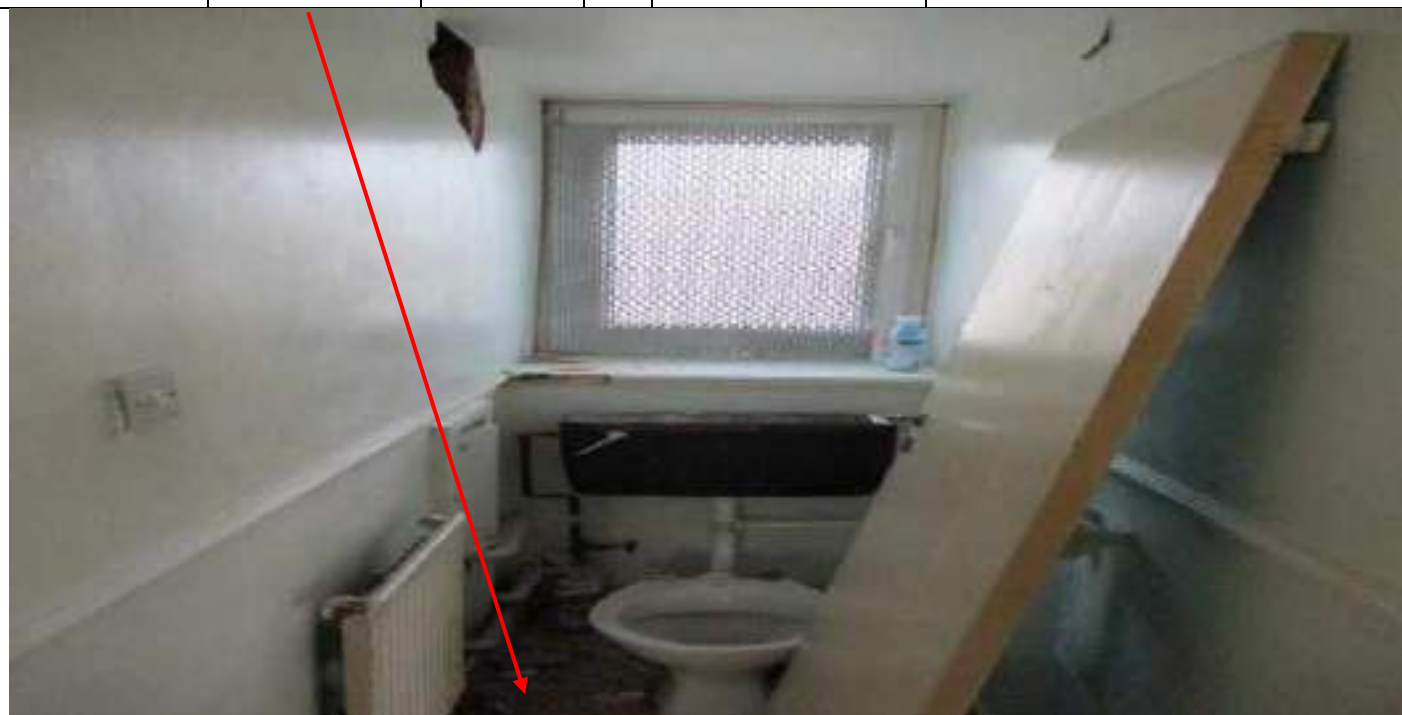
<i>Environmental Inspection Record</i>			FRAMPTON, AGAR GROVE, LONDON, NW1 2SN		
<i>Location</i>		<i>Component</i>		<i>Inspection Ref</i>	
SECOND FLOOR FLAT 12 WC		PLASTERBOARD CEILING TO TIMBER JOISTS CERAMIC TILES TO PLASTERED BRICK/BREEZE BLOCK WALLS MODERN VINYL FLOOR COVERING OVER ASBESTOS VINYL FLOOR TILES & BITUMEN TO CONCRETE		<i>Surveyor:</i>	PB & MC
				PICTURE 85 AS SAMPLE 2	
				<i>Date:</i>	19/01/21
				<i>Survey Type:</i>	REFURBISHMENT/ DEMOLITION SURVEY
<i>Condition:</i>	FAIR	<i>Access:</i>	EASY	<i>Asbestos?</i>	YES
				<i>Re Inspection Date:</i>	N/A
<i>Friability:</i>	LOW	<i>Amount:</i>	APPROX: 2M ²	<i>Type:</i>	CHRYSOTILE TO BOTH
<i>Damage:</i>	LOW	<i>Exposure:</i>	OCCUPANTS	<i>Analysis:</i>	TILES <7% BITUMEN <8%
<i>Position:</i>	VINYL FLOOR TILE & BITUMEN	<i>Risk Factor</i>	4	<i>Priority Assessment:</i>	MINOR RISK
		<i>Risk Band</i>	D

<i>Recommended Action</i>	REMOVE IDENTIFIED ASBESTOS VINYL TILES & ADHESIVE BEFORE DEMOLITION WORKS COMMENCE, USING A COMPETENT CONTRACTOR
----------------------------------	---

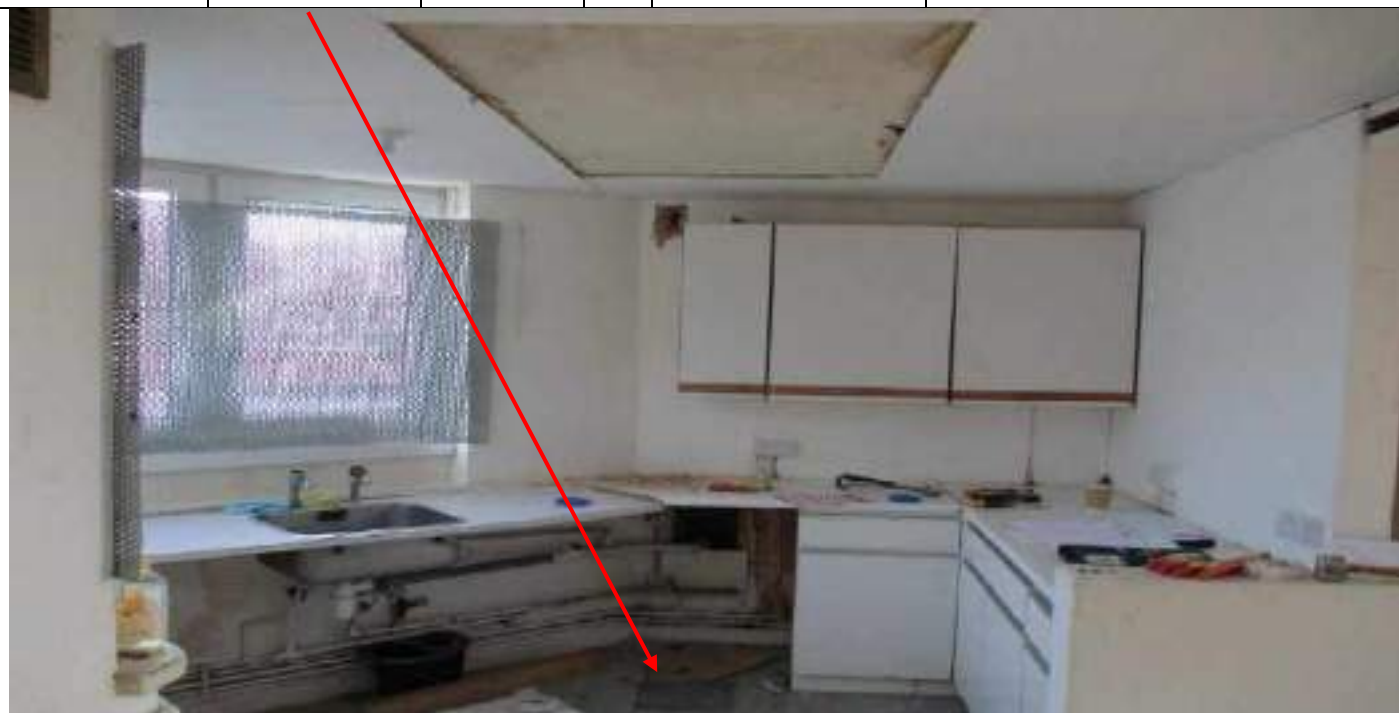
<i>Environmental Inspection Record</i>				FRAMPTON, AGAR GROVE, LONDON, NW1 2SN						
<i>Location</i>		<i>Component</i>			<i>Inspection Ref</i>					
SECOND FLOOR FLAT 12 KITCHEN		PLASTERBOARD CEILING TO TIMBER JOISTS CERAMIC TILES TO PLASTERED BRICK/BREEZE BLOCK WALLS TIMBER FLOORING OVER ASBESTOS VINYL FLOOR TILES & BITUMEN TO CONCRETE			<i>Surveyor:</i>		PB & MC			
					PICTURE 87 AS SAMPLE 2					
					<i>Date:</i>		19/01/21			
					<i>Survey Type:</i>		REFURBISHMENT/ DEMOLITION SURVEY			
<i>Condition:</i>	FAIR	<i>Access:</i>	EASY			<i>Asbestos?</i> YES				
				<i>Re Inspection Date:</i> N/A						
<i>Friability:</i>	LOW	<i>Amount:</i>	APPROX: 12M ²			<i>Type:</i>	CHRYBOTILE TO BOTH			
<i>Damage:</i>	LOW	<i>Exposure:</i>	OCCUPANTS			<i>Analysis:</i>	TILES <7% BITUMEN <8%			
<i>Position:</i>	VINYL FLOOR TILE & BITUMEN	<i>Risk Factor</i>	4	<i>Priority Assessment:</i>		MINOR RISK				
		<i>Risk Band</i>	D

<i>Recommended Action</i>	REMOVE IDENTIFIED ASBESTOS VINYL TILES & ADHESIVE BEFORE DEMOLITION WORKS COMMENCE, USING A COMPETENT CONTRACTOR
----------------------------------	---

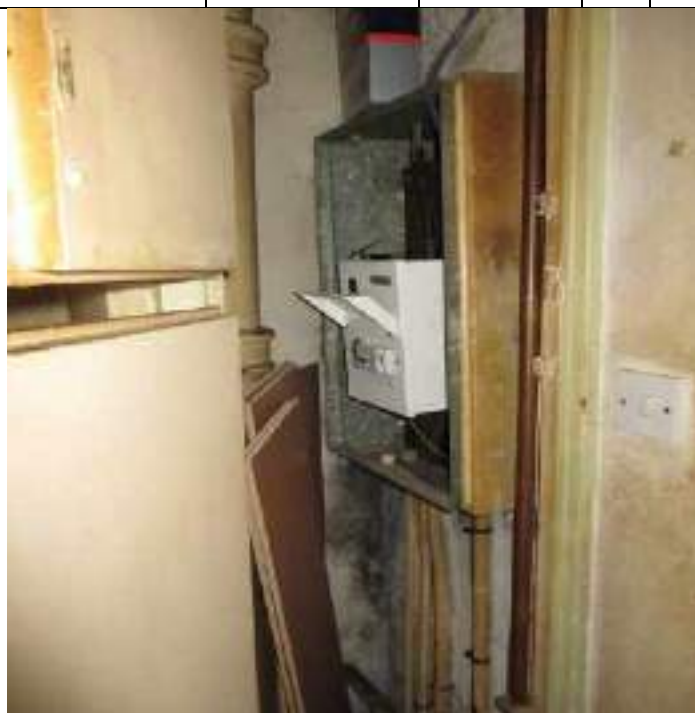
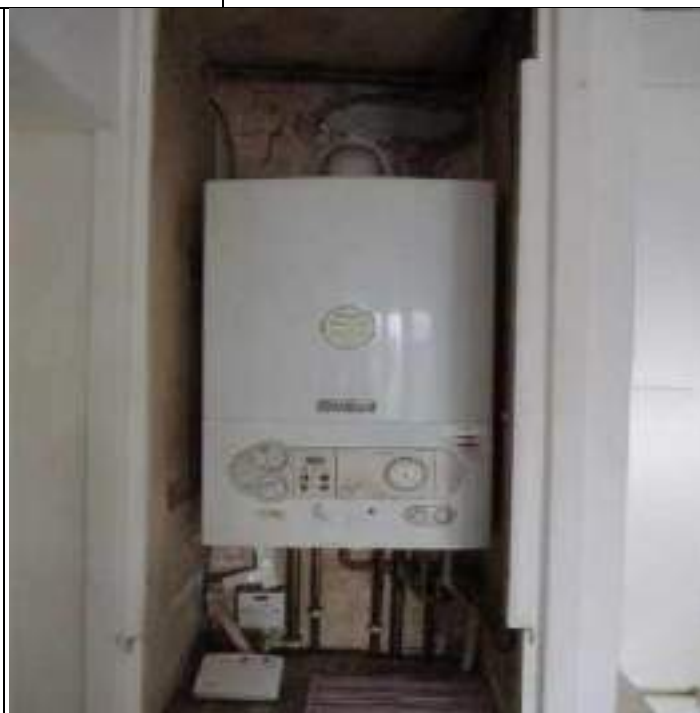
<i>Environmental Inspection Record</i>				FRAMPTON, AGAR GROVE, LONDON, NW1 2SN	
<i>Location</i>		<i>Component</i>		<i>Inspection Ref</i>	
SECOND FLOOR FLAT 12 CUPBOARDS		BOILER WITH METAL FLUE PIPE ELECTRICAL FUSE BOARD		<i>Surveyor:</i>	PB & MC
				PICTURE 88 & 89	
				<i>Date:</i>	19/01/21
				<i>Survey Type:</i>	REFURBISHMENT/ DEMOLITION SURVEY
<i>Condition:</i>	N/A	<i>Access:</i>	N/A	<i>Asbestos?</i>	NO
				<i>Re Inspection Date:</i>	N/A
<i>Friability:</i>	N/A	<i>Amount:</i>	N/A	<i>Type:</i>	NON ASBESTOS
<i>Damage:</i>	N/A	<i>Exposure:</i>	N/A	<i>Analysis:</i>	N/A
<i>Position:</i>	CUPBOARD	<i>Risk Factor</i>	0	<i>Priority Assessment:</i>	NO RISK
		<i>Risk Band</i>	E

<i>Recommended Action</i>	NO ASBESTOS MATERIALS IDENTIFIED.
----------------------------------	--

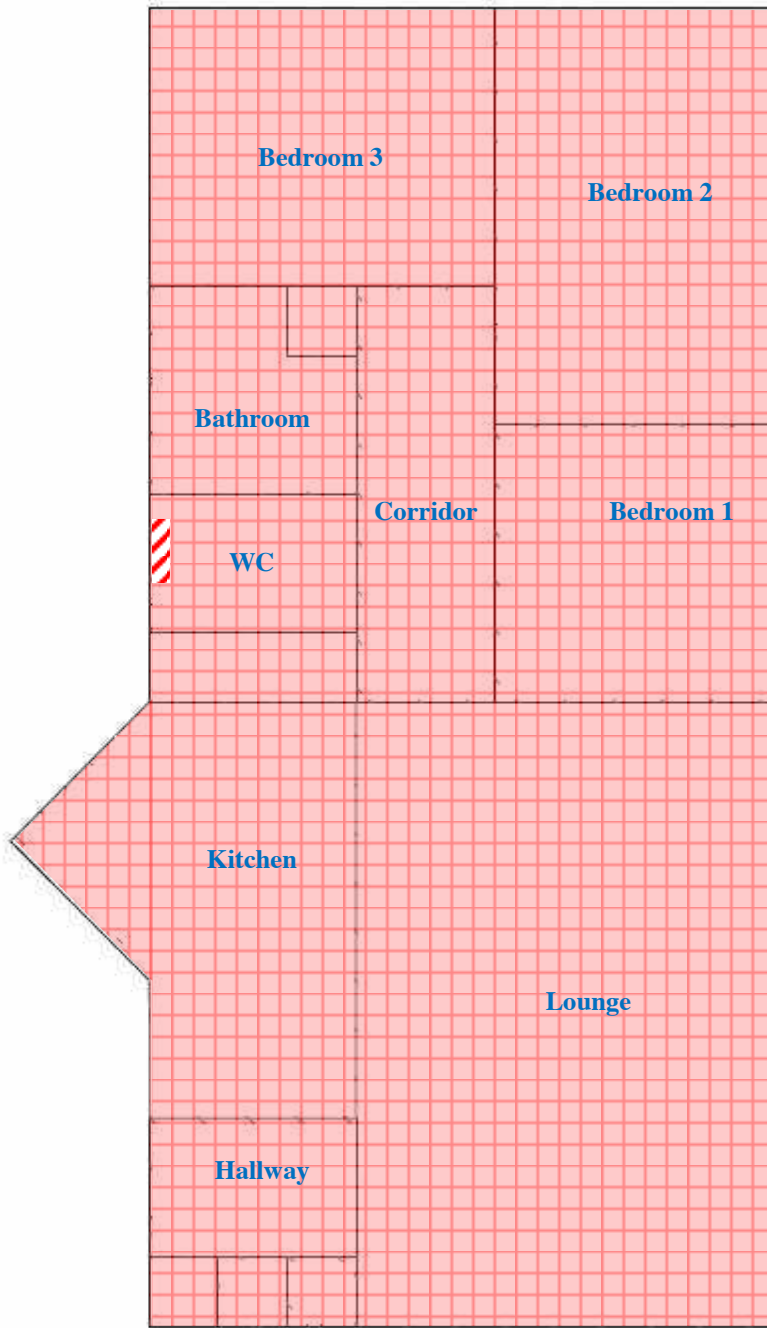
Flat 12

Vinyl Floor Tile

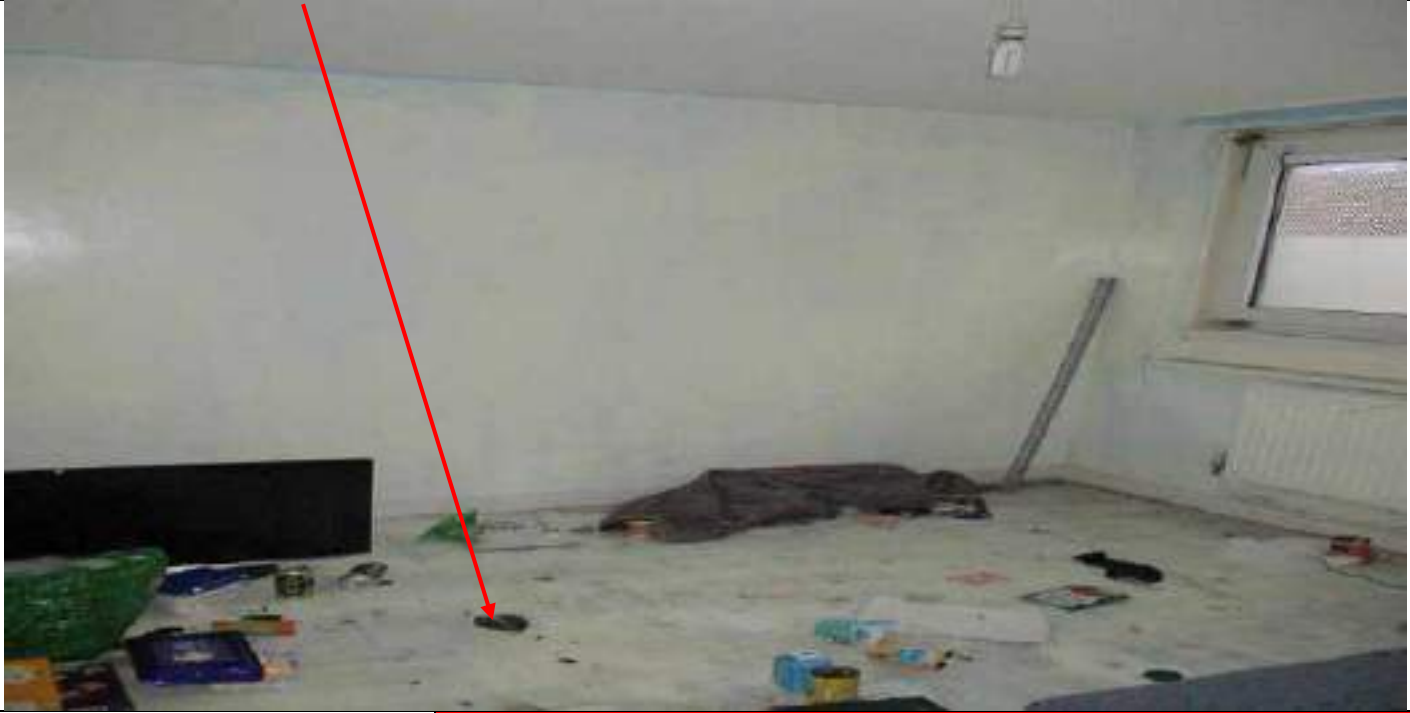
<i>Environmental Inspection Record</i>				FRAMPTON, AGAR GROVE, LONDON, NW1 2SN			
<i>Location</i>		<i>Component</i>			<i>Inspection Ref</i>		
GROUND FLOOR FLAT 3 BEDROOM 1		CONCRETE CEILING PLASTERED BRICK/BREEZE BLOCK WALLS ASBESTOS VINYL FLOOR TILES & BITUMEN TO CONCRETE			<i>Surveyor:</i>	PB & MC	
					PICTURE 90 AS SAMPLE 2		
					<i>Date:</i>	19/01/21	
					<i>Survey Type:</i>	REFURBISHMENT/ DEMOLITION SURVEY	
<i>Condition:</i>	FAIR	<i>Access:</i>	EASY		<i>Asbestos?</i>	YES	
					<i>Re Inspection Date:</i>	N/A	
<i>Friability:</i>	LOW	<i>Amount:</i>	APPROX: 18M ²		<i>Type:</i>	CHRYSOTILE TO BOTH	
<i>Damage:</i>	LOW	<i>Exposure:</i>	OCCUPANTS		<i>Analysis:</i>	TILES	<7%
						BITUMEN	<8%
<i>Position:</i>	VINYL FLOOR TILE & BITUMEN	<i>Risk Factor</i>	4	<i>Priority Assessment:</i>	MINOR RISK		
		<i>Risk Band</i>	D

<i>Recommended Action</i>				REMOVE IDENTIFIED ASBESTOS VINYL TILES & ADHESIVE BEFORE DEMOLITION WORKS COMMENCE, USING A COMPETENT CONTRACTOR

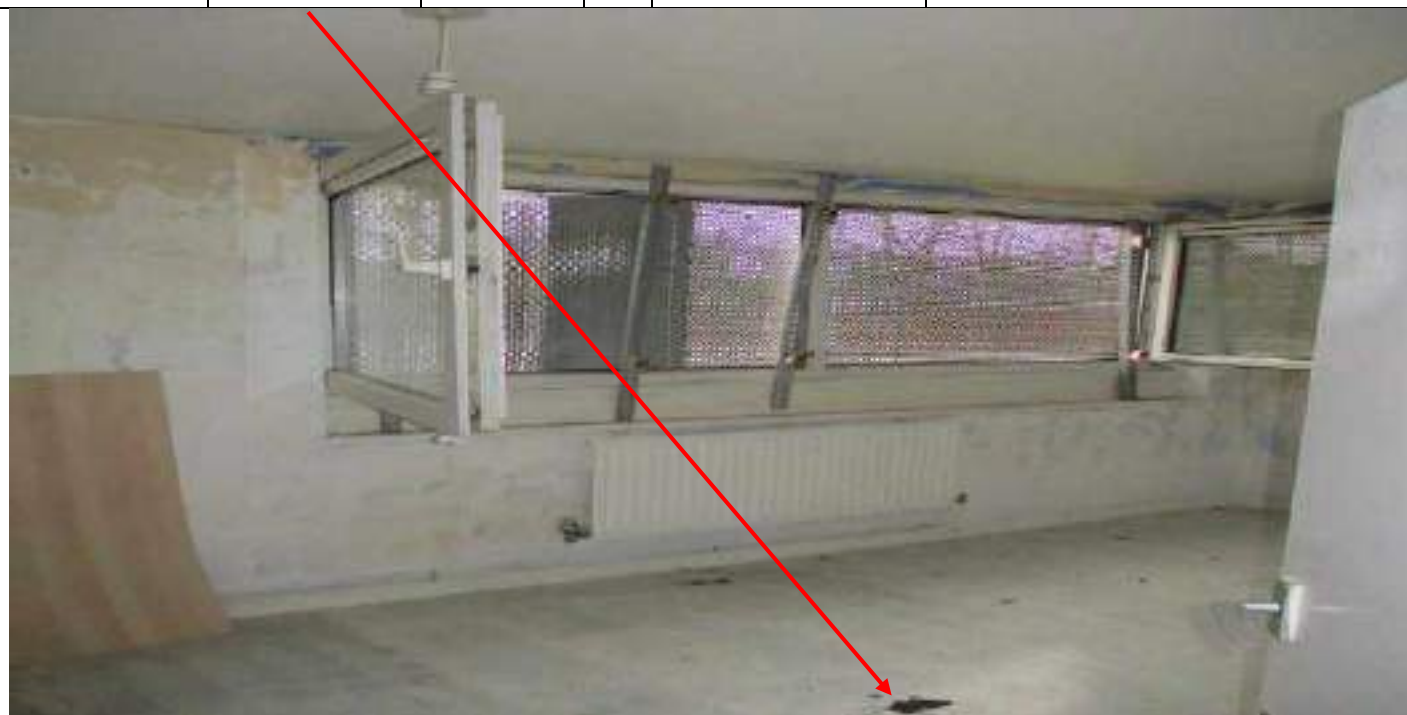
<i>Environmental Inspection Record</i>				FRAMPTON, AGAR GROVE, LONDON, NW1 2SN						
<i>Location</i>		<i>Component</i>			<i>Inspection Ref</i>					
GROUND FLOOR FLAT 3 BEDROOM 2		CONCRETE CEILING PLASTERED BRICK/BREEZE BLOCK WALLS ASBESTOS VINYL FLOOR TILES & BITUMEN TO CONCRETE			<i>Surveyor:</i>		PB & MC			
					PICTURE 91 AS SAMPLE 2					
					<i>Date:</i>		19/01/21			
					<i>Survey Type:</i>		REFURBISHMENT/ DEMOLITION SURVEY			
<i>Condition:</i>	FAIR	<i>Access:</i>	EASY		<i>Asbestos?</i>		YES			
						<i>Re Inspection Date:</i>		N/A		
<i>Friability:</i>	LOW	<i>Amount:</i>	APPROX: 10M ²		<i>Type:</i>	CHRYSOTILE TO BOTH				
<i>Damage:</i>	LOW	<i>Exposure:</i>	OCCUPANTS		<i>Analysis:</i>	TILES	<7%			
						BITUMEN	<8%			
<i>Position:</i>	VINYL FLOOR TILE & BITUMEN	<i>Risk Factor</i>	4	<i>Priority Assessment:</i>	MINOR RISK					
		<i>Risk Band</i>	D

<i>Recommended Action</i>	REMOVE IDENTIFIED ASBESTOS VINYL TILES & ADHESIVE BEFORE DEMOLITION WORKS COMMENCE, USING A COMPETENT CONTRACTOR
----------------------------------	---

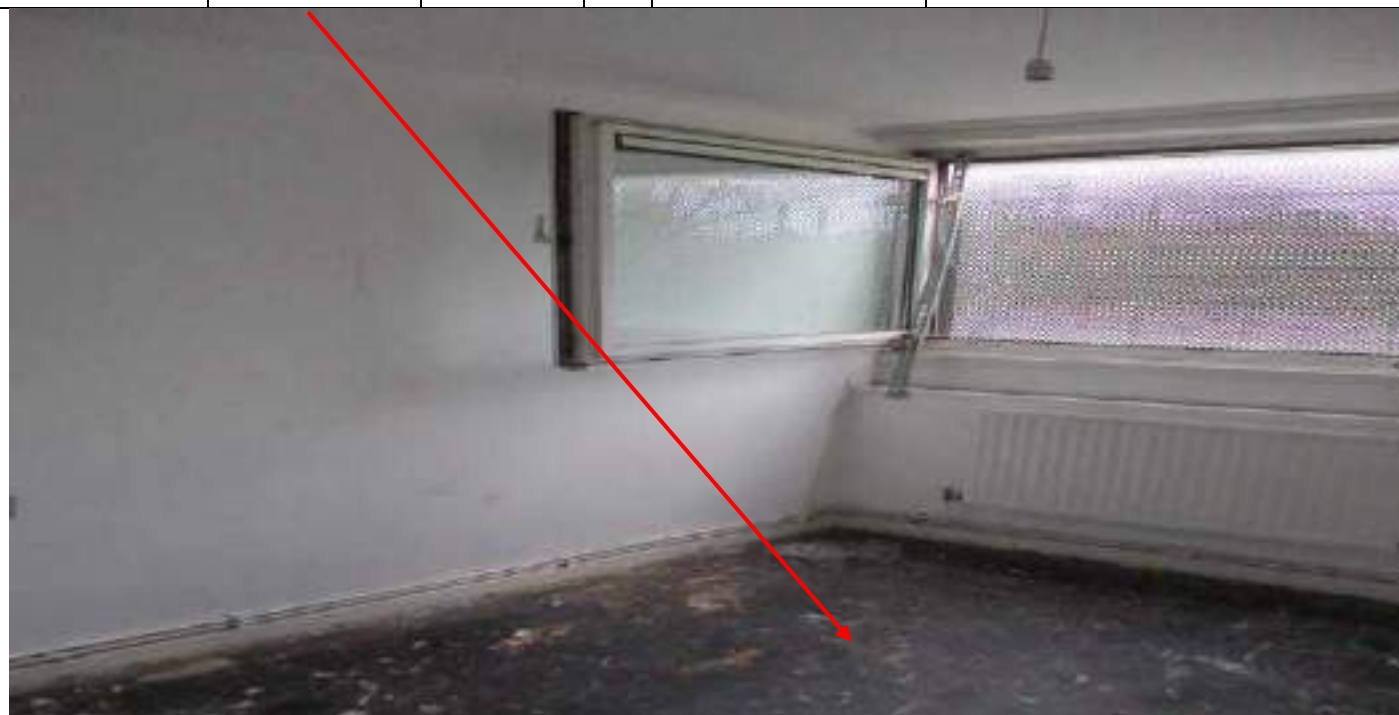
<i>Environmental Inspection Record</i>				FRAMPTON, AGAR GROVE, LONDON, NW1 2SN						
<i>Location</i>		<i>Component</i>			<i>Inspection Ref</i>					
GROUND FLOOR FLAT 3 BEDROOM 1		CONCRETE CEILING PLASTERED BRICK/BREEZE BLOCK WALLS ASBESTOS VINYL FLOOR TILES & BITUMEN TO CONCRETE			<i>Surveyor:</i>		PB & MC			
					PICTURE 92 AS SAMPLE 2					
					<i>Date:</i>		19/01/21			
					<i>Survey Type:</i>		REFURBISHMENT/ DEMOLITION SURVEY			
<i>Condition:</i>	FAIR	<i>Access:</i>	EASY		<i>Asbestos?</i>		YES			
						<i>Re Inspection Date:</i>		N/A		
<i>Friability:</i>	LOW	<i>Amount:</i>	APPROX: 6M ²		<i>Type:</i>	CHRYSOTILE TO BOTH				
<i>Damage:</i>	LOW	<i>Exposure:</i>	OCCUPANTS		<i>Analysis:</i>	TILES	<7%			
						BITUMEN		<8%		
<i>Position:</i>	VINYL FLOOR TILE & BITUMEN	<i>Risk Factor</i>	4	<i>Priority Assessment:</i>	MINOR RISK					
		<i>Risk Band</i>	D

<i>Recommended Action</i>	REMOVE IDENTIFIED ASBESTOS VINYL TILES & ADHESIVE BEFORE DEMOLITION WORKS COMMENCE, USING A COMPETENT CONTRACTOR
----------------------------------	---

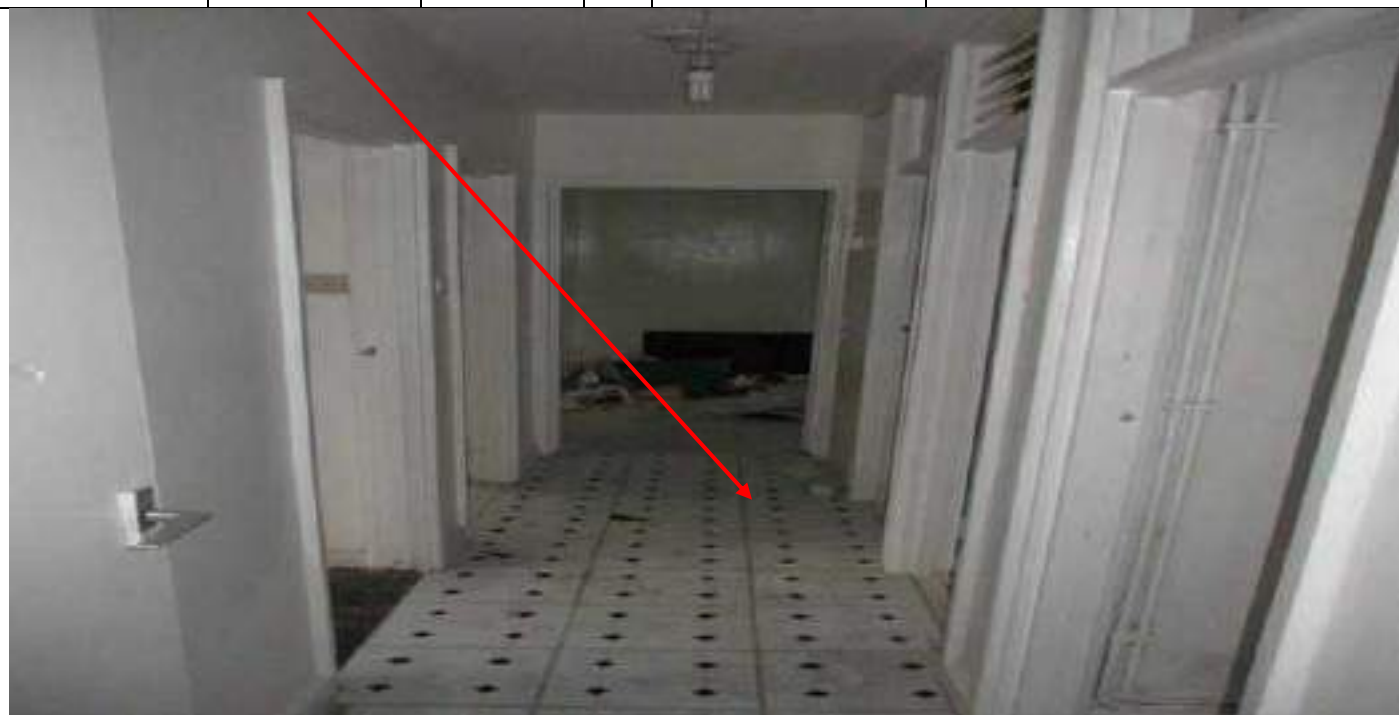
<i>Environmental Inspection Record</i>			FRAMPTON, AGAR GROVE, LONDON, NW1 2SN		
<i>Location</i>		<i>Component</i>		<i>Inspection Ref</i>	
GROUND FLOOR FLAT 3 CORRIDOR		PLASTERBOARD CEILING TO TIMBER JOISTS PLASTERED BRICK/BREEZE BLOCK WALLS MODERN VINYL OVER ASBESTOS VINYL FLOOR TILES & BITUMEN TO CONCRETE		<i>Surveyor:</i>	PB & MC
				PICTURE 93 AS SAMPLE 2	
				<i>Date:</i>	19/01/21
				<i>Survey Type:</i>	REFURBISHMENT/ DEMOLITION SURVEY
<i>Condition:</i>	FAIR	<i>Access:</i>	EASY	<i>Asbestos?</i>	YES
				<i>Re Inspection Date:</i>	N/A
<i>Friability:</i>	LOW	<i>Amount:</i>	APPROX: 5M ²	<i>Type:</i>	CHRYBOTILE TO BOTH
<i>Damage:</i>	LOW	<i>Exposure:</i>	OCCUPANTS	<i>Analysis:</i>	TILES <7% BITUMEN <8%
<i>Position:</i>	VINYL FLOOR TILE & BITUMEN	<i>Risk Factor</i>	4	<i>Priority Assessment:</i>	MINOR RISK
		<i>Risk Band</i>	D

<i>Recommended Action</i>	REMOVE IDENTIFIED ASBESTOS VINYL TILES & ADHESIVE BEFORE DEMOLITION WORKS COMMENCE, USING A COMPETENT CONTRACTOR
----------------------------------	---

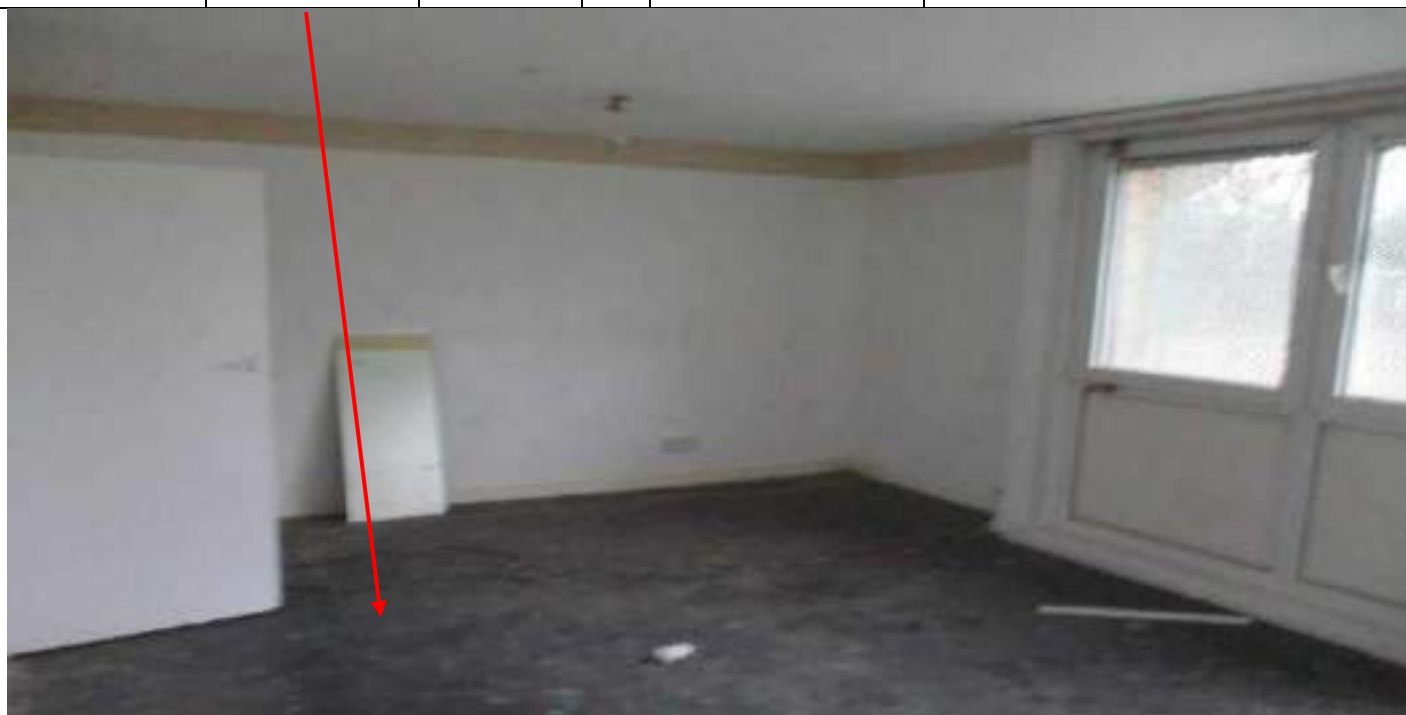
<i>Environmental Inspection Record</i>			FRAMPTON, AGAR GROVE, LONDON, NW1 2SN		
<i>Location</i>		<i>Component</i>		<i>Inspection Ref</i>	
GROUND FLOOR FLAT 3 LOUNGE		PLASTERBOARD CEILING TO TIMBER JOISTS PLASTERED BRICK/BREEZE BLOCK WALLS ASBESTOS VINYL FLOOR TILES & BITUMEN TO CONCRETE		<i>Surveyor:</i>	PB & MC
				PICTURE 94 AS SAMPLE 2	
				<i>Date:</i>	19/01/21
				<i>Survey Type:</i>	REFURBISHMENT/ DEMOLITION SURVEY
<i>Condition:</i>	FAIR	<i>Access:</i>	EASY	<i>Asbestos?</i>	YES
				<i>Re Inspection Date:</i>	N/A
<i>Friability:</i>	LOW	<i>Amount:</i>	APPROX: 25M ²	<i>Type:</i>	CHRYBOTILE TO BOTH
<i>Damage:</i>	LOW	<i>Exposure:</i>	OCCUPANTS	<i>Analysis:</i>	TILES <7% BITUMEN <8%
<i>Position:</i>	VINYL FLOOR TILE & BITUMEN	<i>Risk Factor</i>	4	<i>Priority Assessment:</i>	MINOR RISK
		<i>Risk Band</i>	D

<i>Recommended Action</i>	REMOVE IDENTIFIED ASBESTOS VINYL TILES & ADHESIVE BEFORE DEMOLITION WORKS COMMENCE, USING A COMPETENT CONTRACTOR
----------------------------------	---

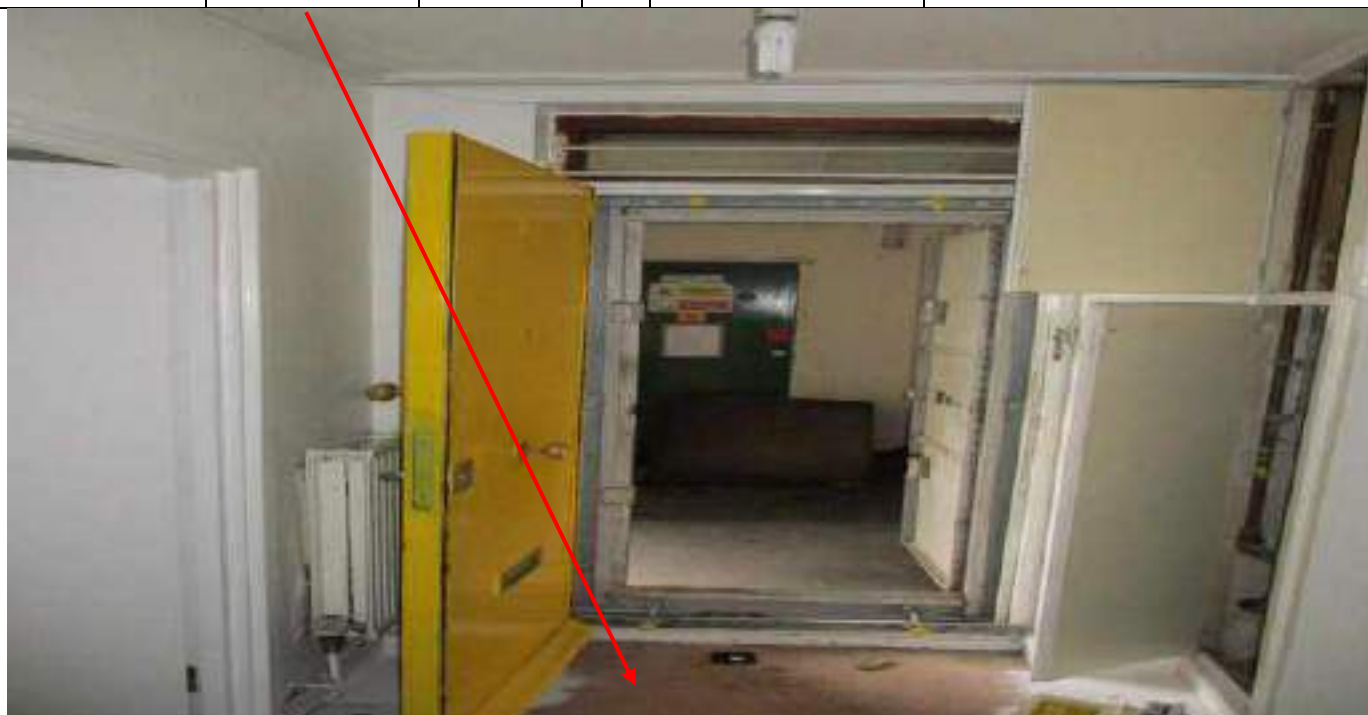
<i>Environmental Inspection Record</i>			FRAMPTON, AGAR GROVE, LONDON, NW1 2SN			
<i>Location</i>		<i>Component</i>		<i>Inspection Ref</i>		
GROUND FLOOR FLAT 3 HALLWAY		PLASTERBOARD CEILING TO TIMBER JOISTS PLASTERED BRICK/BREEZE BLOCK WALLS MODERN VINYL OVER ASBESTOS VINYL FLOOR TILES & BITUMEN TO CONCRETE		<i>Surveyor:</i>	PB & MC	
				PICTURE 95 AS SAMPLE 2		
				<i>Date:</i>	19/01/21	
				<i>Survey Type:</i>	REFURBISHMENT/ DEMOLITION SURVEY	
<i>Condition:</i>	FAIR	<i>Access:</i>	EASY	<i>Asbestos?</i>	YES	
				<i>Re Inspection Date:</i>	N/A	
<i>Friability:</i>	LOW	<i>Amount:</i>	APPROX: 5M ²	<i>Type:</i>	CHRYBOTILE TO BOTH	
<i>Damage:</i>	LOW	<i>Exposure:</i>	OCCUPANTS	<i>Analysis:</i>	TILES	<7%
					BITUMEN	<8%
<i>Position:</i>	VINYL FLOOR TILE & BITUMEN	<i>Risk Factor</i>	4	<i>Priority Assessment:</i>	MINOR RISK	
		<i>Risk Band</i>	D

<i>Recommended Action</i>	REMOVE IDENTIFIED ASBESTOS VINYL TILES & ADHESIVE BEFORE DEMOLITION WORKS COMMENCE, USING A COMPETENT CONTRACTOR
----------------------------------	---
