APPENDICES

APPENDIX G

Agar Grove noise policy for Demolition works.

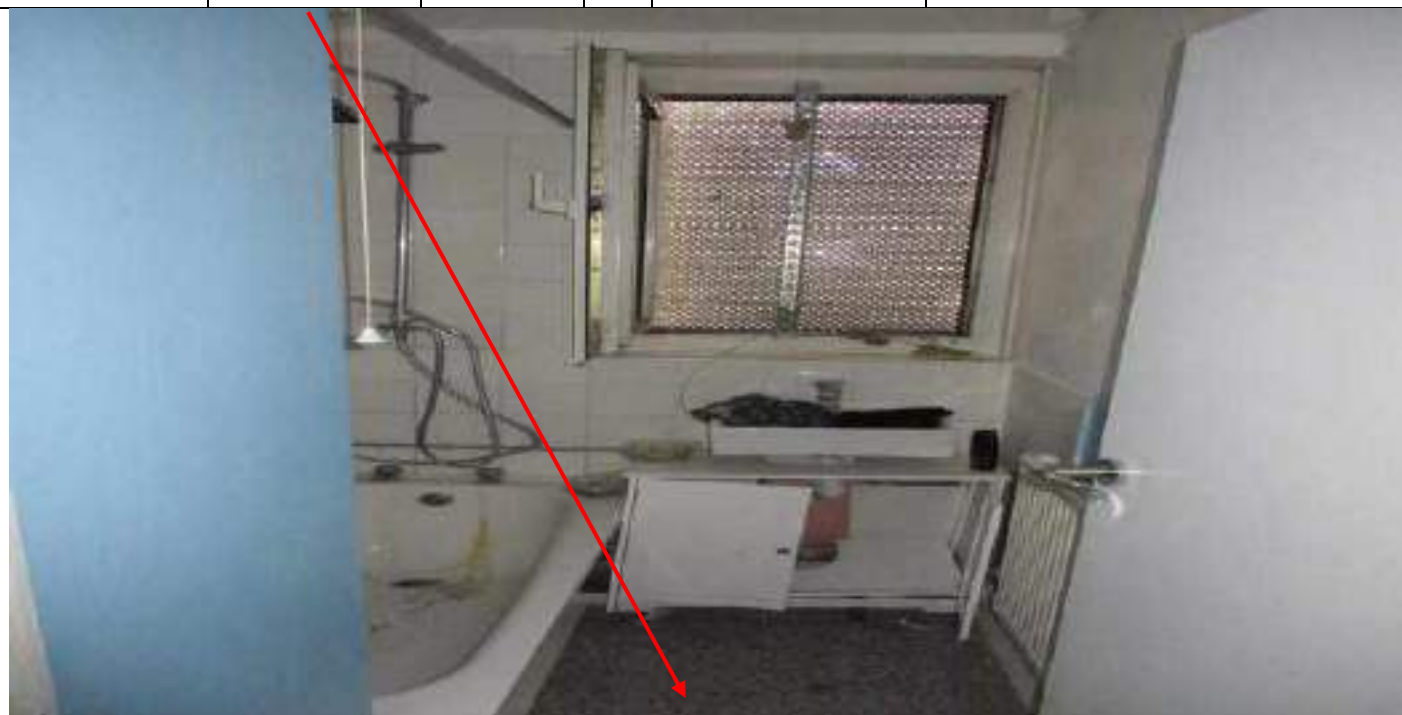
<i>Environmental Inspection Record</i>				FRAMPTON, AGAR GROVE, LONDON, NW1 2SN			
<i>Location</i>		<i>Component</i>			<i>Inspection Ref</i>		
GROUND FLOOR FLAT 3 BATHROOM		PLASTERBOARD CEILING TO TIMBER JOISTS CERAMIC TILES TO PLASTERED BRICK/BREEZE BLOCK WALLS MODERN VINYL FLOOR COVERING OVER ASBESTOS VINYL FLOOR TILES & BITUMEN TO CONCRETE			<i>Surveyor:</i>	PB & MC	
					PICTURE 96 AS SAMPLE 2		
					<i>Date:</i>	19/01/21	
					<i>Survey Type:</i>	REFURBISHMENT/ DEMOLITION SURVEY	
<i>Condition:</i>	FAIR	<i>Access:</i>	EASY		<i>Asbestos?</i>	YES	
					<i>Re Inspection Date:</i>	N/A	
<i>Friability:</i>	LOW	<i>Amount:</i>	APPROX: 2M²		<i>Type:</i>	CHRYBOTILE TO BOTH	
<i>Damage:</i>	LOW	<i>Exposure:</i>	OCCUPANTS		<i>Analysis:</i>	TILES	<7%
						BITUMEN	<8%
<i>Position:</i>	VINYL FLOOR TILE & BITUMEN	<i>Risk Factor</i>	4	<i>Priority Assessment:</i>	MINOR RISK		
		<i>Risk Band</i>	D

<i>Recommended Action</i>	REMOVE IDENTIFIED ASBESTOS VINYL TILES & ADHESIVE BEFORE DEMOLITION WORKS COMMENCE, USING A COMPETENT CONTRACTOR
----------------------------------	---

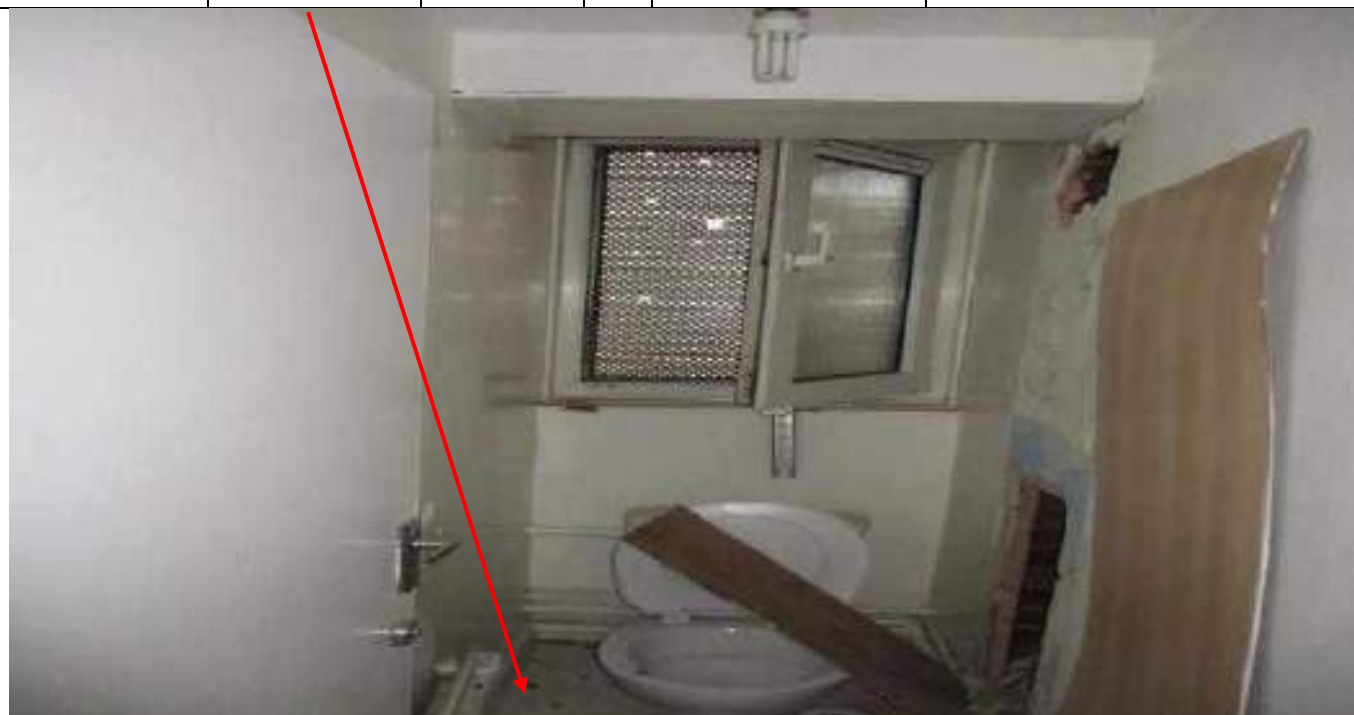
<i>Environmental Inspection Record</i>			FRAMPTON, AGAR GROVE, LONDON, NW1 2SN		
<i>Location</i>		<i>Component</i>		<i>Inspection Ref</i>	
GROUND FLOOR FLAT 3 WC		PLASTERBOARD CEILING TO TIMBER JOISTS CERAMIC TILES TO PLASTERED BRICK/BREEZE BLOCK WALLS MODERN VINYL FLOOR COVERING OVER ASBESTOS VINYL FLOOR TILES & BITUMEN TO CONCRETE		<i>Surveyor:</i>	PB & MC
				PICTURE 97 AS SAMPLE 2	
				<i>Date:</i>	19/01/21
				<i>Survey Type:</i>	REFURBISHMENT/ DEMOLITION SURVEY
<i>Condition:</i>	FAIR	<i>Access:</i>	EASY	<i>Asbestos?</i>	YES
				<i>Re Inspection Date:</i>	N/A
<i>Friability:</i>	LOW	<i>Amount:</i>	APPROX: 2M ²	<i>Type:</i>	CHRYBOTILE TO BOTH
<i>Damage:</i>	LOW	<i>Exposure:</i>	OCCUPANTS	<i>Analysis:</i>	TILES <7% BITUMEN <8%
<i>Position:</i>	VINYL FLOOR TILE & BITUMEN	<i>Risk Factor</i>	4	<i>Priority Assessment:</i>	MINOR RISK
		<i>Risk Band</i>	D

<i>Recommended Action</i>	REMOVE IDENTIFIED ASBESTOS VINYL TILES & ADHESIVE BEFORE DEMOLITION WORKS COMMENCE, USING A COMPETENT CONTRACTOR
----------------------------------	---

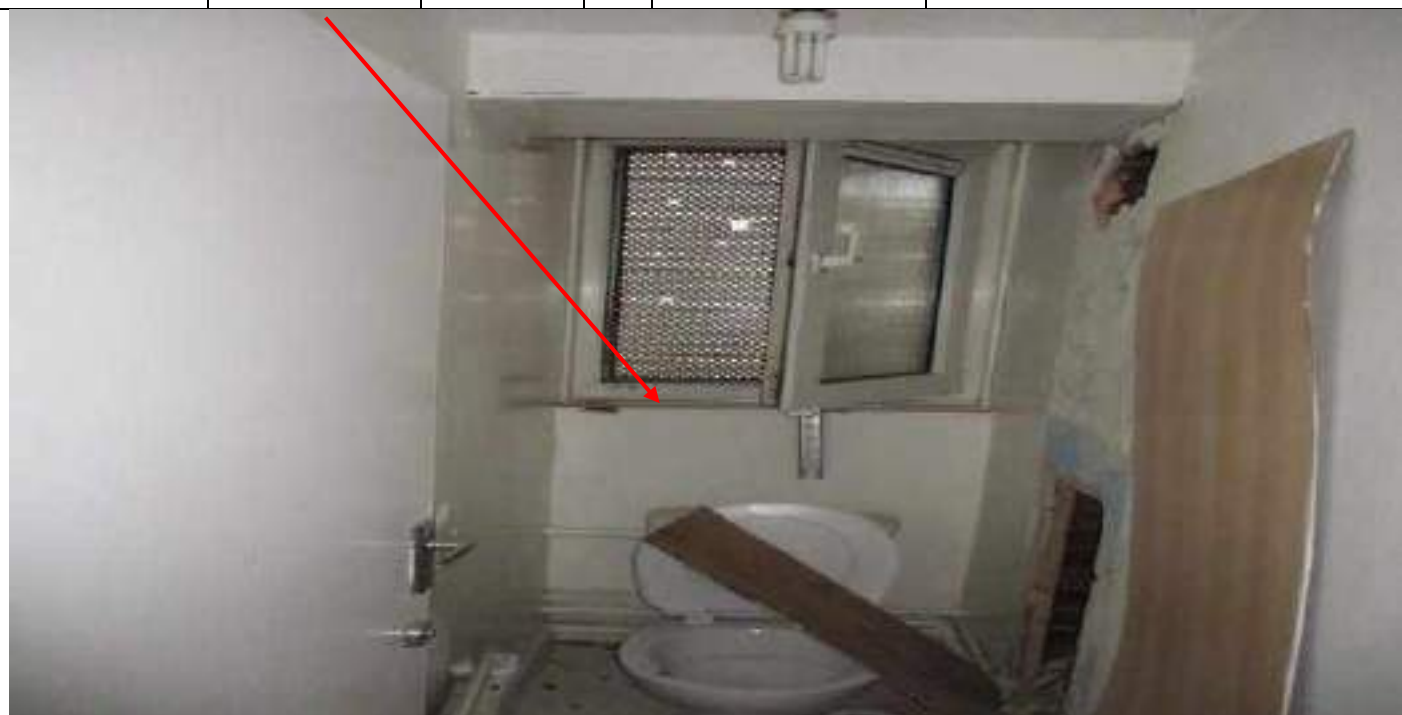
<i>Environmental Inspection Record</i>			FRAMPTON, AGAR GROVE, LONDON, NW1 2SN		
<i>Location</i>		<i>Component</i>		<i>Inspection Ref</i>	
GROUND FLOOR FLAT 3 WC		ASBESTOS CEMENT SHELF		<i>Surveyor:</i>	PB & MC
				PICTURE 98 AS SAMPLE 4	
				<i>Date:</i>	19/01/21
				<i>Survey Type:</i>	REFURBISHMENT/ DEMOLITION SURVEY
<i>Condition:</i>	FAIR	<i>Access:</i>	EASY	<i>Asbestos?</i>	YES
				<i>Re Inspection Date:</i>	N/A
<i>Friability:</i>	LOW	<i>Amount:</i>	APPROX: 0.5M ²	<i>Type:</i>	CHRYSOTILE
<i>Damage:</i>	LOW	<i>Exposure:</i>	OCCUPANTS	<i>Analysis:</i>	< 25%
<i>Position:</i>	CEMENT SHELF	<i>Risk Factor</i>	5	<i>Priority Assessment:</i>	MINOR RISK
		<i>Risk Band</i>	D

<i>Recommended Action</i>	REMOVE IDENTIFIED ASBESTOS CEMENT SHELF BEFORE DEMOLITION WORKS COMMENCE, USING A COMPETENT CONTRACTOR
----------------------------------	---

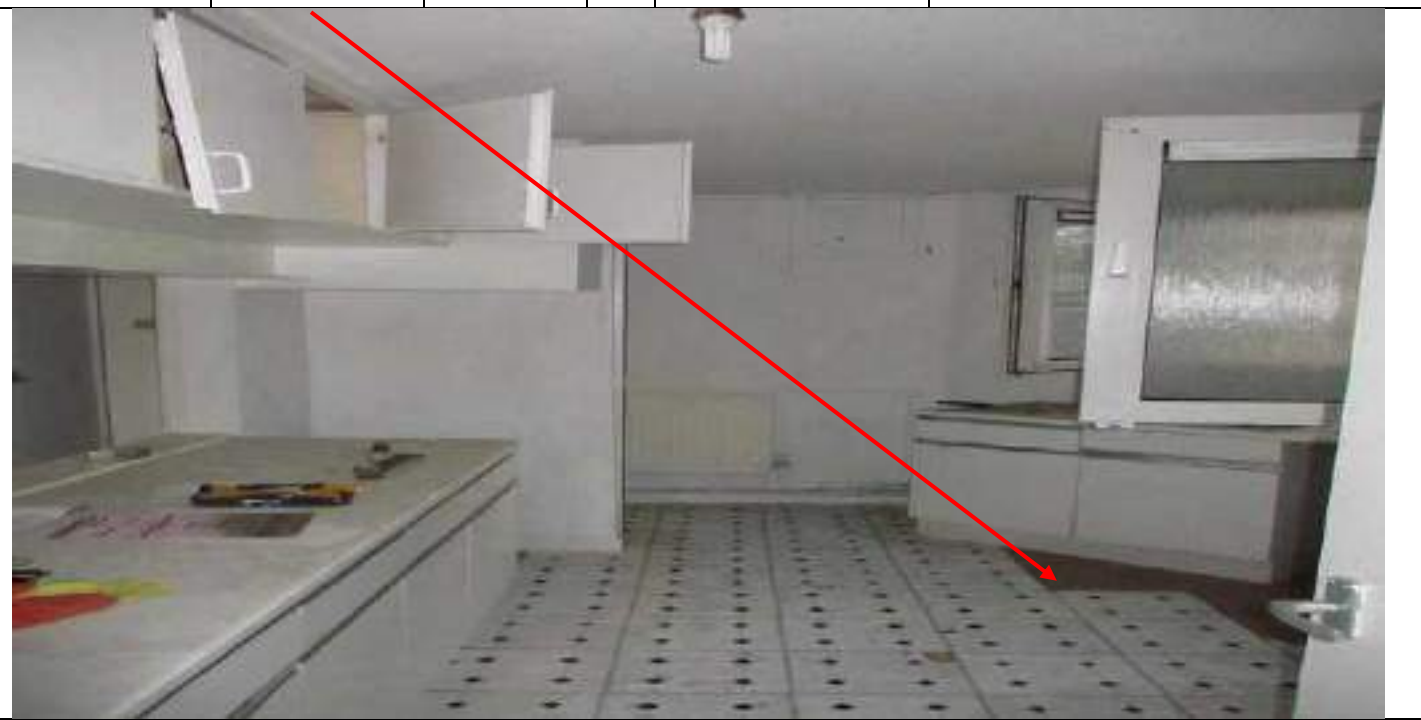
<i>Environmental Inspection Record</i>				FRAMPTON, AGAR GROVE, LONDON, NW1 2SN						
<i>Location</i>		<i>Component</i>			<i>Inspection Ref</i>					
GROUND FLOOR FLAT 3 KITCHEN		PLASTERBOARD CEILING TO TIMBER JOISTS CERAMIC TILES TO PLASTERED BRICK/BREEZE BLOCK WALLS MODERN VINYL FLOOR COVERING OVER ASBESTOS VINYL FLOOR TILES & BITUMEN TO CONCRETE			<i>Surveyor:</i>		PB & MC			
					PICTURE 99 AS SAMPLE 2					
					<i>Date:</i>		19/01/21			
					<i>Survey Type:</i>		REFURBISHMENT/ DEMOLITION SURVEY			
<i>Condition:</i>	FAIR	<i>Access:</i>	EASY			<i>Asbestos?</i> YES				
		<i>Re Inspection Date:</i> N/A								
<i>Friability:</i>	LOW	<i>Amount:</i>	APPROX: 12M ²			<i>Type:</i>	CHRYSOTILE TO BOTH			
<i>Damage:</i>	LOW	<i>Exposure:</i>	OCCUPANTS			<i>Analysis:</i>	TILES <7% BITUMEN <8%			
<i>Position:</i>	VINYL FLOOR TILE & BITUMEN	<i>Risk Factor</i>	4	<i>Priority Assessment:</i>		MINOR RISK				
		<i>Risk Band</i>	D

<i>Recommended Action</i>	REMOVE IDENTIFIED ASBESTOS VINYL TILES & ADHESIVE BEFORE DEMOLITION WORKS COMMENCE, USING A COMPETENT CONTRACTOR
----------------------------------	---

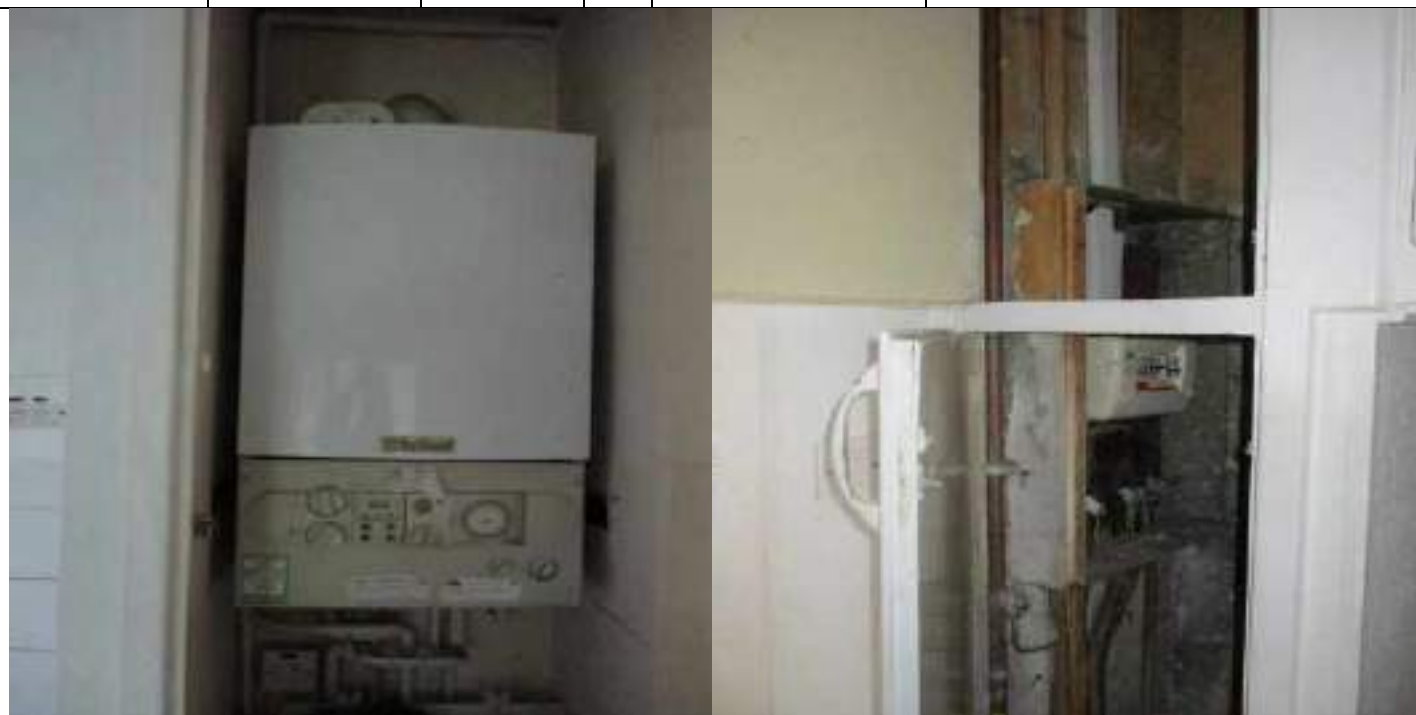
<i>Environmental Inspection Record</i>				FRAMPTON, AGAR GROVE, LONDON, NW1 2SN	
<i>Location</i>		<i>Component</i>		<i>Inspection Ref</i>	
GROUND FLOOR FLAT 3 CUPBOARDS		BOILER WITH METAL FLUE PIPE ELECTRICAL FUSE BOARD		<i>Surveyor:</i>	PB & MC
				PICTURE 100 & 101	
				<i>Date:</i>	19/01/21
				<i>Survey Type:</i>	REFURBISHMENT/ DEMOLITION SURVEY
<i>Condition:</i>	N/A	<i>Access:</i>	N/A	<i>Asbestos?</i>	NO
				<i>Re Inspection Date:</i>	N/A
<i>Friability:</i>	N/A	<i>Amount:</i>	N/A	<i>Type:</i>	NON ASBESTOS
<i>Damage:</i>	N/A	<i>Exposure:</i>	N/A	<i>Analysis:</i>	N/A
<i>Position:</i>	CUPBOARD	<i>Risk Factor</i>	0	<i>Priority Assessment:</i>	NO RISK
		<i>Risk Band</i>	E

<i>Recommended Action</i>	NO ASBESTOS MATERIALS IDENTIFIED.
---------------------------	--
